**ASSESSMENT OF EROSION AND PLANT COVER  
ON THE TRANS ALASKA PIPELINE  
RIGHT OF WAY  
MILEPOSTS 0 TO 800  
VOLUME 2**

**PREPARED FOR  
THE STATE PIPELINE COORDINATOR'S OFFICE  
ALASKA DEPARTMENT OF NATURAL RESOURCES  
SEPTEMBER, 1992**

**PREPARED BY  
NANCY J. MOORE  
ALASKA PLANT MATERIALS CENTER  
DIVISION OF AGRICULTURE  
ALASKA DEPARTMENT OF NATURAL RESOURCES**

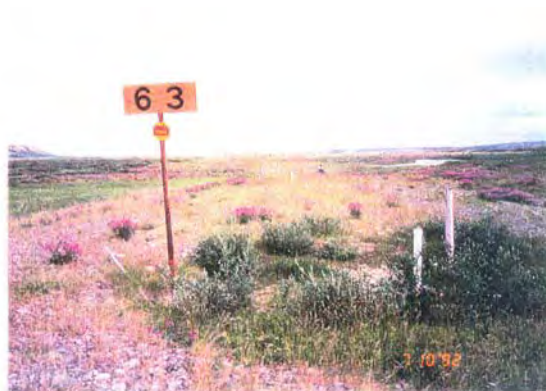
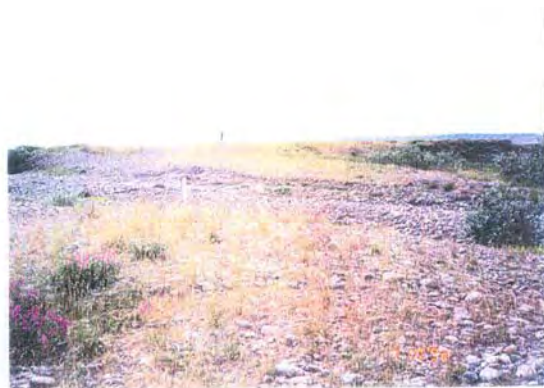
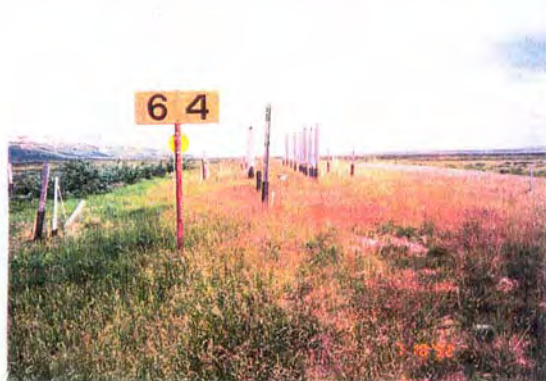
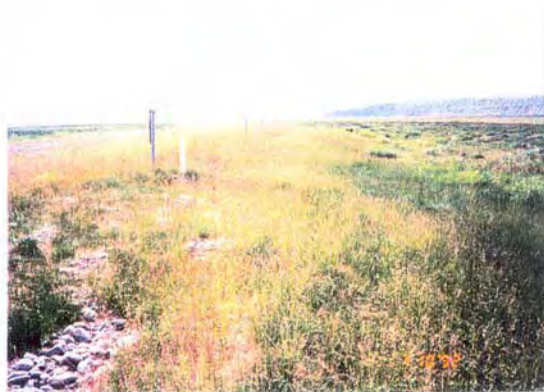
Mileposts 63 and 64. Thermokarst activity (refers to all four photographs).

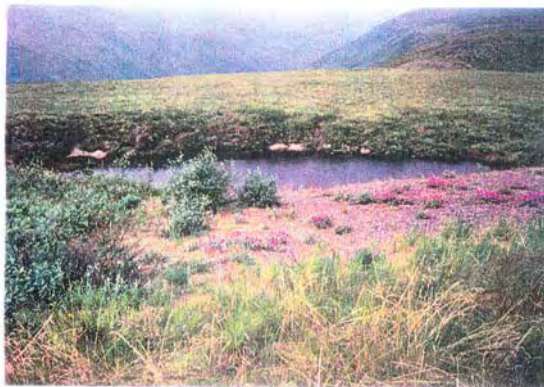
Thermokarst adjacent to workpad at approximately 174.8.
