Rehabilitation of the Kanuti Pit Materials Site 65-9-031-2 Located at Milepost 105 of the Dalton Highway

2007

Prepared by: Andrew Nolen Agronomist State of Alaska Department of Natural Resources Division of Agriculture Plant Materials Center

Prepared for: State of Alaska Department of Transportation and Public Facilities

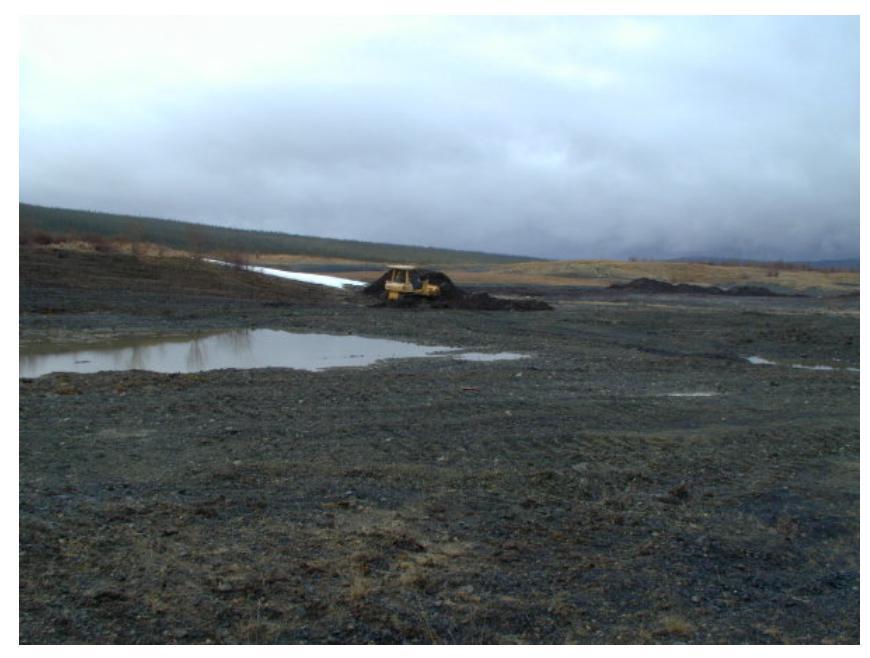
Photo 1. Dozer spreading organic soil June 2003

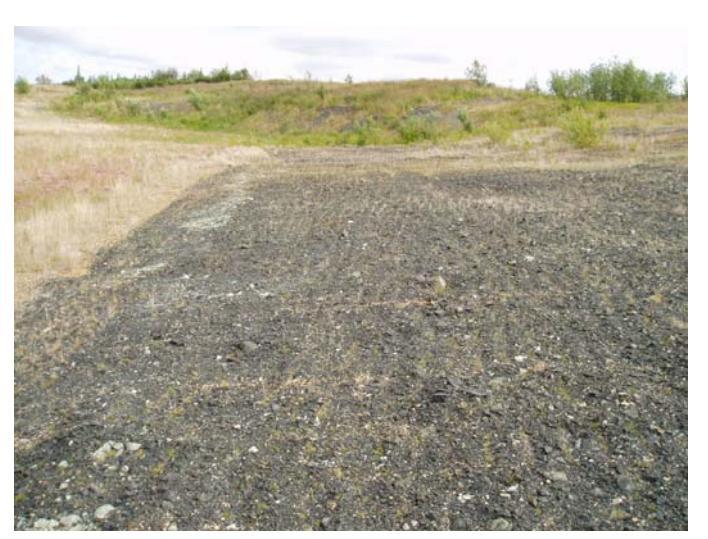
Photo 3. Sandy gravel soils with little vegetation on the south end of the project. (2006 photo)

As previously described, it was intended that the contractor applying the seed and fertilizer would be directed by a PMC staff member. This did not occur due to poor scheduling by the contractor. A few shortcomings in the execution of the seed and fertilizer applications resulted from the lack of direction. This, combined with some other factors, has resulted in one area of the project with lower plant cover than other areas. Photo 3 shows a portion of the north facing slope on the south side of the project (see figure 1). Soil in this area is sandy gravel. This is

also the area that had portions covered by snow drifts during the site preparation phase of the project. No organic soil was spread in this area (see figure 2). One reason for the lack of vegetation may be associated with the poor moisture holding capacity of the soil. This would have been improved by an organic soil application. Ripping may also have improved the ability of this area to sustain plant growth. This location is also one of the furthest points away from the pit access road. This may have resulted in a lower rate of seed and fertilizer application than in other areas. Photo 4 was taken in the fall of 2003 approximately two months after seed and fertilizer applications. The fact that seedling density appears to decrease uniformly away from this location indicates this area was probably used to load broadcast equipment. If spreading was done from this location for each load without a focus on uniformity, application rates would be greatest at this point and decrease as one moves away. Figure 3 depicts the approximate areas with relation to the reduced applications rates of seed and fertilizer.

Significant efforts should be made on future projects for professional oversight of all revegetation treatment activities. Also, highly organic topsoil should be placed across the entire project area to help insure uniform establishment of revegetation species and encourage natural reinvasion of native plants.

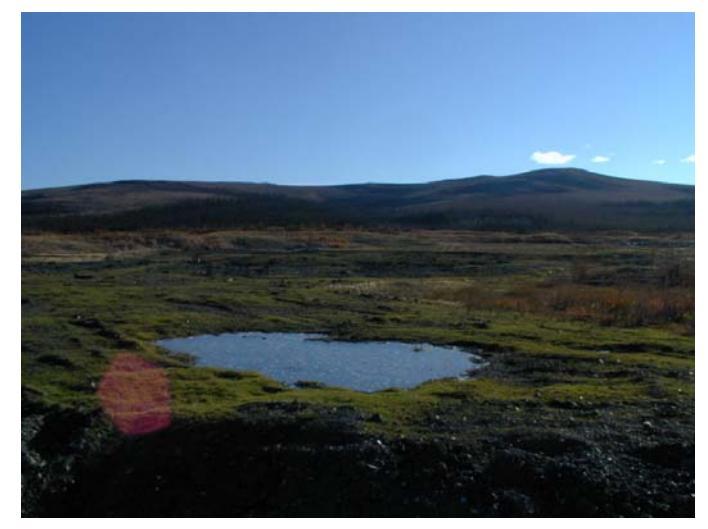
Photo 4. Heavier seeding rate close to loading area (Sept. 2003)

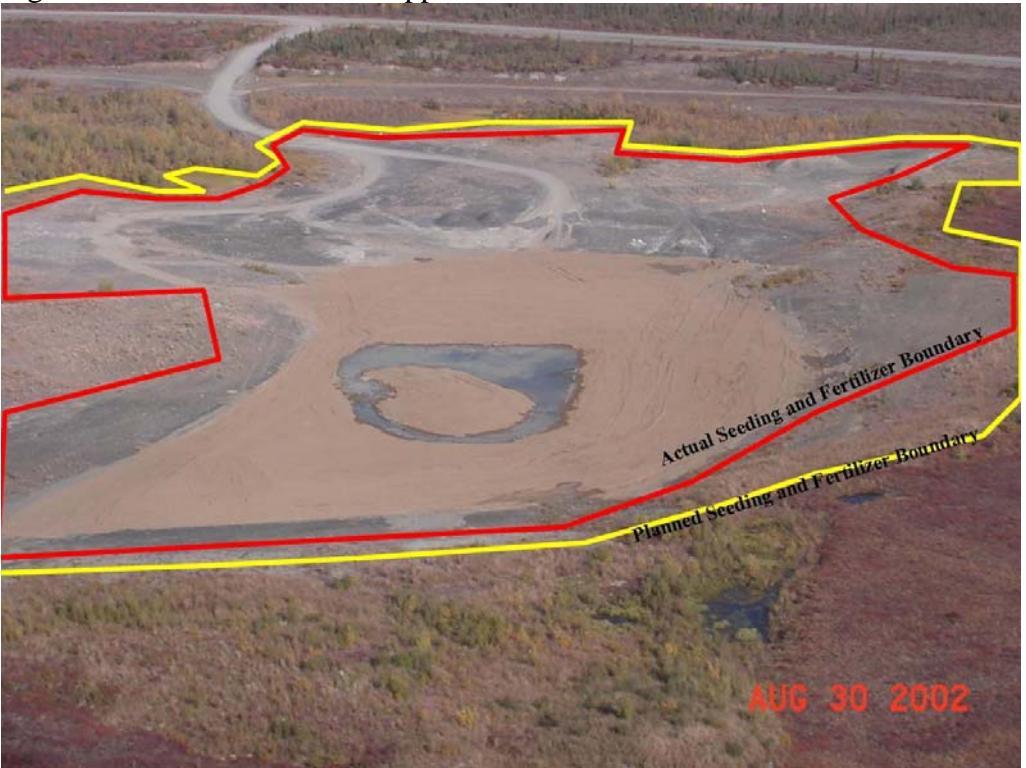
Figure 4. Planned vs. Actual Application Boundaries

The other shortcomings were primarily associated with the treatment area boundaries. The areas treated with seed and fertilizer appeared to only include portions that were completely void of vegetation. It was intended that the fertilizer boundary would have encompassed the entire pit area. This would have included much of the site that had not been disturbed for an extended period of time exhibiting vegetation establishment. It was intended that fertilizing these areas would have encouraged seed production on the primary invader species already present thus promoting the natural re-invasion of native plants to the site. Figure 4 compares the planned application boundary to the perceived application boundary. Since a PMC staff member was not present during the applications, all of the discussion regarding such are assumptions based on monitoring observations.

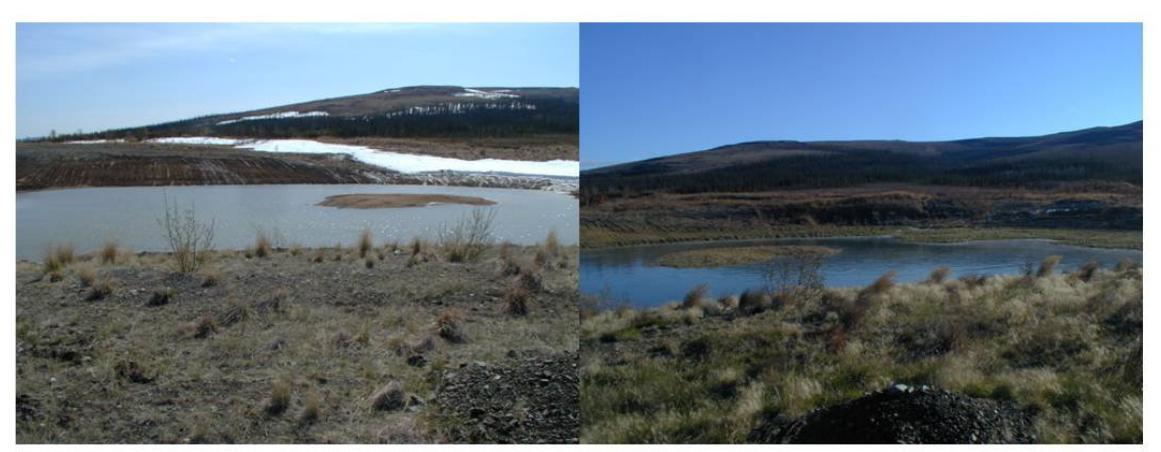
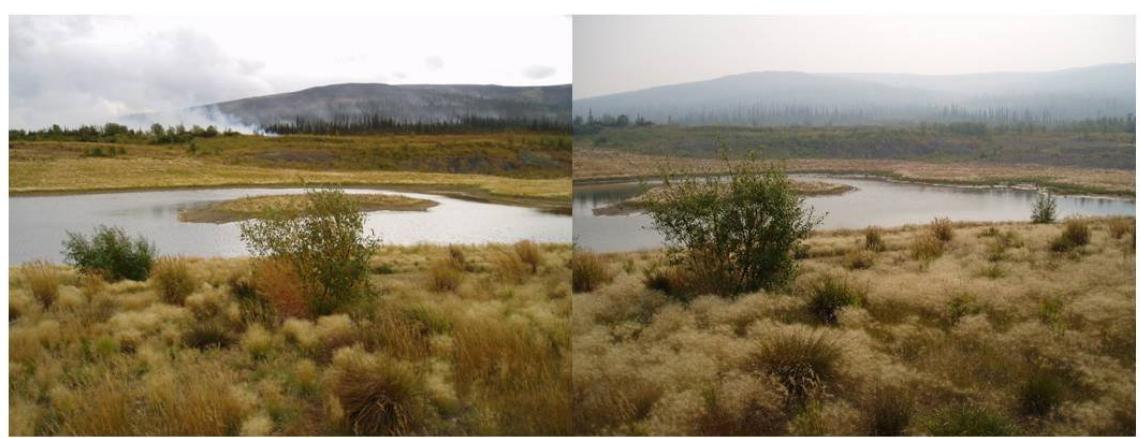
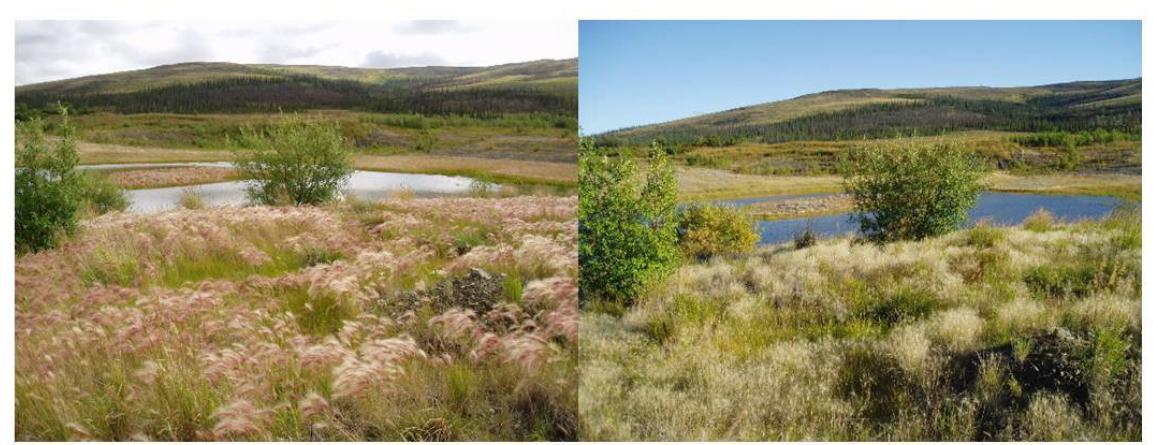
Photo Point 3.

*Vicia cracca*, a species not native to the area, was observed on the site near the location of photo points 3 and 4 during the 2006 and 2007 monitoring visits. Only one plant was observed each visit and was pulled out both times. This may warrant treatment before the scope of the infestation increases.
