# **1996 FINAL REPORT**

## **CHUGACH ELECTRIC ASSOCIATION, INC.**

### **GIRDWOOD TO INGRAM CREEK RESTORATION PROJECT**

**JANUARY 3, 1997**

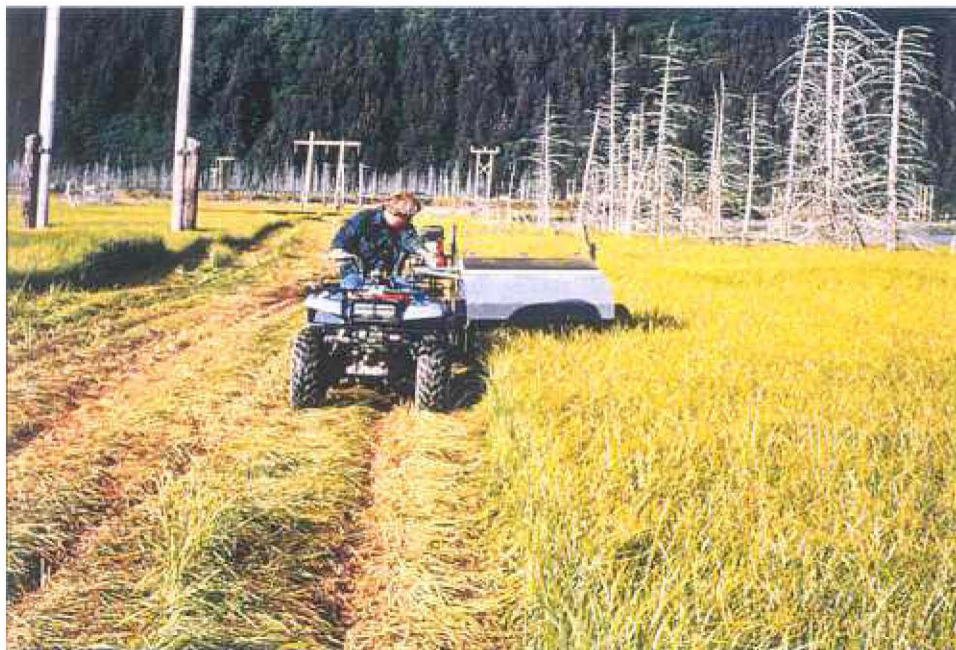
Figure      Seed stripper harvesting Lyngby sedge      STR 33

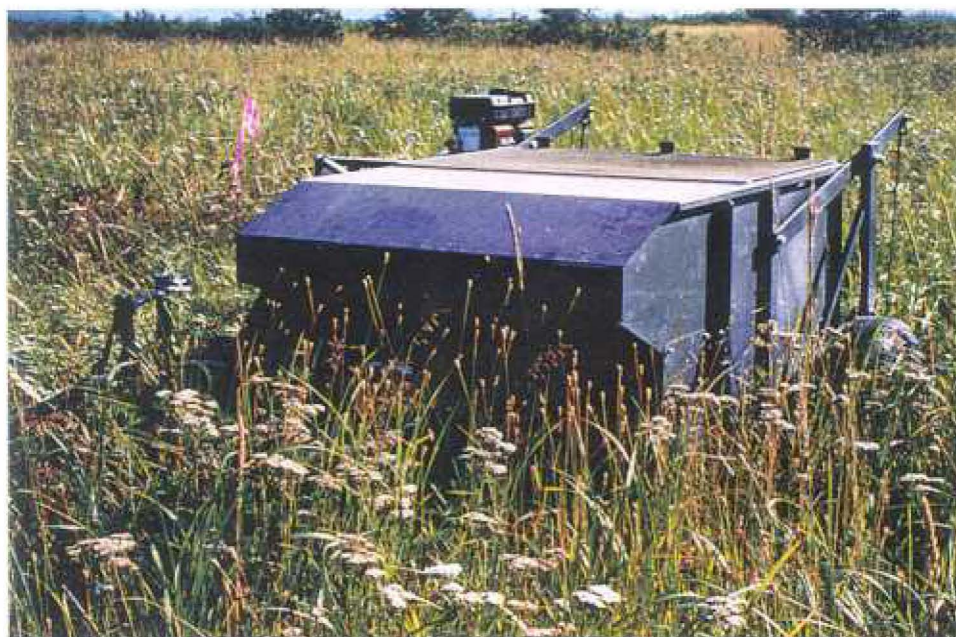
Figure 2. Seed stripper harvesting "upland" mix      native seed\* yarrow lupine and  
beach wildrye      STR      .8

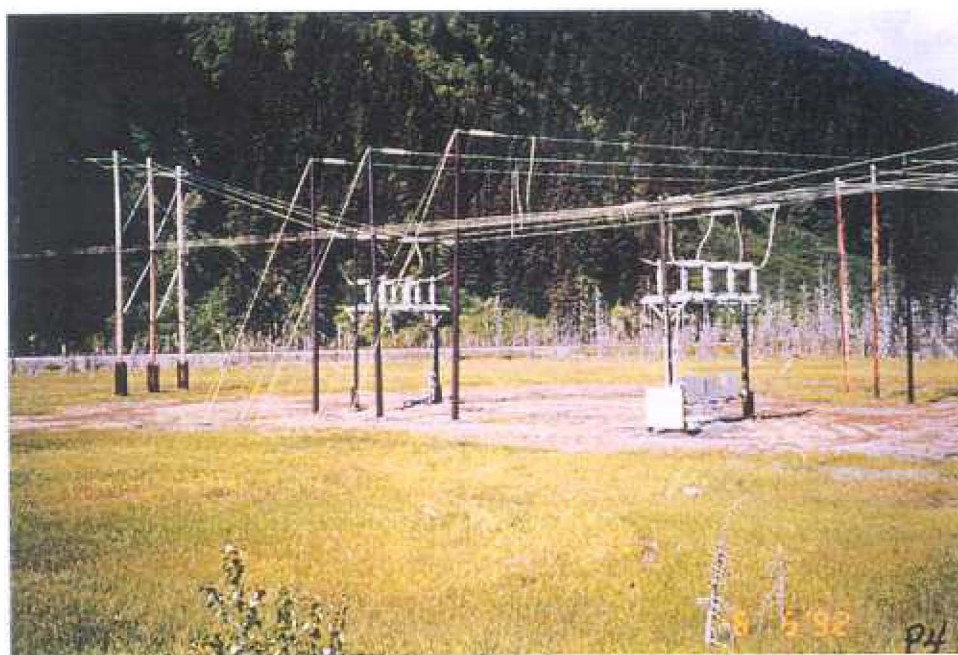
During August and September 1991, construction activities around the area known as the Girdwood Circuit Switcher caused a significant disturbance to the existing vegetation. The area failed to re-establish vegetation by natural means. CEA received numerous complaints regarding the "eyesore" caused by their activities. As part of the Girdwood to Twenty Mile River transmission line rebuild, additional construction activities were scheduled for this area resulting in additional surface disturbance. CEA was sensitive to the criticism received in the past and this area became a priority for restoration.

Figure 4. Girdwood Circuit Switcher, 1992.

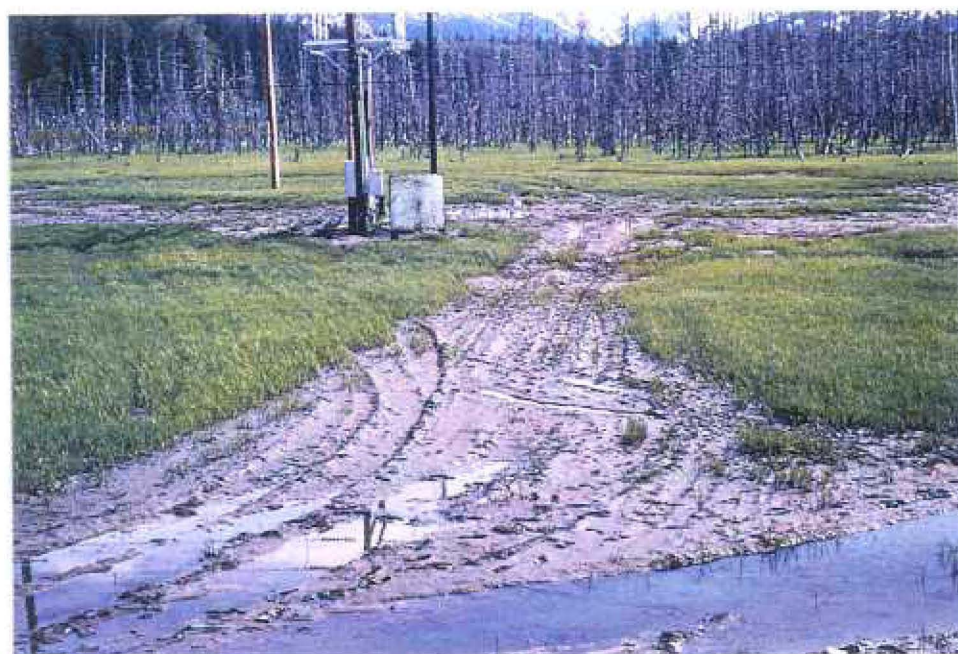
Figure 5. Girdwood Circuit Switcher area, May 31, 1995, prior to restoration.

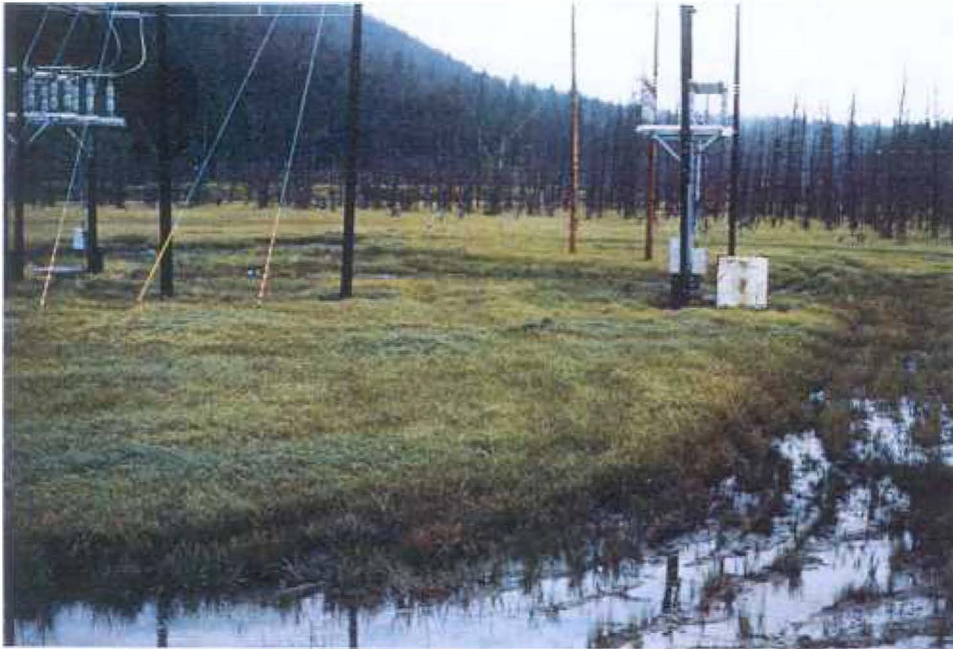
Figure 6. Girdwood Circuit Switcher area, August 30, 1995

The restoration activities conducted in Phase I (1995) greatly enhanced the overall appearance of the site. Natural reinvasion of native species expected after the 1991 construction project did not occur as hoped. However, After a single growing season in 1995 following the prescribed restoration treatment which included seeding with *Carex lyngbyaei* (Lyngby sedge), heavy rates of 8-32-16 fertilizer (1,000 pounds per acre), and transplanting, the area supported an excellent stand of natural vegetation. The restoration effort appears to have been effective and appropriate. It is interesting to note that though the transplanting activities were, for the most part, successful, they contributed relatively little to the overall success and appearance. The seeded sedge performed well and accounts for the majority of the vegetation composition; approximately 80% at the end of 1996. The most interesting finding at the end of 1996 was the increased occurrence of seashore arrowgrass, *Triglochin maritimum*. This species was not seeded, however, it contributed nearly 20% of the species composition. The presence of other species not seeded; i.e., *Plantago maritima*, *Potentilla Egedii* and *Hordeum brachyantherum* suggests the fertilizer is the critical component in coastal restoration programs. The true extent of fertilizer's role in the apparent success was not investigated. The overall cover in the area was estimated to range between 80-85% at the end of 1996. This is an exceptionally good cover value for two growing seasons.

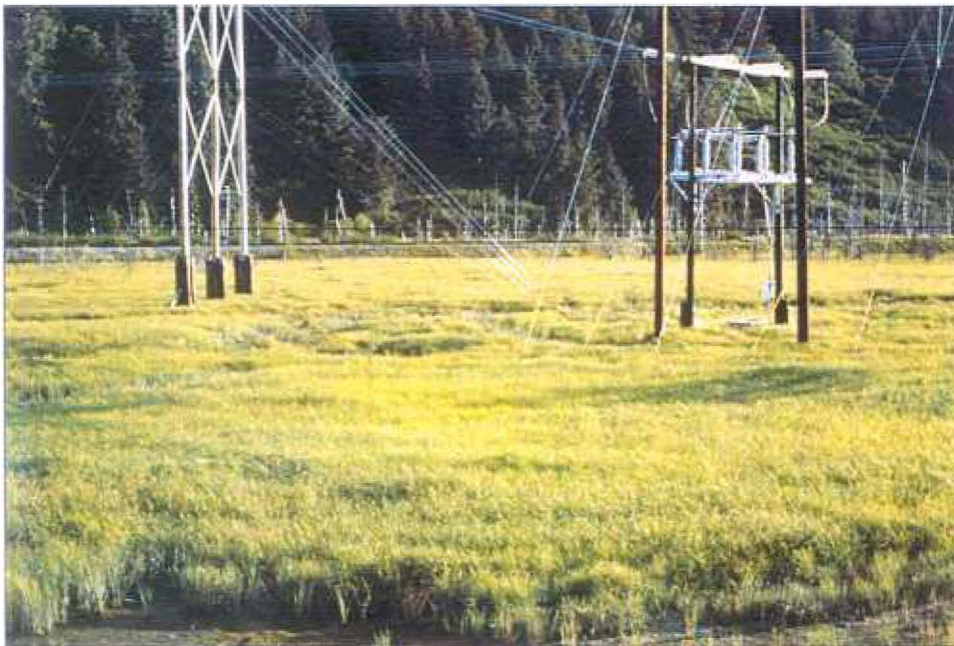
Figure 7. Girdwood Circuit Switcher Area, September 3, 1996.

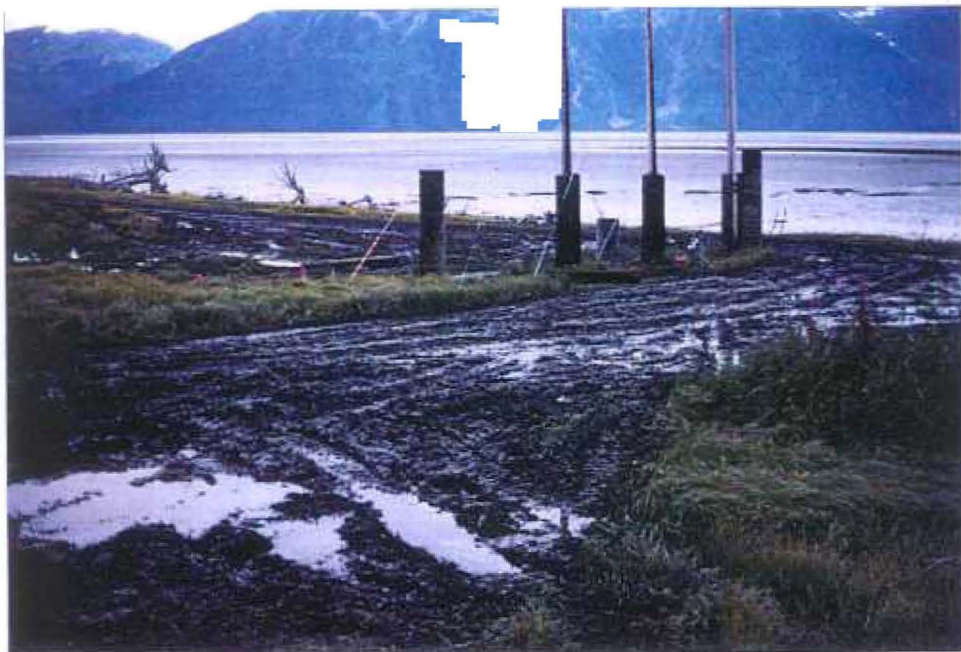
The access point and the area around 32-3 was initially the least responsive area on the project. As noted earlier, this site was seeded and fertilized twice. This action was taken when it was observed and noted that regrowth was not occurring to a rate nearly as good as other sites on the project. The reasons for the initial poor response are still speculation. However, evidence suggests that excessive equipment passes and turning may be in part the blame. Another possible explanation could be the action of ebbing and waning of extreme tides. The area is a major entry and exit point for these tides. The resulting current could be the detrimental force negatively affecting plant establishment (See Figure 12).

Figure 8. Access point 20-1, September 1995.

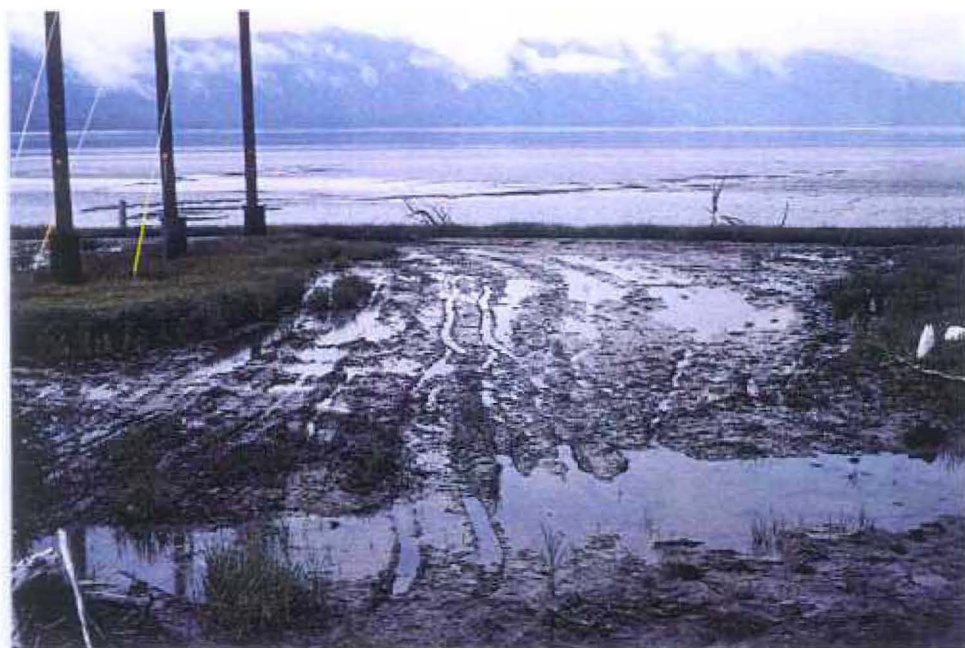
Figure 9. Access point 20-1, July 1995.

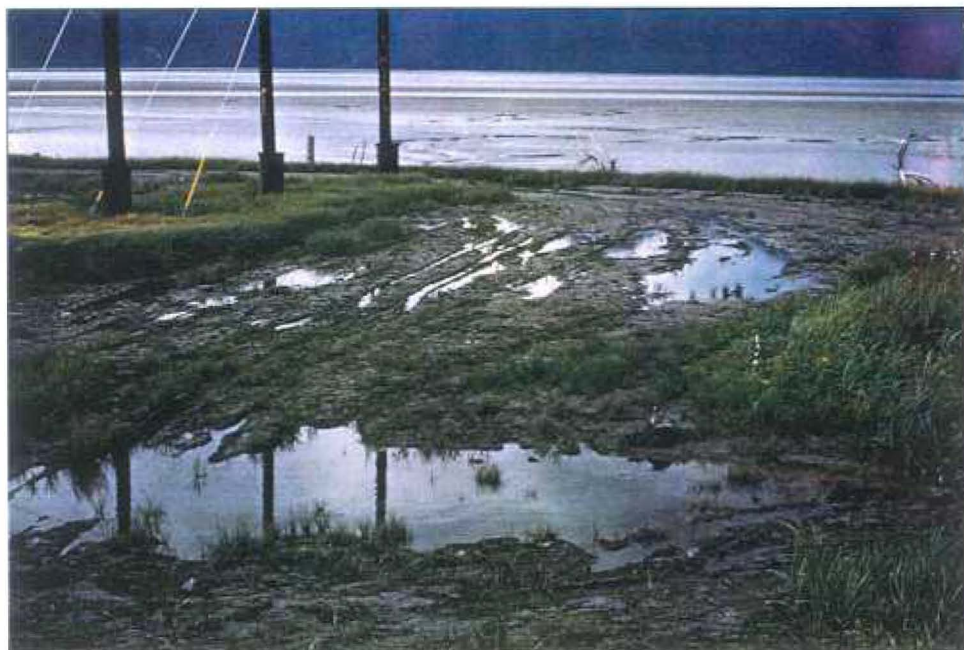
Figure 10. Access point 20-1, September 1995, after second treatment.

The only remedial work conducted on the project was in the area around Access Point 20-1. This action was taken on July 27, 1995 after it was obvious that the original activity was not working. This area was once more seeded with Lyngby sedge seed and fertilized. The second fertilization program relied on 8-32-16 fertilizer applied at a rate of 500 pounds per acre.

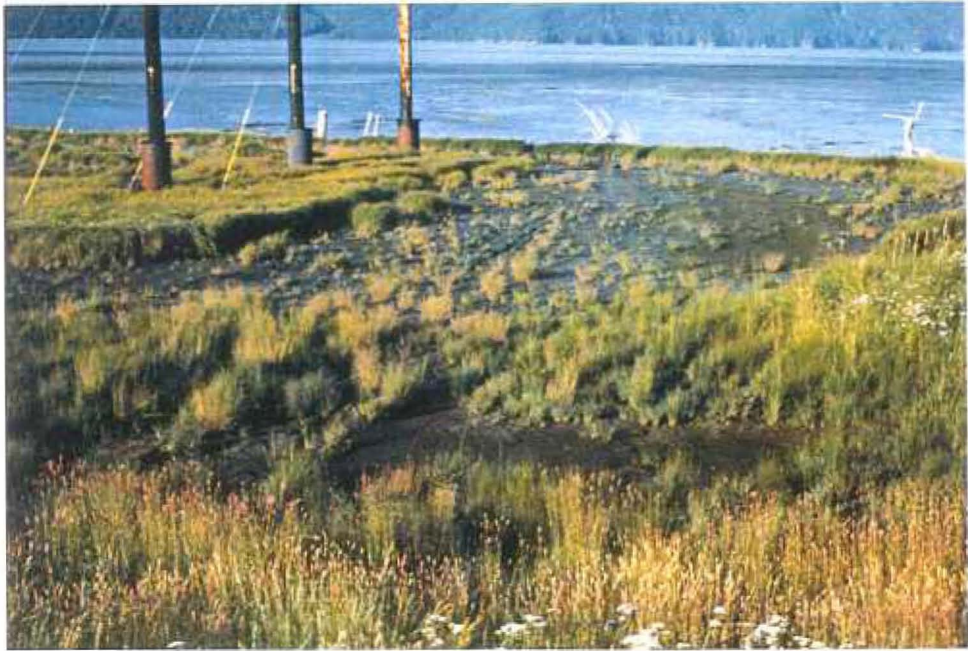
Figure 11. Access point 20-1, September 1996.

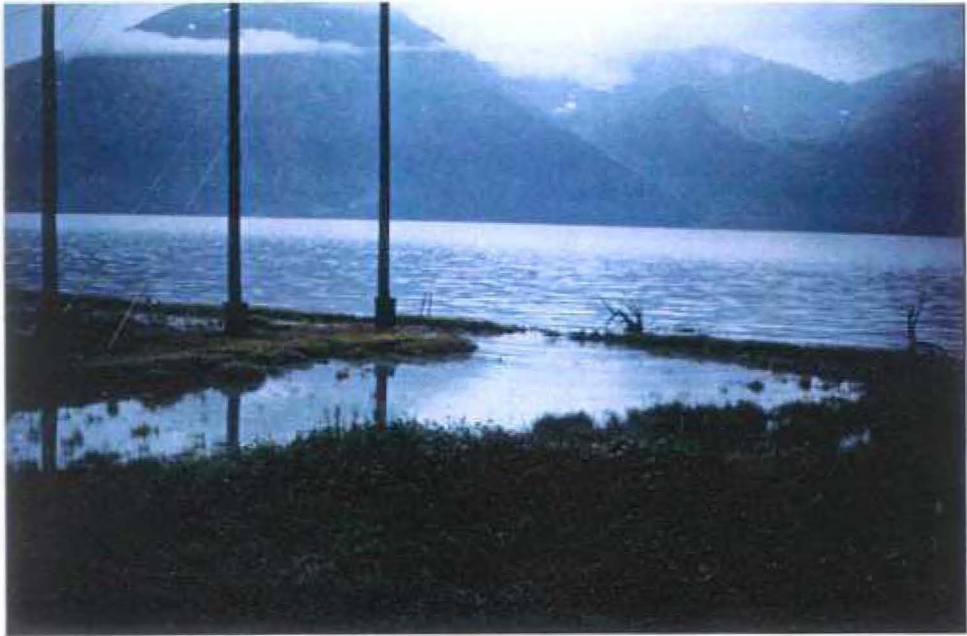
Figure 12. Access point 20-1 during an extreme high tide, August 1996.

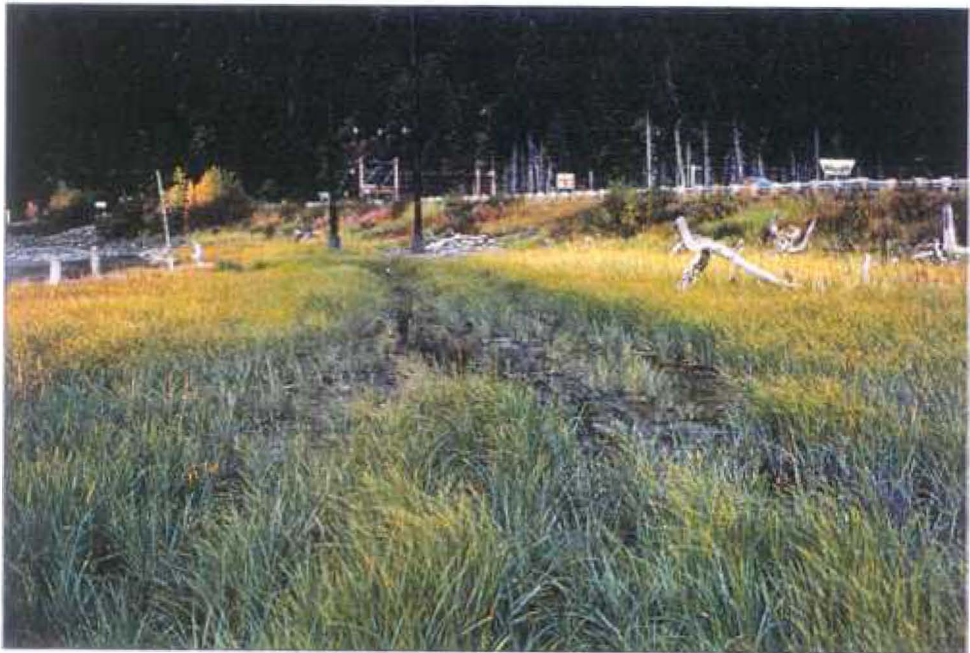
By September 1995, the area began responding to the restoration activities. This area also exhibited a high degree of *Triglochin* and *Potentilla* invasion. At the end of the study in September 1996, the area was showing approximately a 40% cover and appeared to be slowly responding to the restoration effort. The area between STR 32-2 and STR 32-3 responded well to the original treatment. In September 1995, the area supported a decent stand of native vegetation to the point where signs of construction activity were nearly negated. By September 1996, all evidence of the construction was gone, with the exception of a slightly lighter green appearance.

Figure 13. Area from STR 32-3 to STR 32-2, September 1995.

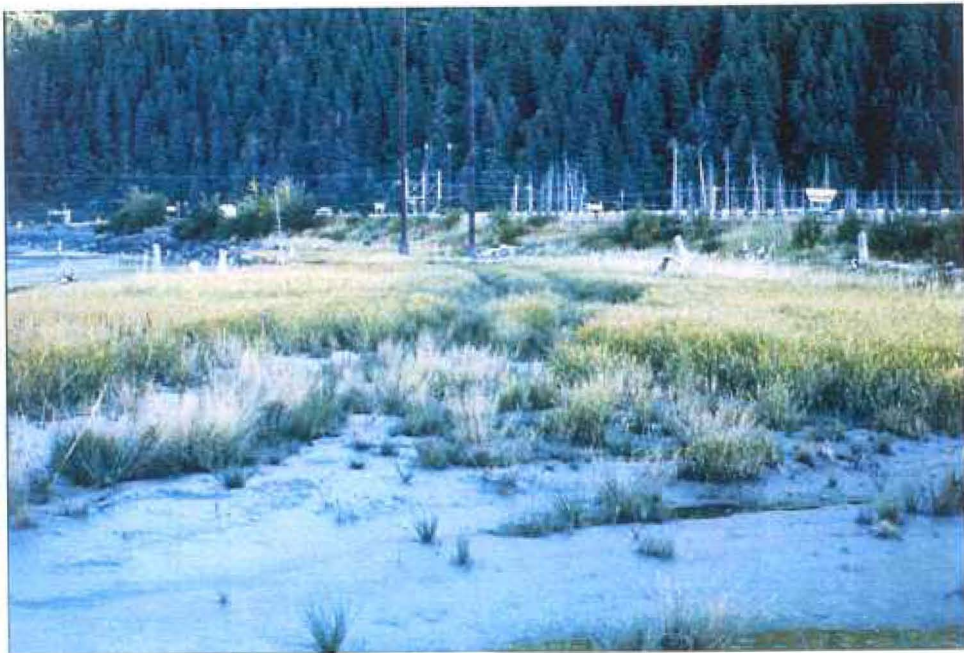
Figure 14. Area from STR 32-3 to STR 32-2, September 1996.

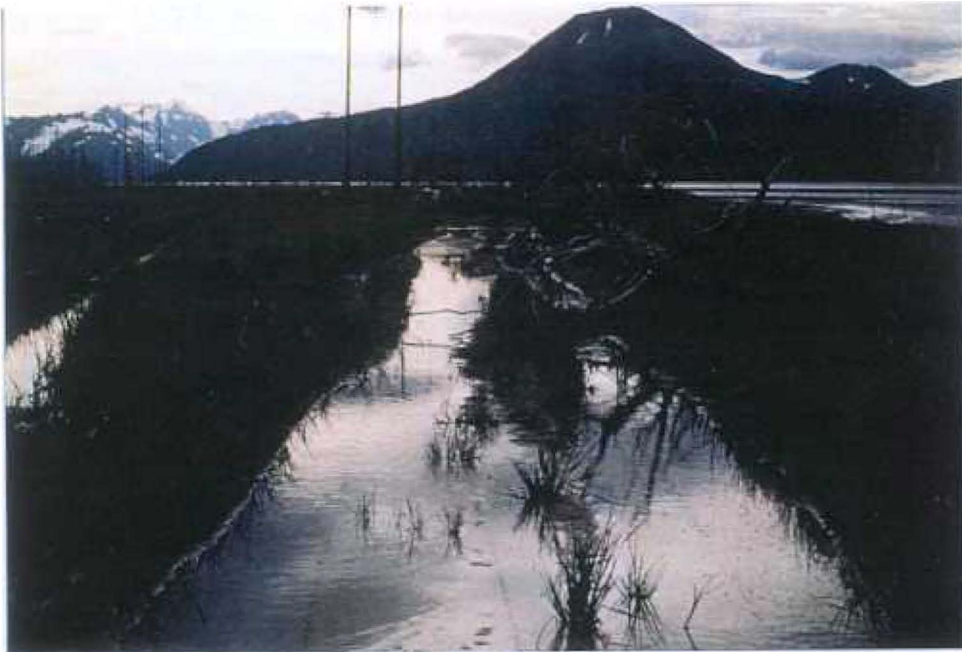
The area from STR 32-3 and 32-6 responded well to the restoration effort. However, the track marks are still quite visible. This tends to be less noticeable as STR 32-6 is approached, suggesting that the number of equipment passes plays a role in a site's ability to recover. By September 1996, the width of the equipment tracks was reduced by 70% and as STR 32-6 was approached, were no longer visible. As sediment and vegetation matter fill the ruts, the trail will become covered with vegetation.

Figure 15 Typical view between STR 32-3 and 32-6, 1995.

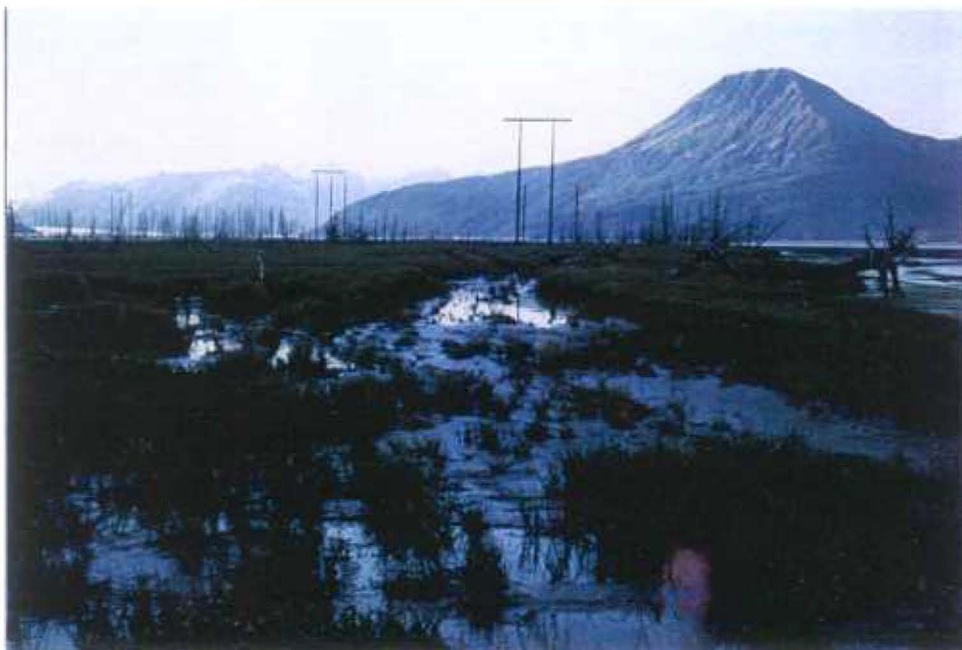
Figure 16. Typical view between STR 32-3 and 32-6 in September 1996

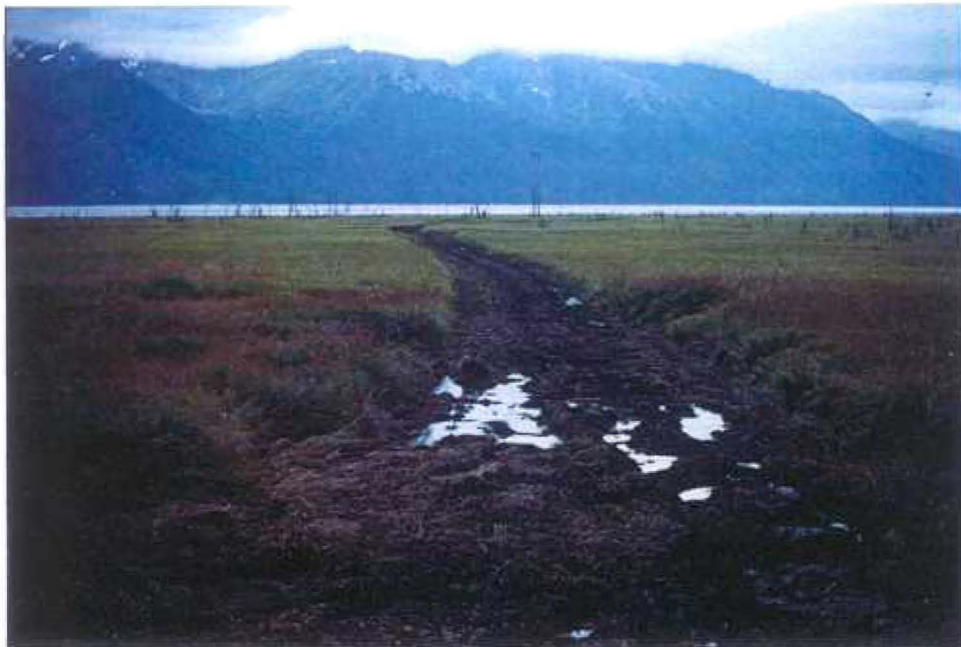
This access road, 20-2A, responded well to the restoration program. In September 1995, the trail supported a heavy growth of sedge seedlings. By September 1996, the trail supported a vigorous stand of sedge. It still, however, was showing signs of higher than normal fertilizer levels in the fact that the bright green color was still apparent. The bright color had, however, subsided from the level in 1995.

Figure 17. Access trail 20-2A, September 1994.

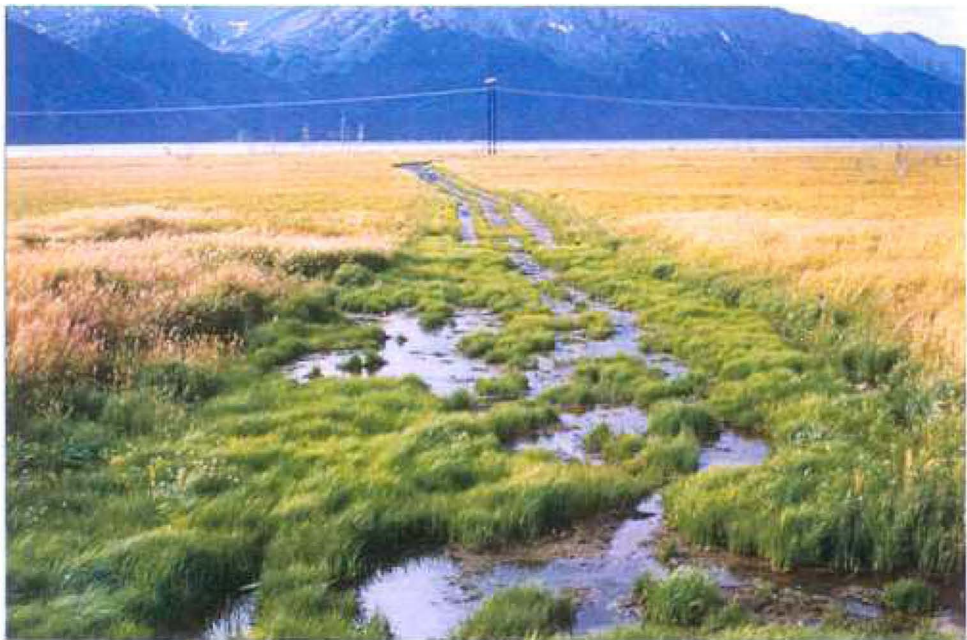
Figure 18. Access trail 20-2A, September 1995.

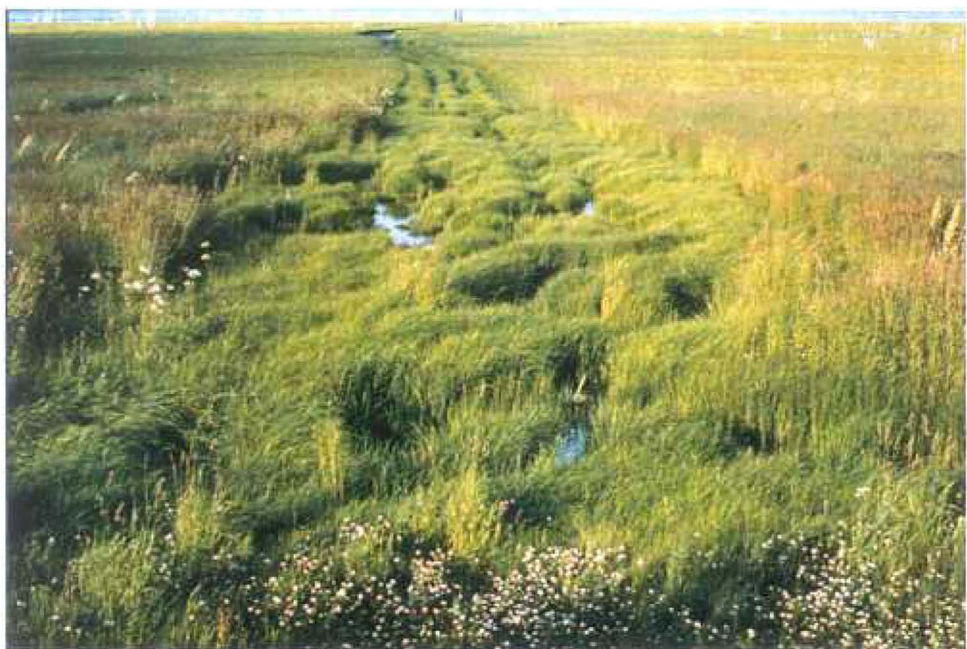
Figure 19. Access trail 20-2A, September 1996.

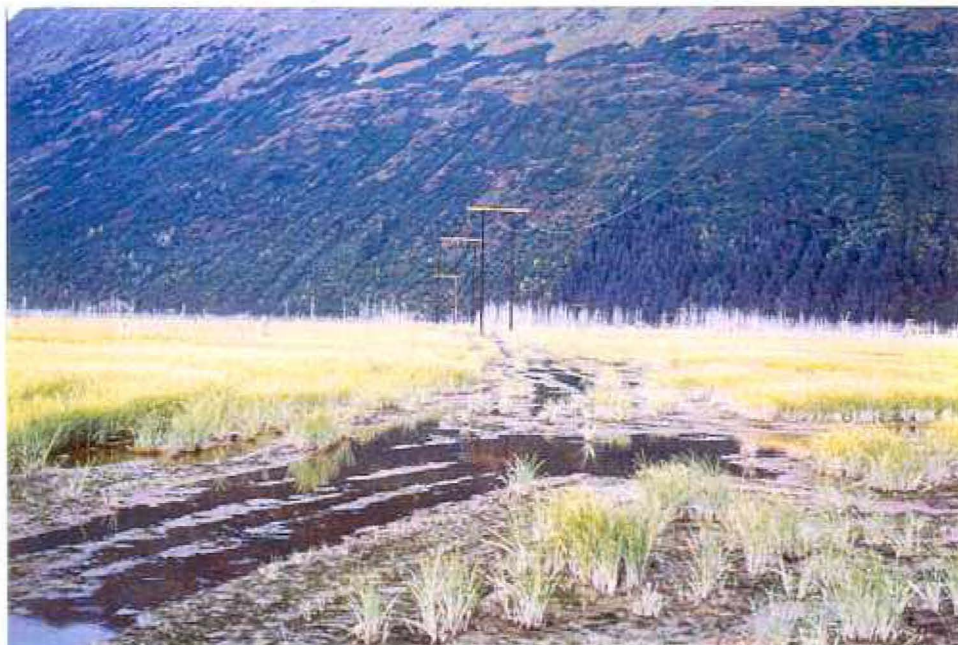
The ROW between STR 32-7 and STR 33-3 responded much like the area between STR 32-3 and STR 32-6. The overall width of the disturbance had been reduced to 12 to 8 feet. Track marks are barely visible; sedges are growing between the depressions left by the tracks. The degree of visible impact recedes as STR 32-7 and 33-3 are approached from the access trail; i.e., the far ends of the construction segment. At the end of the segment, signs of construction activity are almost non-existent.

Figure 20. Typical view of ROW segment between STR 32-7 and STR 33-3, September 1995.

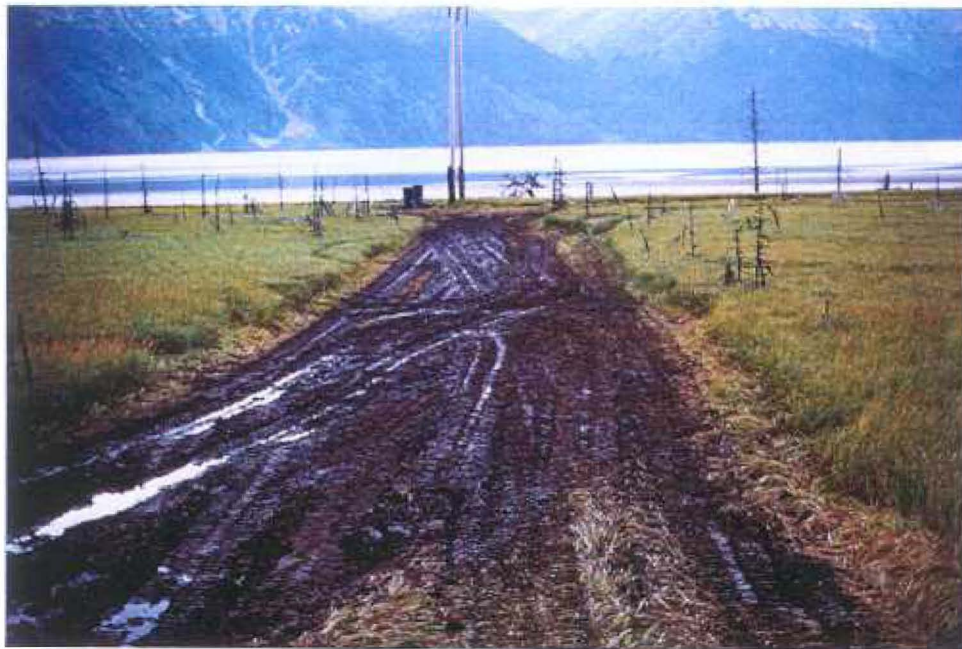
Access trail 21-1A exhibited the best response to the restoration program out of the three access points crossing saturated wetlands. In September 1995, this area supported nearly an 80% cover of seedling sedges. Cover levels increased to 90%+ in 1996.

Figure 21 Access trail 21-1A, September 1994

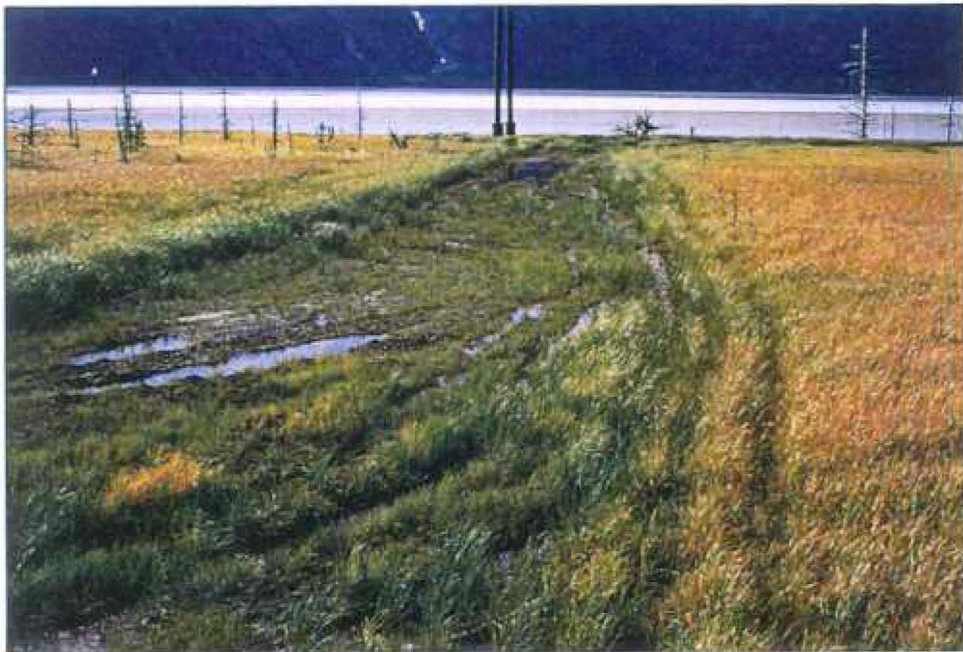
Figure 22. Access trail 21-1A, September 1995.

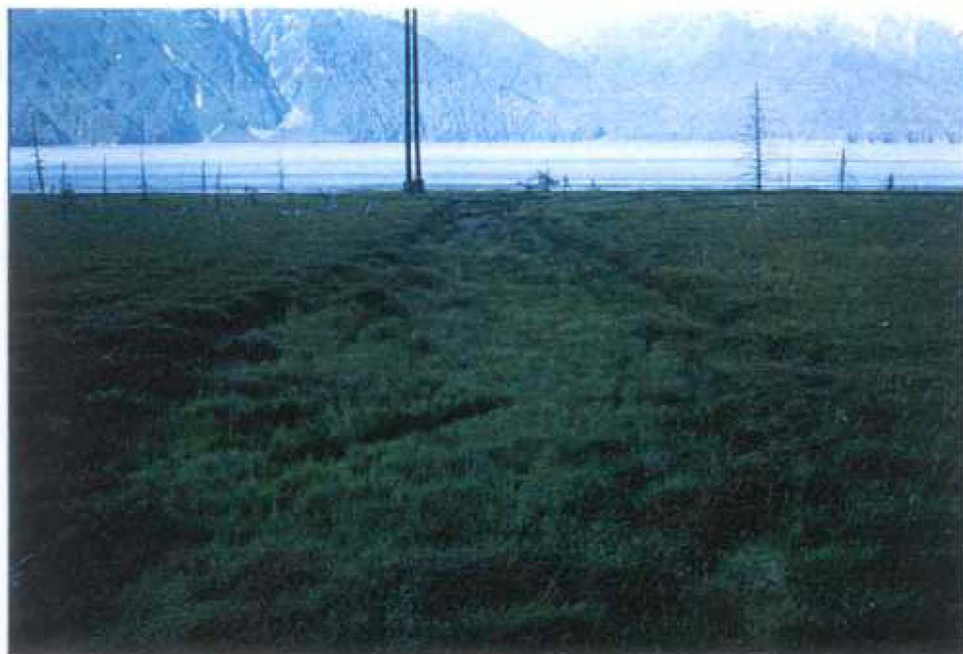
Figure 23. Access trail 21-1A, September 1996.

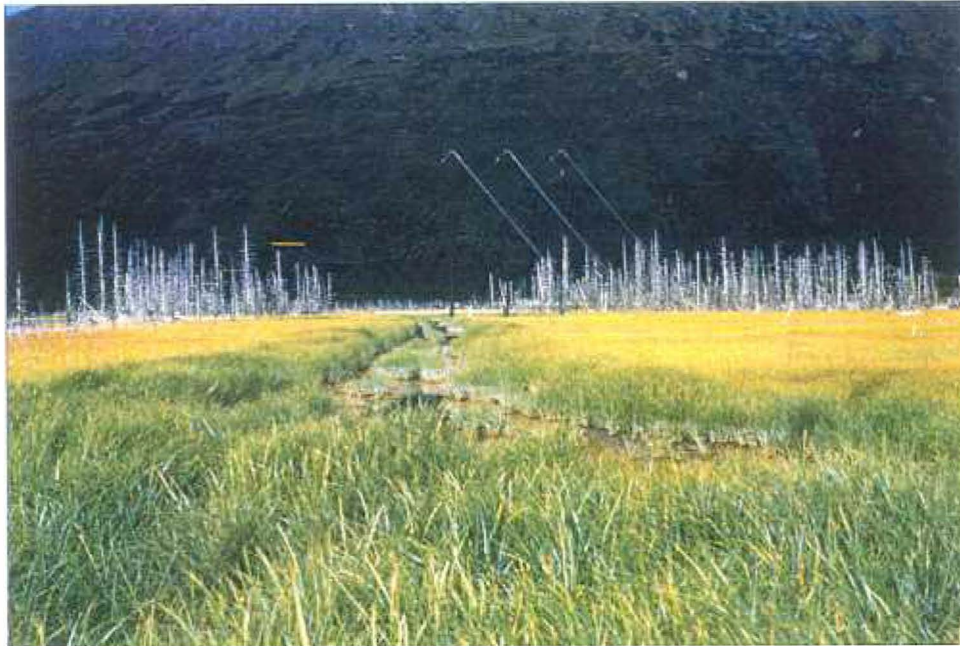
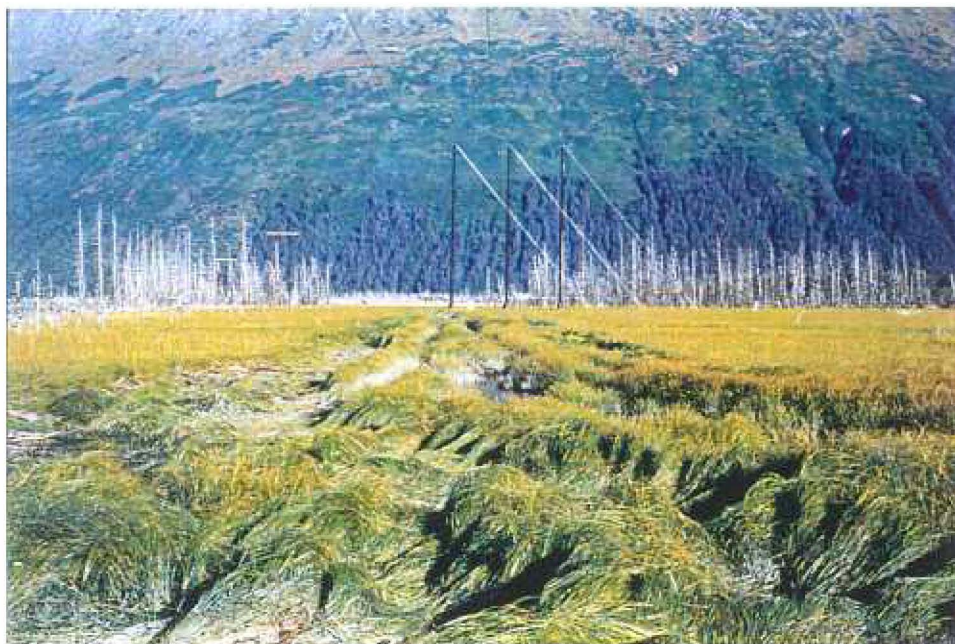
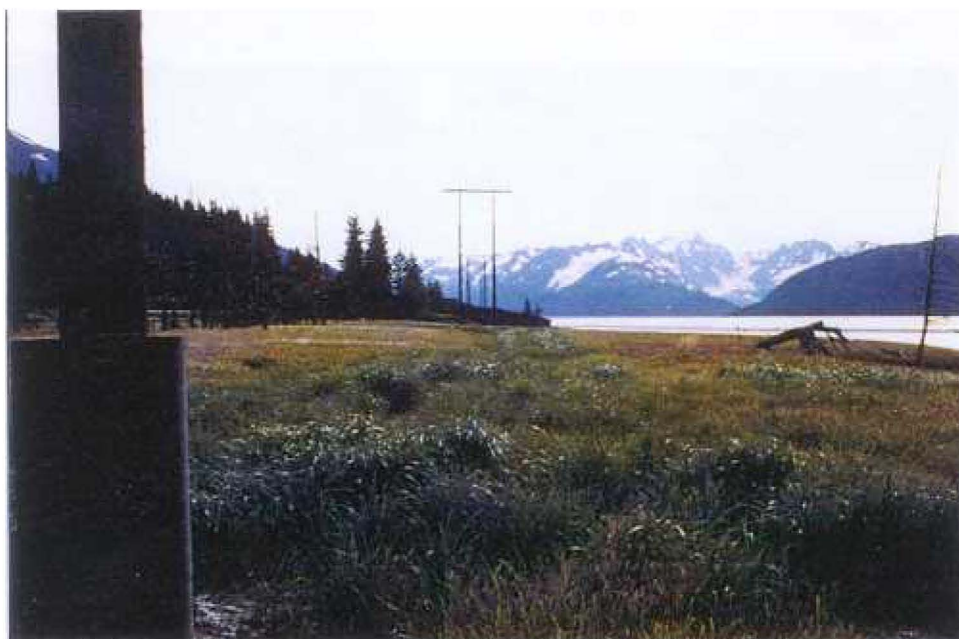
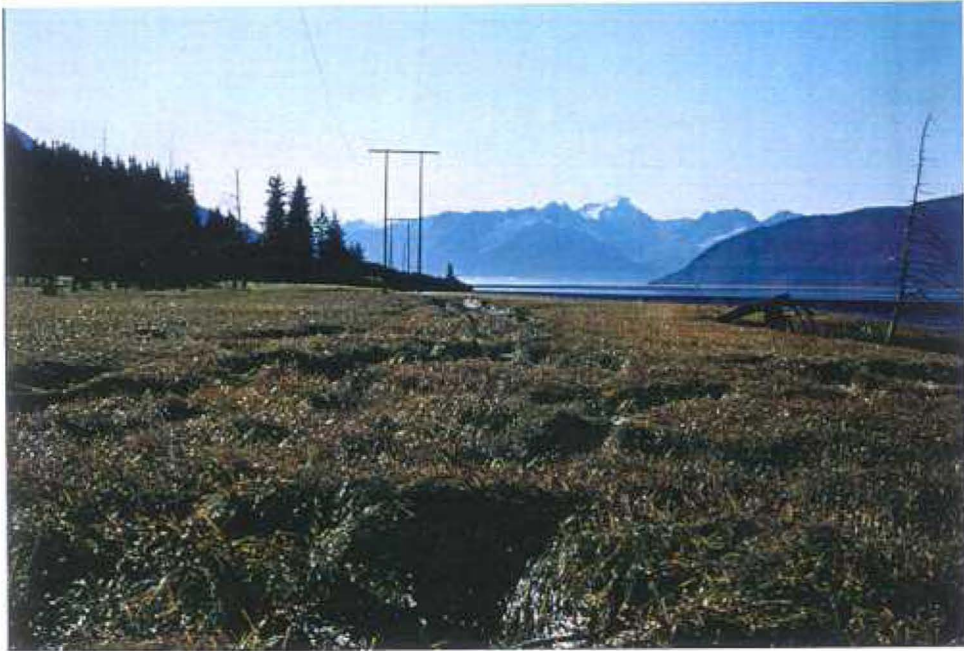
The ROW between STR 33-4 and STR 34-1 also responded better than the previously mentioned ROW segments. This is probably in part due to drier soils resulting from the increase in site elevation. By September 1995, only small vestiges of track marks remained between STR 33-4 and STR 33-6. No tracks were apparent from 33-6 to 34-1. When the site was last visited in September 1996, no signs other than a slight color difference in the vegetation, of construction were observed.

Figure 24. View from STR 33-6 to STR 33-5, September 1995.

Figure 25. View from STR 33-6 to STR 33-5, September 1996.

Figure 26. View from STR 33-6 to STR 34-1, September 1995

Figure 27. Same area in September 1996.

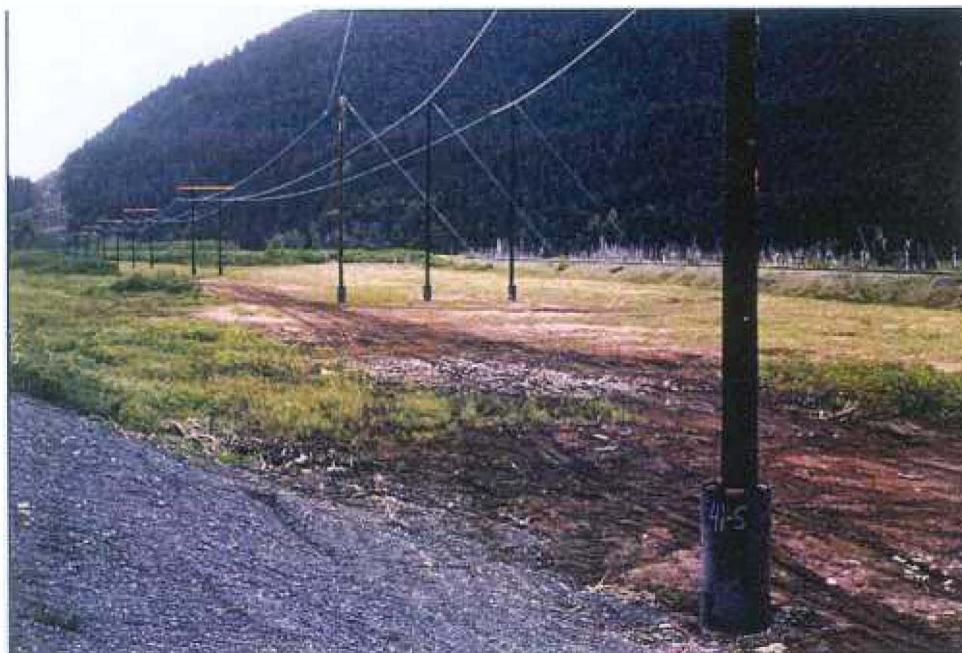
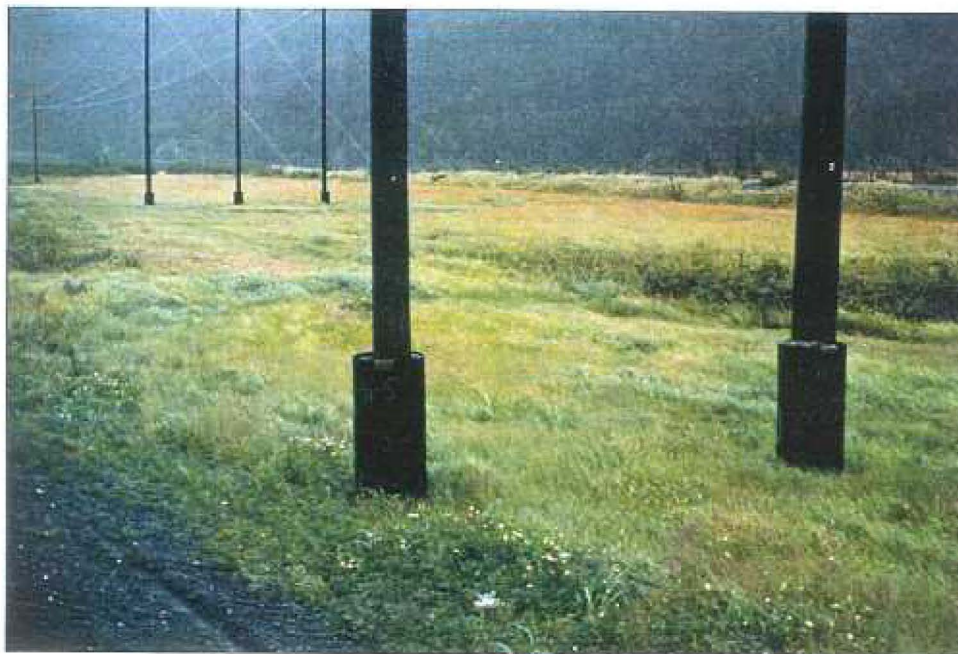
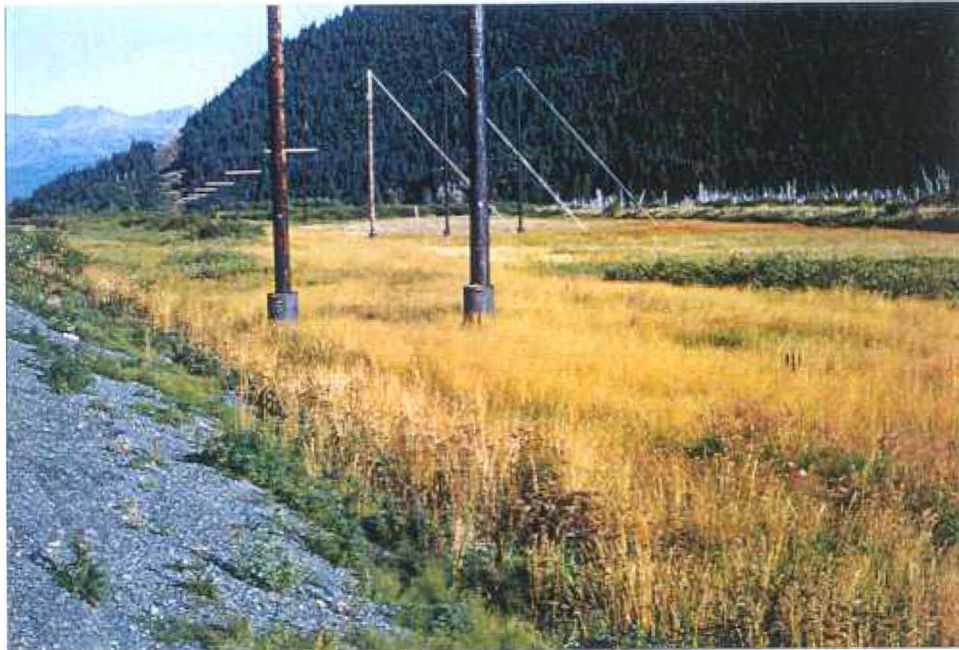
These three segments; STR 38-4+ to STR 38-6, STR 40-5 to 41-5, and 41-6 to 41-10+, were not considered significant restoration problems. The higher surface elevations of the site and resulting drier soil reduced the potential for excessive damage by construction equipment. While significant damage could still have resulted, the contractor utilized low impact practices to prevent unnecessary damage. These areas also supported more upland types of vegetation allowing for a more traditional and proven approach to restoration.

Figure 28. Area around STR 41-5 looking back to STR 41-4, June 1995. Note: Only superficial vegetation damage occurred.

Figure 29. Same area around STR 41-5, September 1995.

Figure 30. STR 41-5 in September 1996.

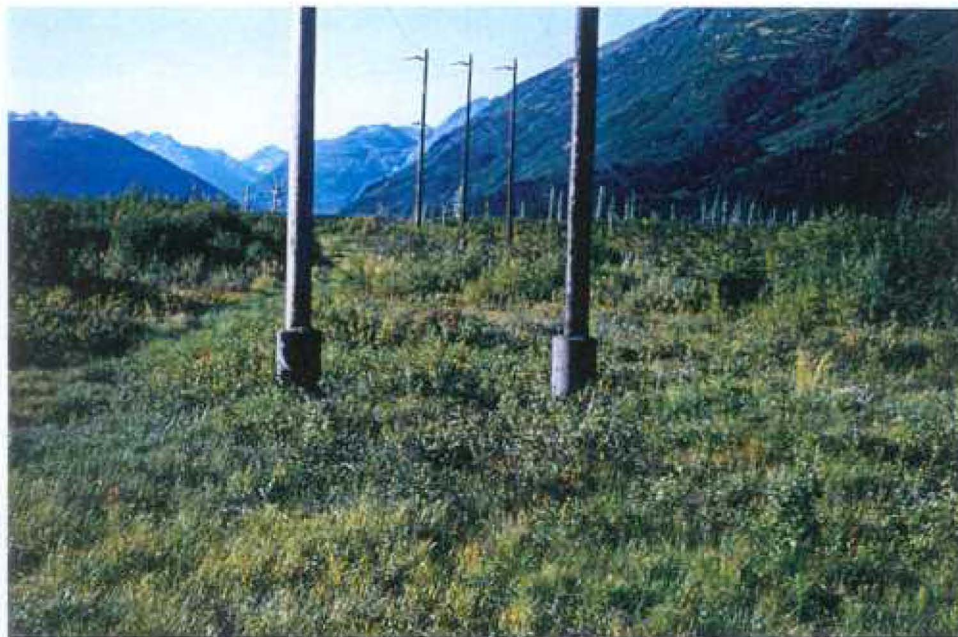
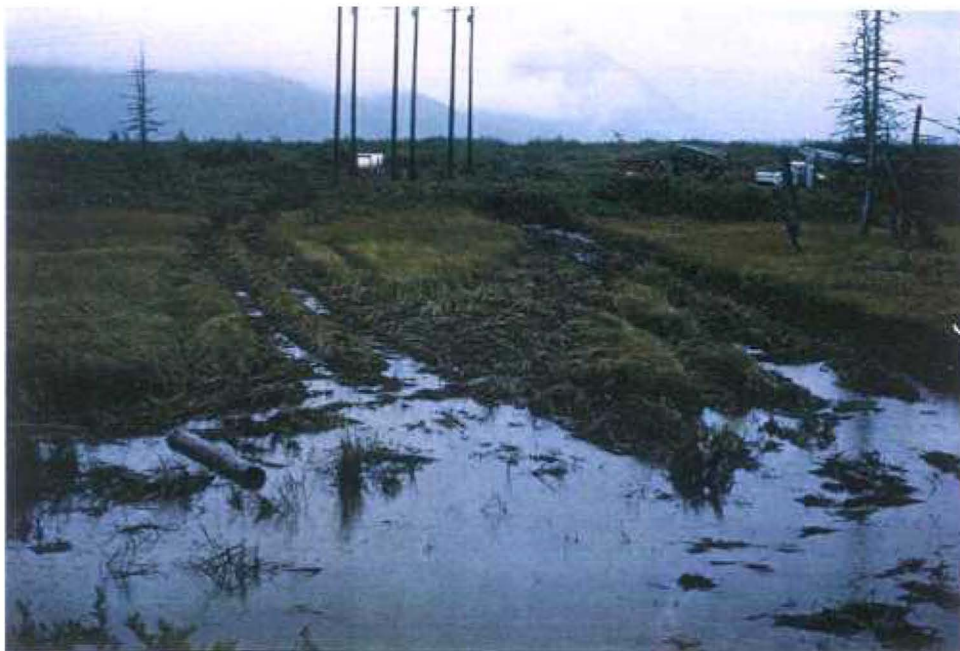
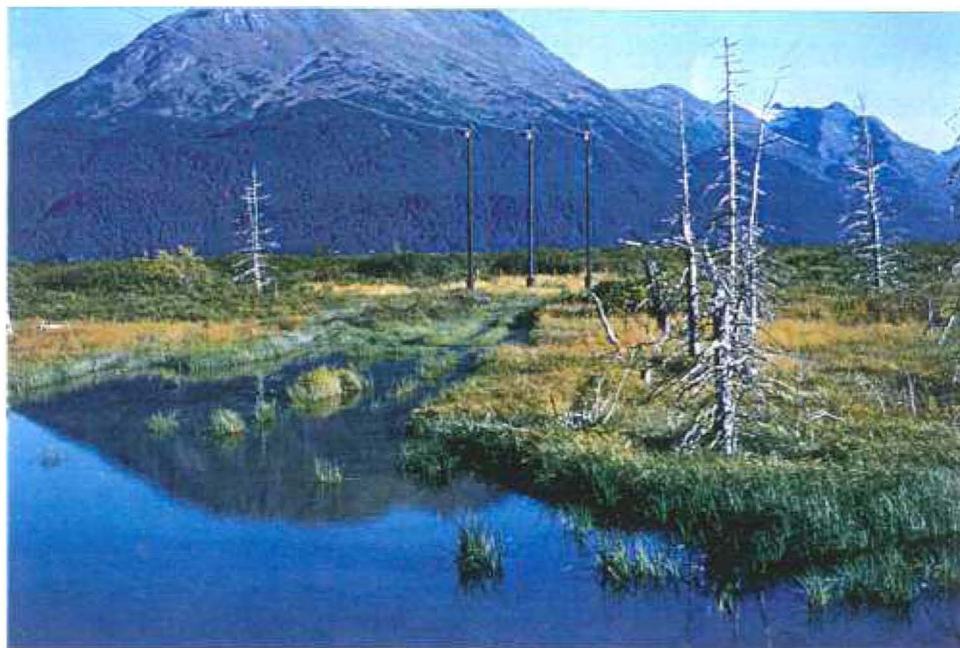
This area was prone to freshwater ponding and was in direct view from the highway. Access from the highway required crossing saturated soils which resulted in rutting. The area also opened up dense stands of alder exacerbating the visual impact. The area was restored using the fertilizer and seed mix listed in tables 3 and 4 respectively.

Figure 31. STR 45-6 after restoration in September 1996.

Figure 32. View of STR 45-7 from highway in 1995.

Figure 33. View of STR 45-7 from highway after restoration in September 1996.
