# **1996 FINAL REPORT**

## **CHUGACH ELECTRIC ASSOCIATION, INC.**

### **GIRDWOOD TO INGRAM CREEK RESTORATION PROJECT**

**JANUARY 3, 1997**

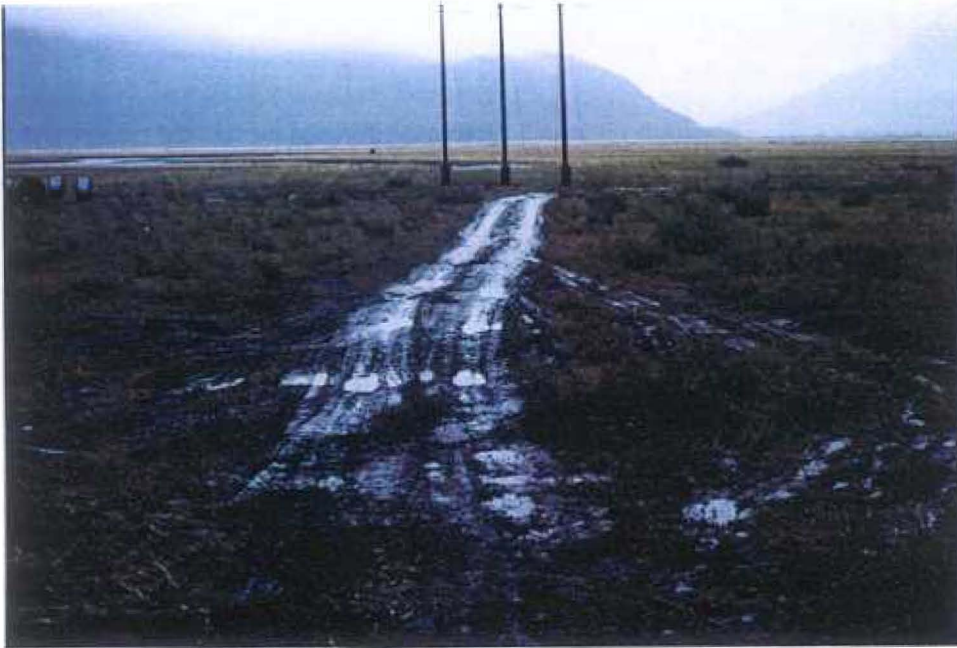
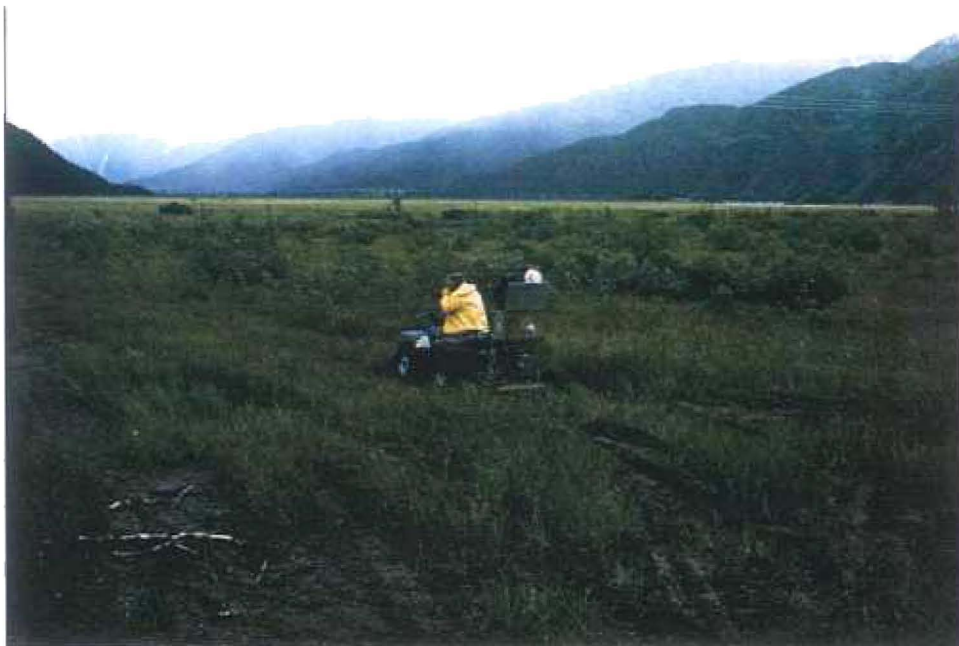
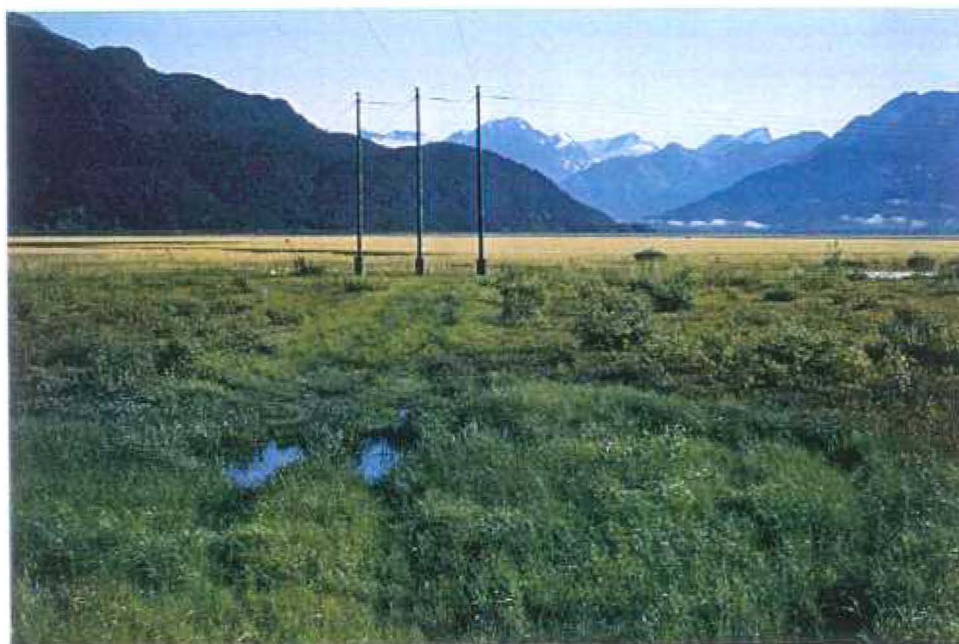
This area was the driest site of all. It was also a highly visible site. The species composition in the area is short shrub and grasses. Cursory observation indicated that the predominate grass species was hairgrass (*Deschampsia* sp.).

Figure 34. STR 47-5 viewed from the Seward Highway, 1995.

Figure 35. STR 47-5 viewed from Seward Highway, June 1996.

Figure 36. STR 47-5 from same general area, September 1996

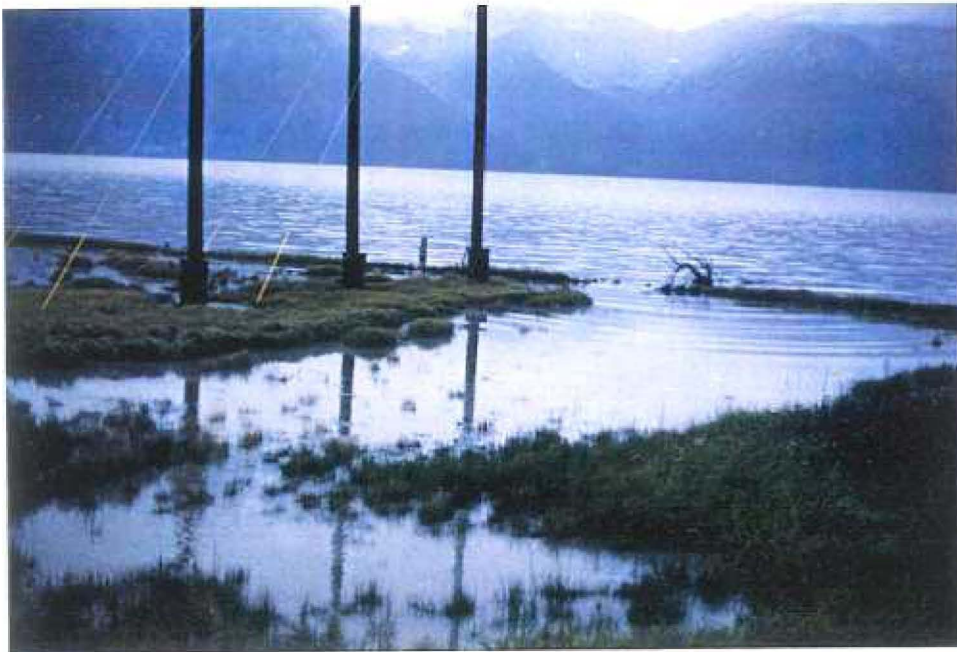
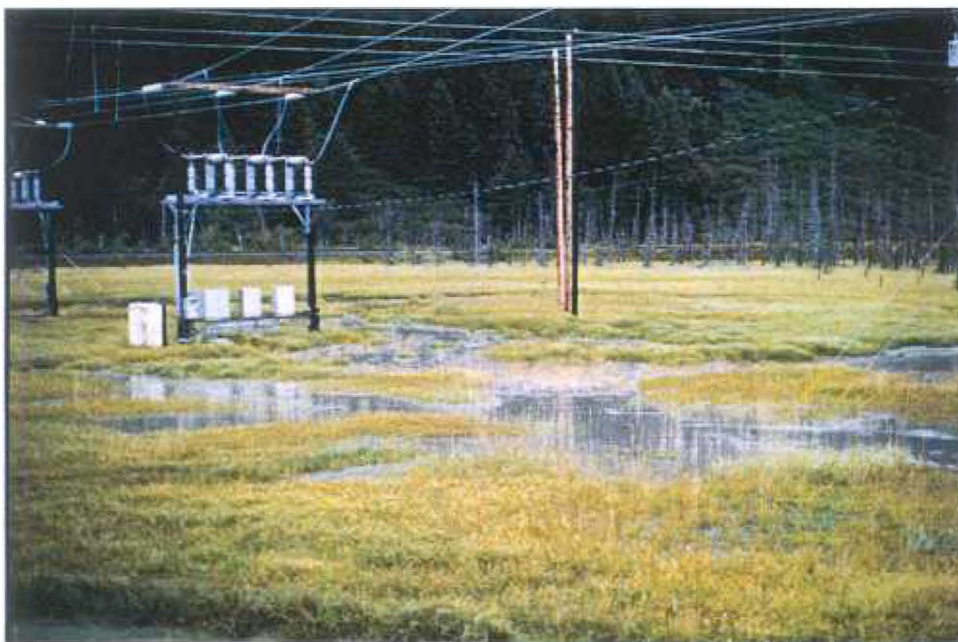
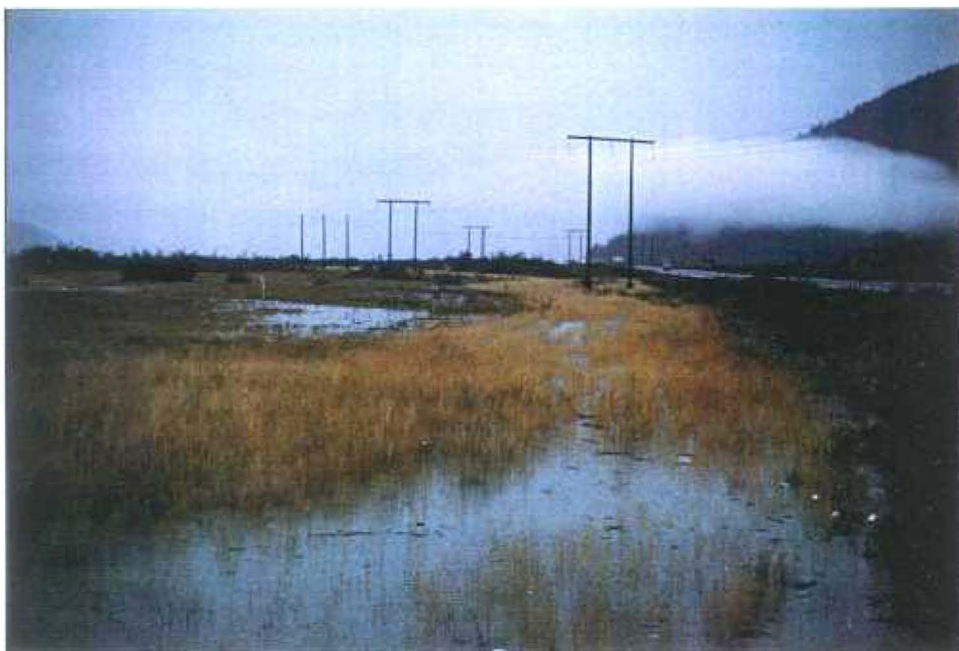
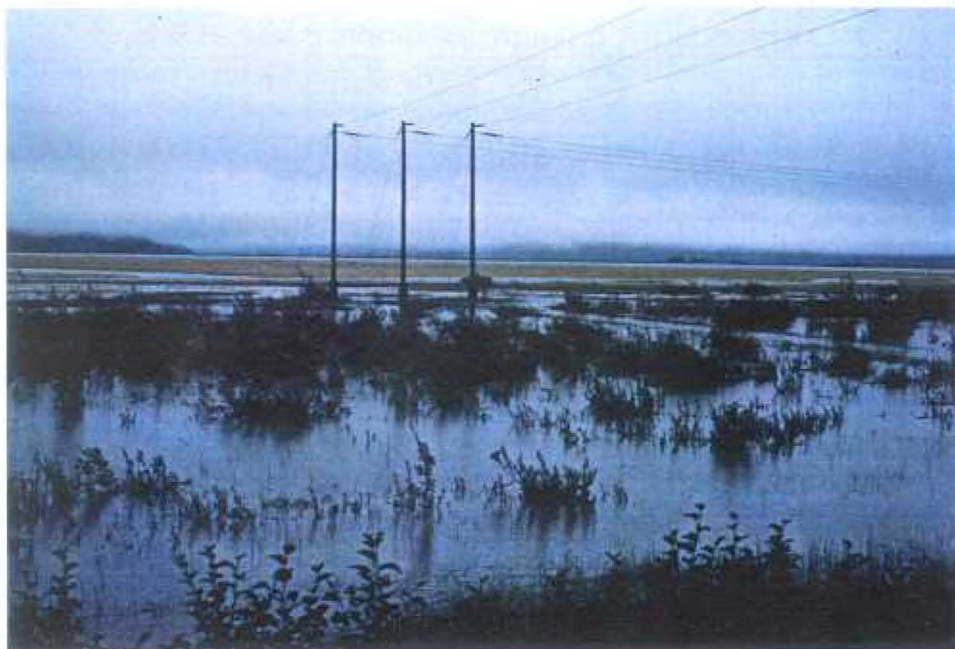
Very few areas worldwide are affected by tides to the extent as occurs on this project site. Maximum tides in the Turnagain Arm of Cook Inlet can exceed 42 feet. This takes the definition of inter-tidal zone to extremes. Other restoration projects have occurred in inter-tidal zones, but few areas that could be vegetatively classified upland are affected by tides as are portions of this project. The area is quite unique in this regard due to the extremely high tides. The affect of the tides in the actual restoration effort was not documented. It can be assumed that it did have an effect.

Figure 37. Access point 20-1 during a 33.2 + tide at 8:09 a.m. on August 29, 1996.

Figure 38. Girdwood circuit switcher during a 33.2 + tide at 8:09 a.m. on August 29, 1996.

Figure 39. Twenty Mile area at slack water during the August 29, 1996 high tide.

Figure 40. Ingram Creek area during slack water on the August 29, 1996 33.2 + high tide. Approximately 8:30 a.m.
