1990 Final Report of
Data and Observations
Obtained From the Red Dog Mine
Evaluation and Demonstration Plots

Cominco Alaska

Stoney Wright

Alaska Plant Materials Center

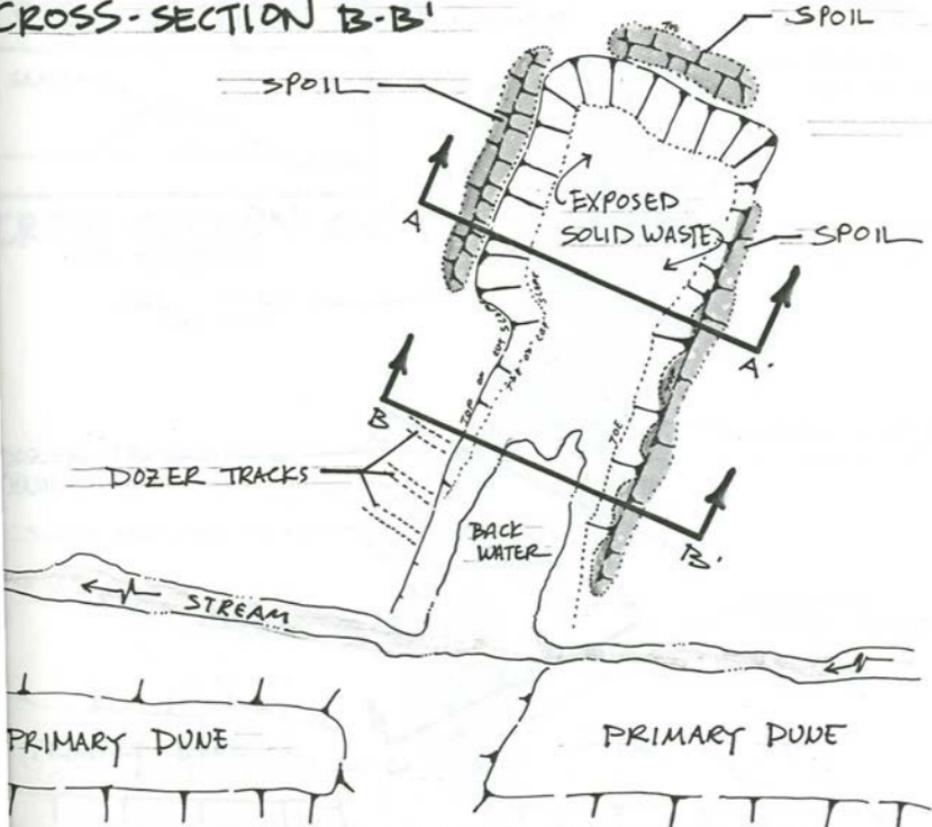
SOLID WASTE DISPOSAL SITE

Prior to seeding in 1988, the existing berms of spoil along the edges of the pit were pushed back into the pit. The pit was then contoured in a manner to reshape cut slopes and the visually objectionable features (See Figures 6 and 7).

CROSS SECTION A-A'

CROSS-SECTION B-B'

NORTH OF COMINCO PORT SITE 9-9-87

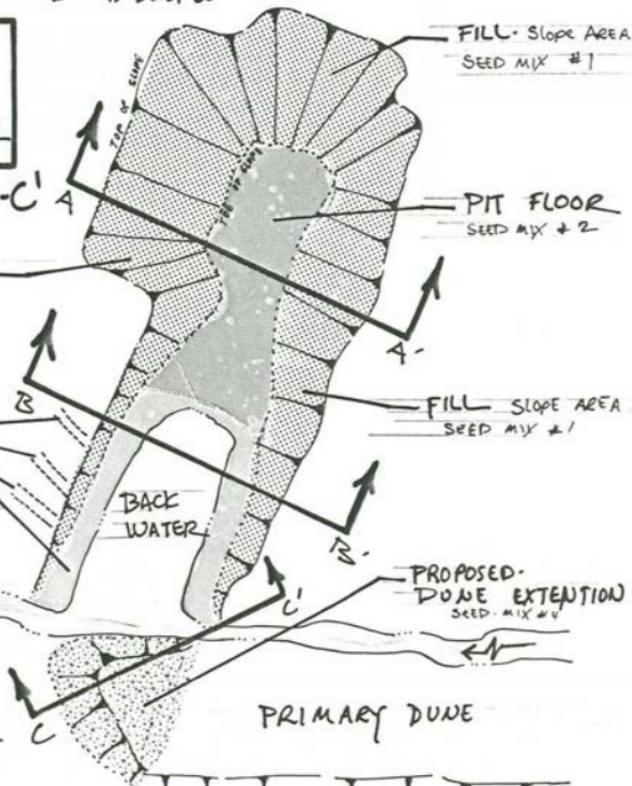
Figure 7.

SEEDING KEY

CROSS-SECTION A-A' AS-BUILT BB'

CROSS-SECTION B-B' AS-BUILT DD'

CROSS-SECTION C-C' AS-BUILT EE'

DUNE EXTENSION
FILL - Slope Area
SEED MIX #1

DOZER TRACKS (HAND SEED)
SLOUGH AREA - SEED MIX #3

SOLID WASTE DISPOSAL SITE

RECLAMATION PLAN FOR 1988

As stated earlier, the actual pit area was seeded with three different seed mixes. These mixes were developed to respond to differing levels of available moisture in the recontoured pit. Figure 8 lists these mixes and Figure 7 notes the areas where the mixes were intended to be used.

Initially, a plan was developed to recreate a portion of the breached foredune that existed between the disposal pit and the shoreline (Figure 7). This plan was suggested as a method to prevent vehicles from entering the restored pit. Upon further investigation, it appeared that this effort would be futile since the recreated dune segment would not be able to withstand storm forces. This assumption was later verified. Instead of the rebuilding of the dune, the breached Beach Wildrye (Elymus mollis) communities were reconnected using transplanted sprigs and overseeded by 'Norcoast' Bering Hairgrass and 'Arctared' Red Fescue. This area was fertilized with 20-20-10 at a rate of 600 pounds per acre.
