PROJECT CHARIOT

Site Revegetation Program

Prepared by
Stoney J. Wright, Manager
Alaska Plant Materials Center
Palmer, Alaska

December 1995

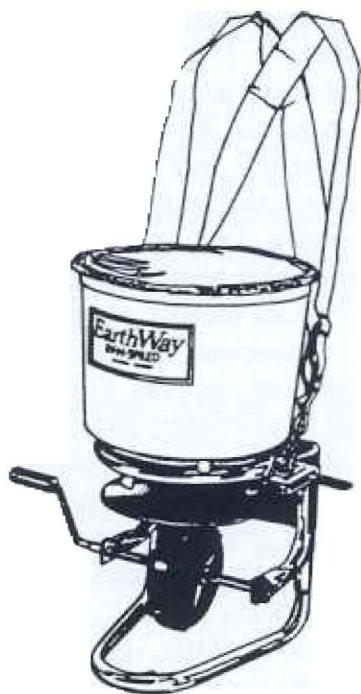
Figure 4. The type of broadcast spreader used on the project.

The site's remote location, size of disturbance and general site conditions dictated that hand application of both seed and fertilizer would be the most appropriate method to conduct the project. The proper use of this type of equipment is easily learned by the labor crews, even if never previously used.

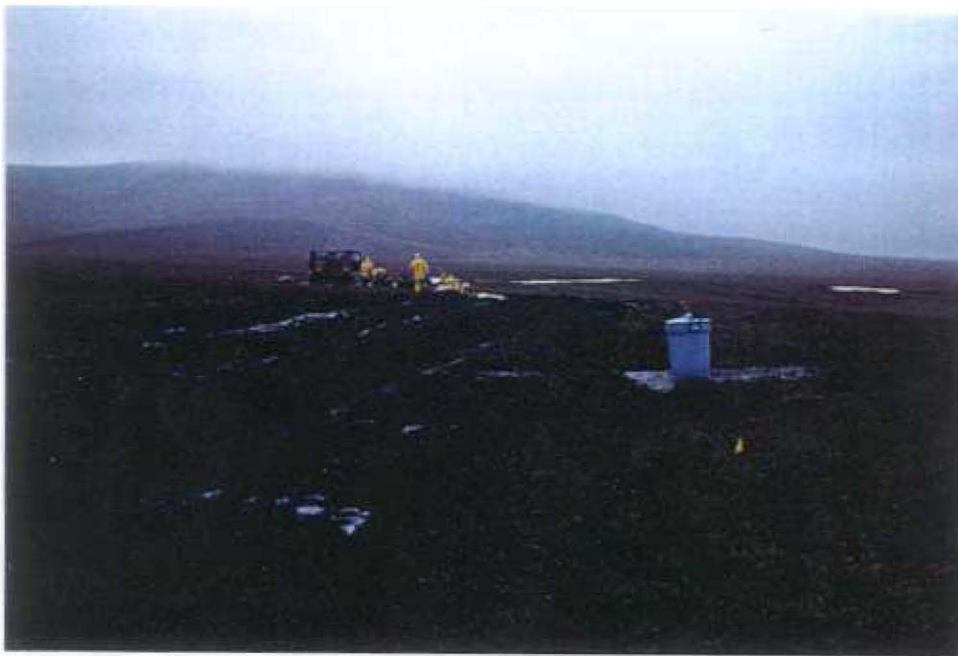
On August 26, 1993, the clean-up site was assessed on the ground. Tundra damage was more severe than ever anticipated. Frequent passes by tracked vehicles and four wheelers had churned the access trail into a muddy strip of land. In an effort to minimize damage on some areas of the trail, traffic lanes were widened in an attempt to avoid creating deeper mud holes. This action helped to some extent, however, in two areas it simply enlarged the surface area of the mudhole. It was determined that the agreed to plan would still provide satisfactory results. The surface condition at the mound area was more acceptable. In only a few areas did equipment churn up mud.

Figure 5. Trail area prior to seeding on August 26, 1993.

The seeding and fertilization program started on August 27. The restoration plan called for the use of hand broadcast seeders. The deep mud (in excess of two feet in some areas) created problems for the labor crew. When using hand spreaders, maintaining a constant stride is critical to successful and effectual operation. This was not how the operation progressed. Heavy rain and slogging through knee-deep mud made for a very unhappy labor crew (Figure 5). Application of seed and fertilizer was less than satisfactory. However, the seeding and fertilizing was completed on August 27.

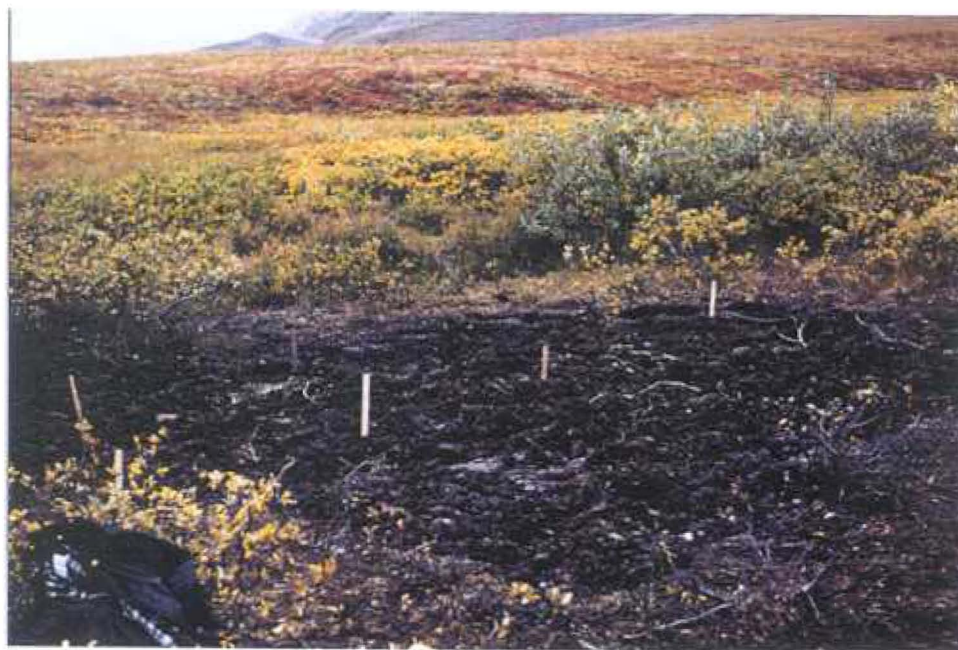
The U.S.F.W.S. approved revegetation plan required that all species used in the mix be seeded singularly in a small plot. This plot was established adjacent to Snowbank Creek on August 27, 1993 (Figures 8 and 9). The plot was laid out on a small disturbance north of the mound area. This disturbance was typical of the main disturbance at the mound site.

Figure 9. Photograph of plot on August 27, 1993.

The individual species were hand seeded at a rate of 15 pounds per acre and fertilized with 20-20-10 fertilizer at a rate of 600 pounds per acre.

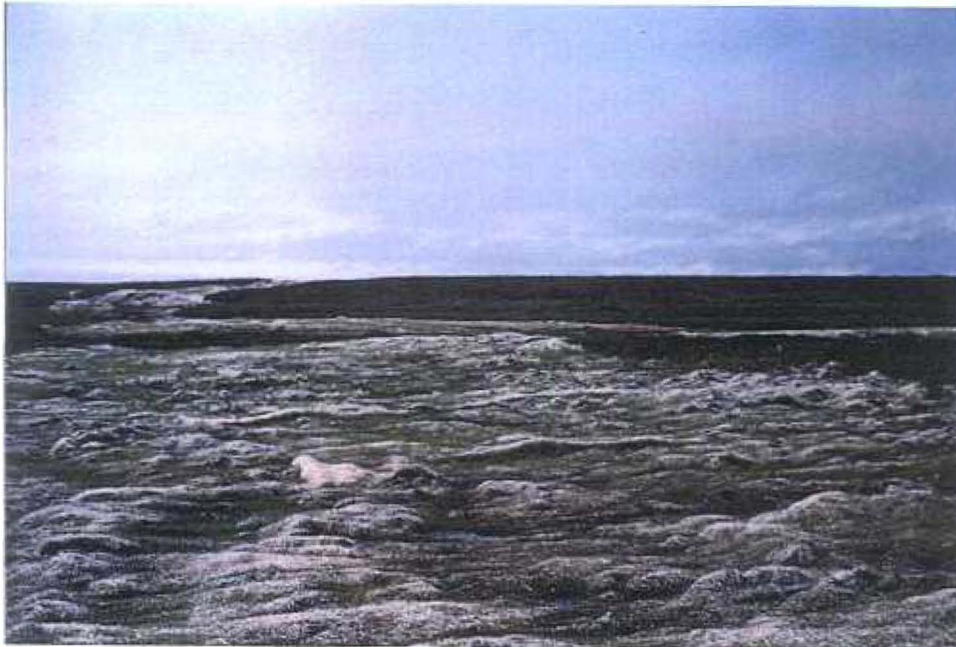
On August 3, 1994, the revegetation program was evaluated. This was the first visit to the site since seeding was completed the previous year. A 40% ground cover was estimated for the entire mound area. Some sites within the mound area had ground cover values in excess of 80%. That portion of the mound area where the actual pile of contaminated soil was located, had a 60% ground cover (Figures 10 and 11).

Figure 10. Trail and mound area, August 3, 1994, westerly view.

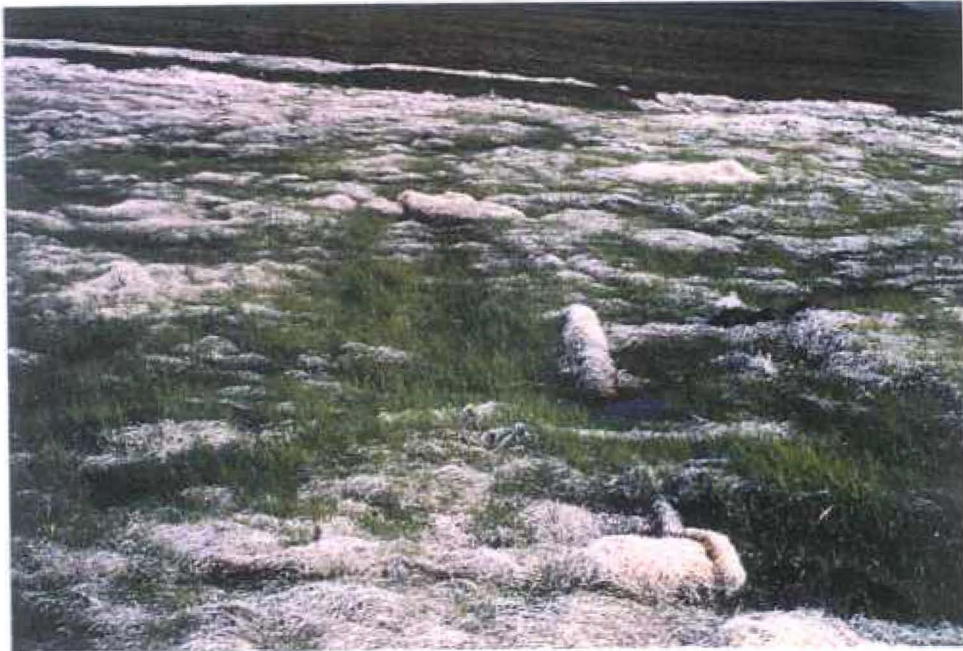
Figure 11. Mound area, August 3, 1994, easterly view.

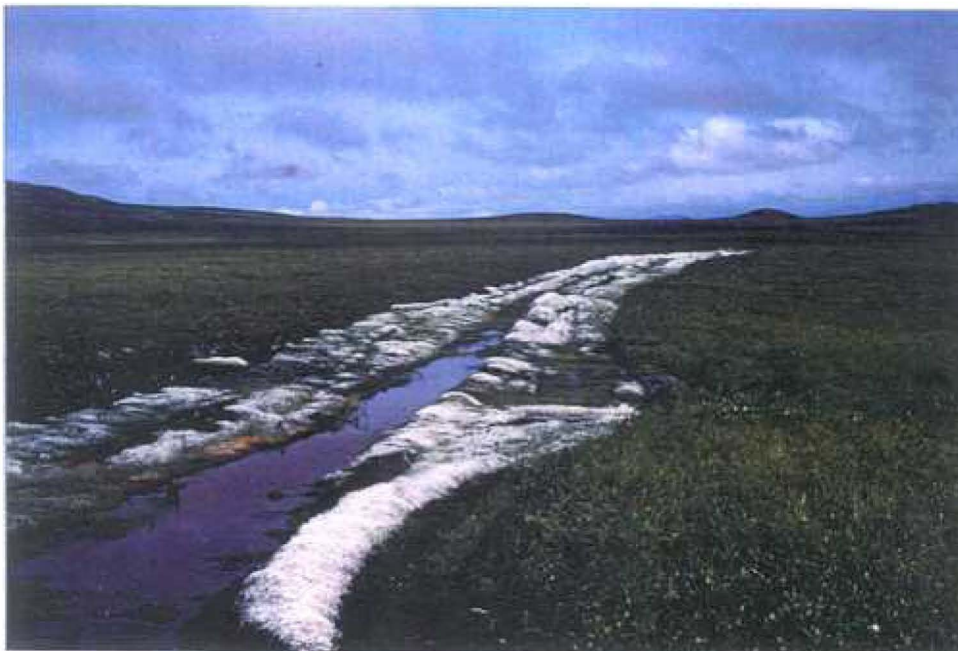
The trail leading to the mound site was more problematic with regard to initial success. Without doubt, the less than satisfactory first year growth is due to the site's level of disturbance the previous year. The trail's open water areas in the depressions created by repeated equipment passes, detracted from overall cover values (Figure 12). The site, however, could not be classified as a failure. Overall cover was estimated at 40%. Species composition was equivalent to the mound site. Reinvasion, however, was more pronounced in the trail. The disadvantage of visual impact created by a linear disturbance is often countered by more rapid plant reinvasion. This is usually due to the fact that linear disturbances are narrow with a profusion of undisturbed vegetation immediately adjacent. This undisturbed vegetation often has underground portions already within the disturbed area, allowing for relatively quick recovery. Spread by seed also tends to be more rapid on linear disturbances once traffic is stopped and if compaction has not been significant.

Figure 12. A portion of the trail showing effects of excessive traffic, August 1994.

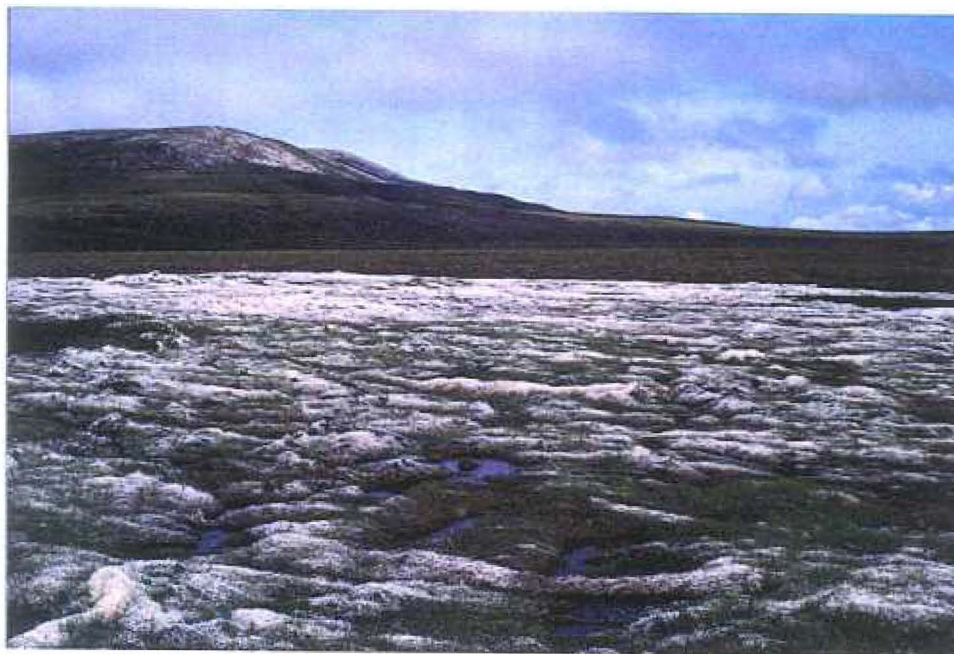
The mound area revegetation was (for the time of the year) performing well. Most of the seeded grasses had not yet grown above the excelsior blankets. When the site was observed from the air or casually glanced at from the ground, plant cover would have been rated poor. However, when detailed examination was conducted and the excelsior moved back, a true measure could be determined. The southwest quadrant of the mound exhibited the best growth, approximately 70% cover by the seeded grasses. This was followed by the southeast quadrant with 20-50% cover, the northwest quadrant with 25% cover and the northeast quadrant with approximately 20% cover (Figures 13 and 14).

Figure 13. Mound area, August 3, 1994, view to the northeast.

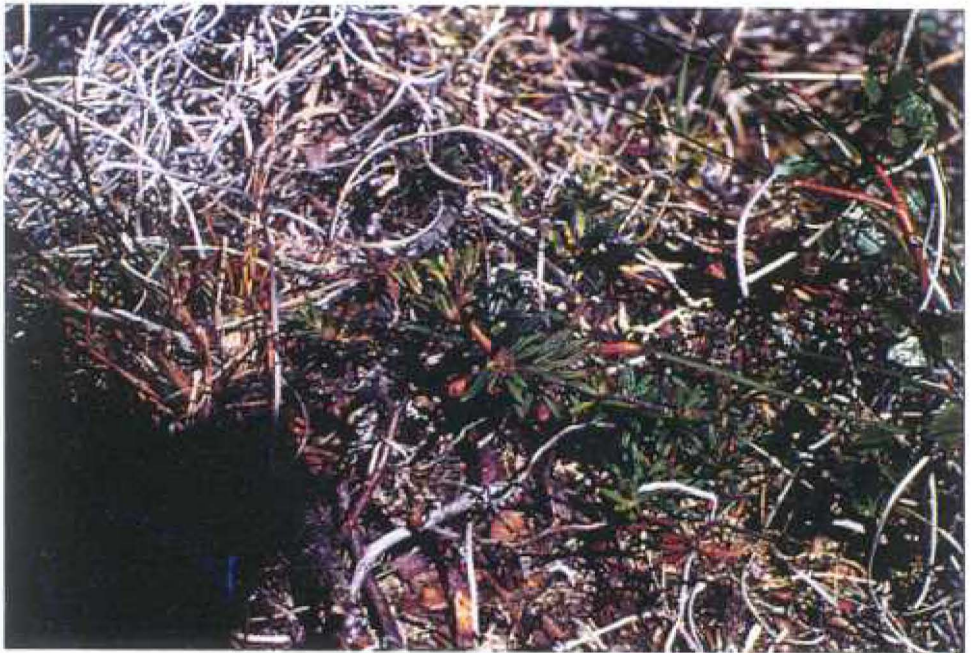
The reinvasion of other species was continuing at an exceptional rate. The invaders noted in 1995 included rush, *Juncus* sp., sedges, *Carex* sp., willow, *Salix* sp., sweet coltsfoot, *Petasites* sp., cotton grass, *Eriophorum* sp., dock, *Rumex* sp., blueberries, *Vaccinium* sp., *Ledum* sp., and birch, *Betula* sp. (Figures 15 and 16). Perhaps, the most surprising plant invaders on the site were the mosses. When the excelsior was rolled back, heavy moss growth was observed on nearly all the examined areas (Figure 17). This is quite unusual and to the author's knowledge, has not been documented to the degree observed at this site. Perhaps, the shading provided by the excelsior has aided in the reestablishment of mosses.

Figure 15. Natural reinvasion on the mound area, July 1995. Note: *Betula* sp., *Carex* sp., *Vaccinium* sp. and *Ledum* sp.

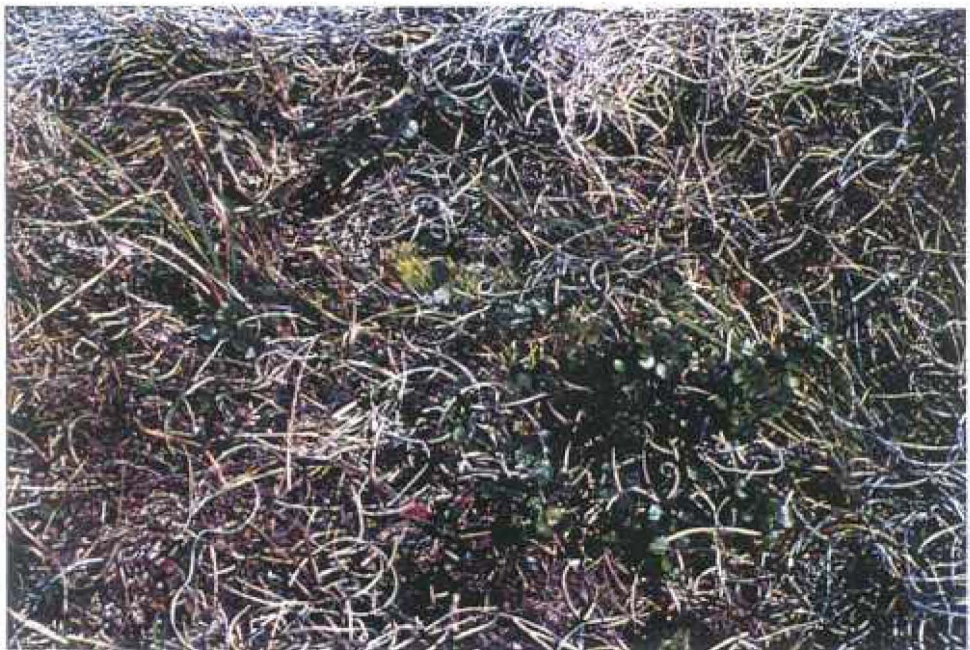
Figure 16. Reinvasive *Carex* sp., *Betula* sp., *Salix* sp. and moss.

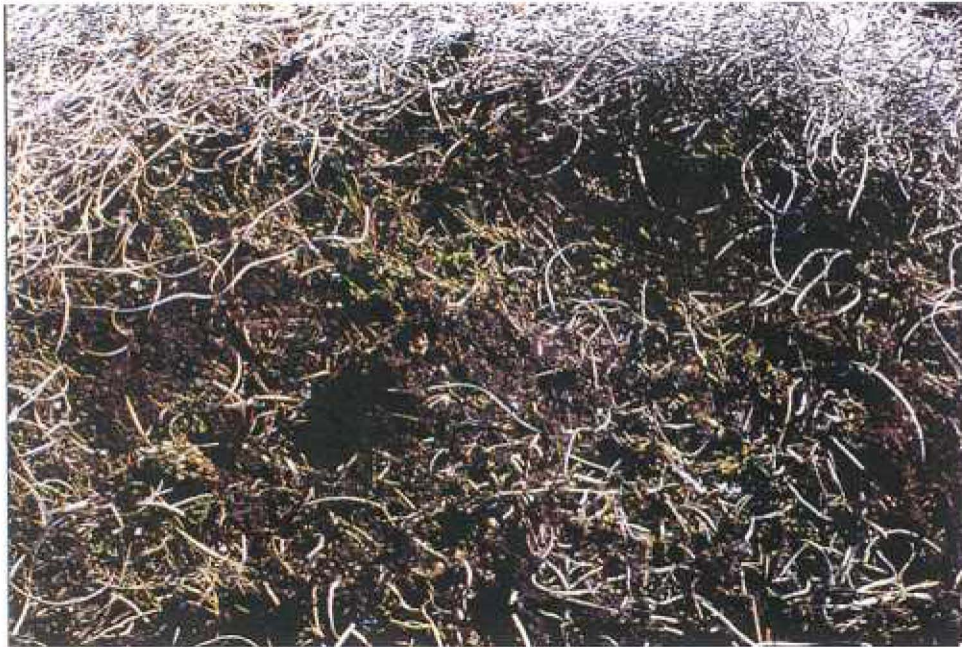
Figure 17. Area of heavy moss growth, July 1995.

Additional speculation may suggest that the site is naturally predisposed to moss invasion. Nonetheless, this is worthy of further study and a very interesting observation. Overall, the site appeared in good condition (Figures 18 and 19).

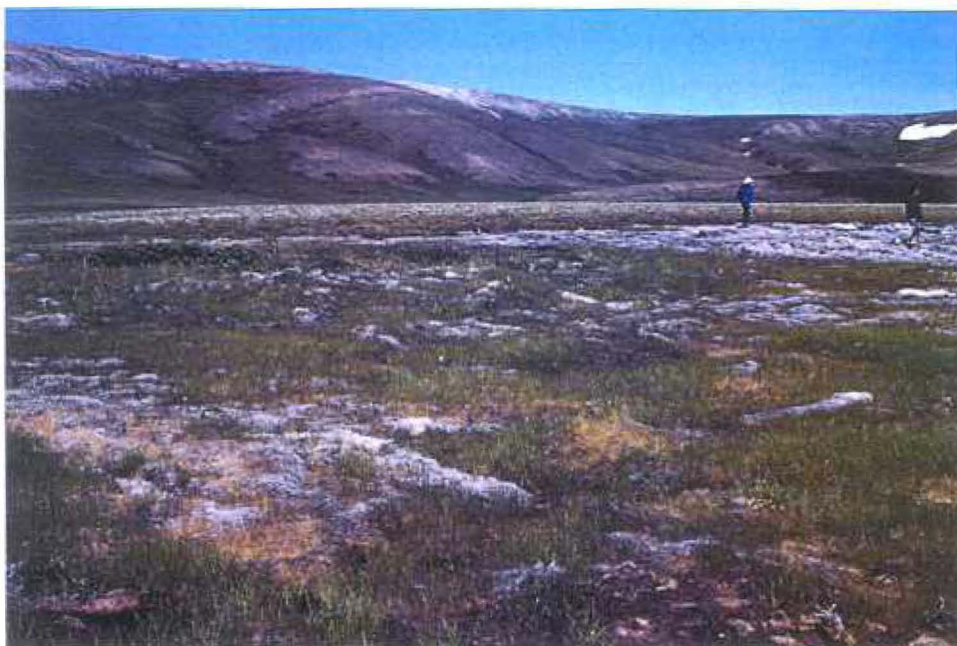
Figure 18 Mound area, July 1995, view north.

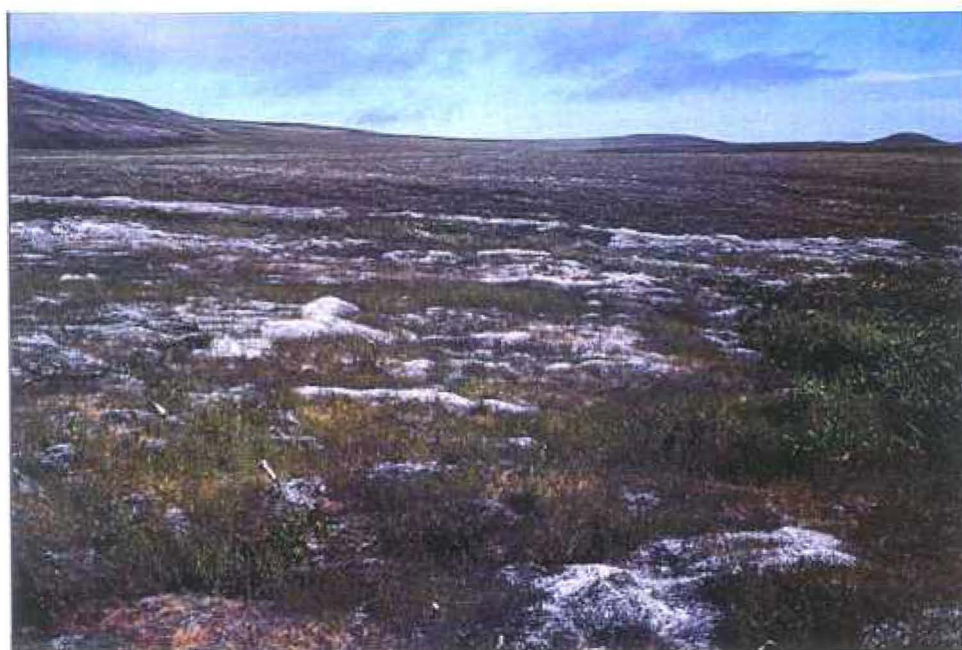
Figure 19 Mound area, July 1995, view east

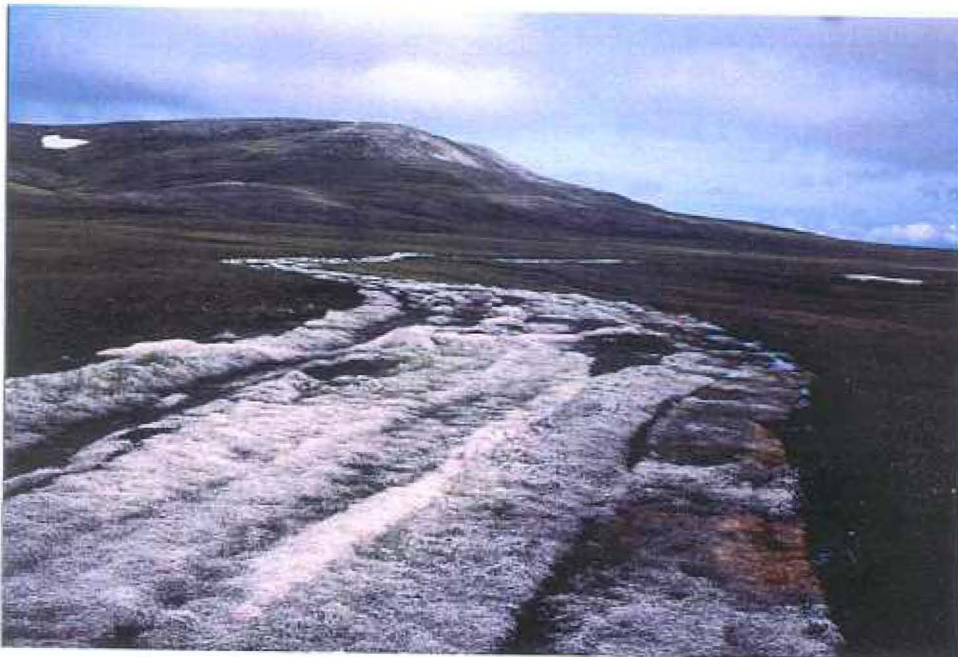
In 1995, the trail leading to the mound site exhibited areas of excellent growth and areas of very poor growth. This was similar to observations made in 1994. The trail showed signs of reinvasion similar to the mound site. The ground cover values for the trail ranged from 90% to less than 5%, with an overall cover of approximately 50% (Figures 20 and 21).

Figure 20. Portion of the trail in 1994, view east.

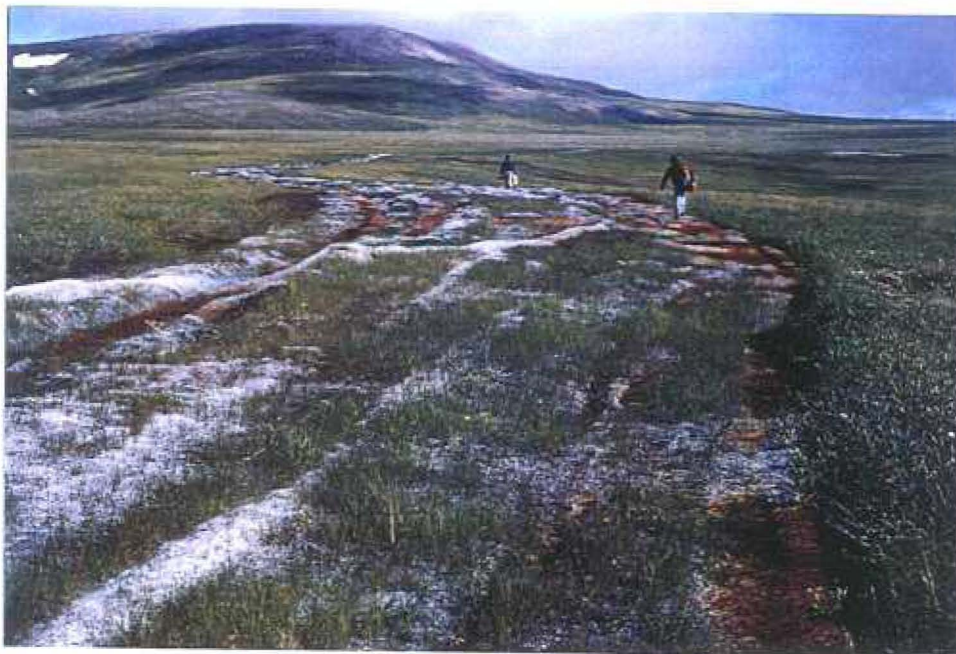
Figure 21. Same portion of the trail as Figure 20 in 1995.

Depressions and ponding caused by vehicle tracks were still detracting from cover values. The best cover values and plant vigor was noted on "higher" portions of the trail where ponding did not occur and the soils were less saturated. Species composition on the trail was similar to the mound site.

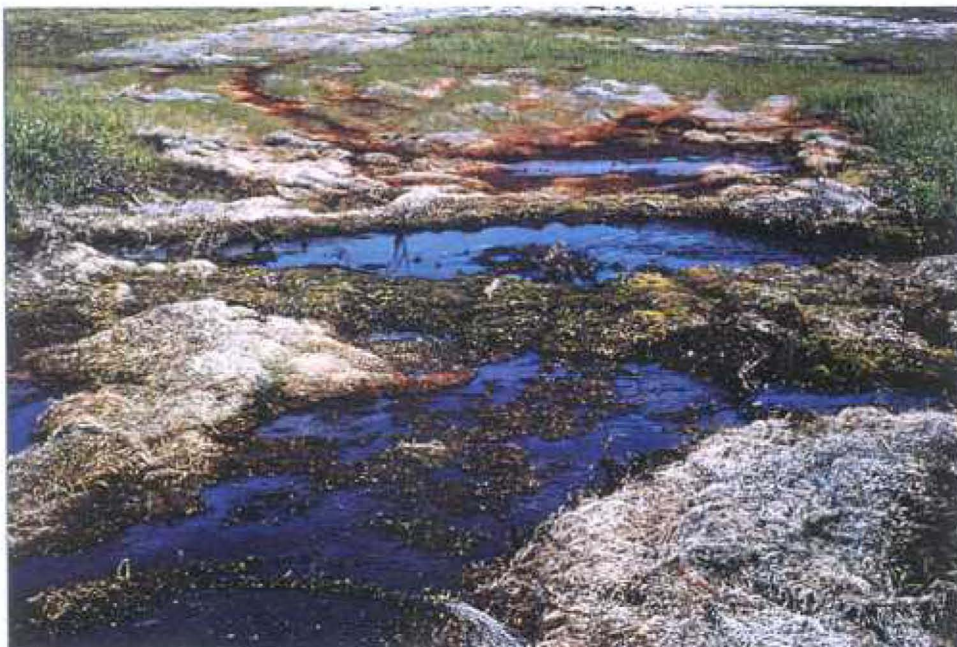
No large areas of hydraulic erosion were noted in 1995. One small area of thermal degradation was noted on the west site of Snowbank Creek (Figure 22). This may stabilize with time. Cross flow drainage patterns seem to have been reestablished (Figures 23 and 24).

Figure 22. Area of thermal degradation on west side of Snowbank Creek.

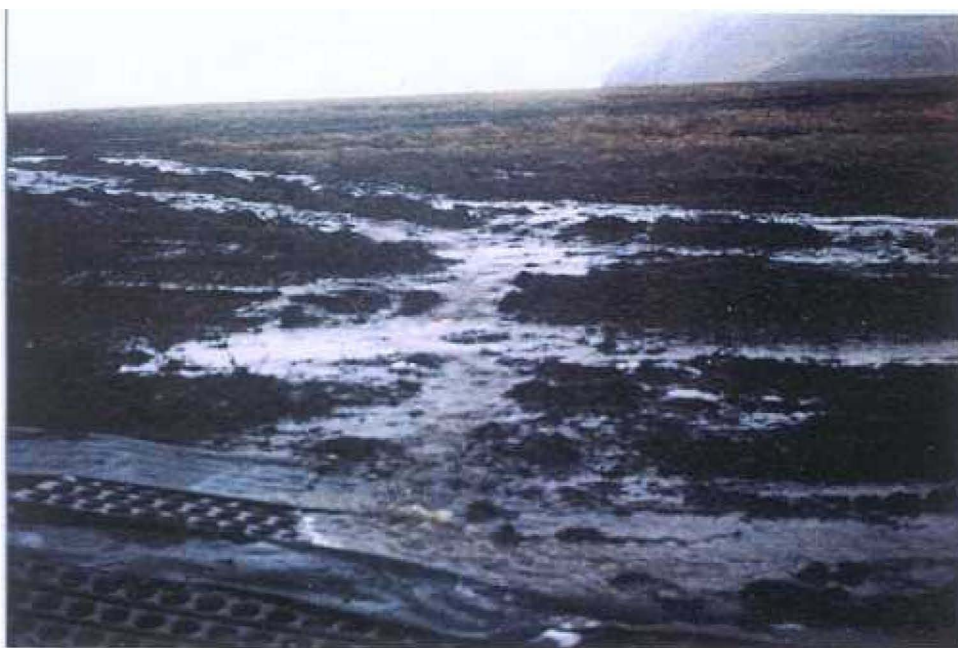
Figure 23. Area of massive cross-flow on the trail, August 1993, view to the north.

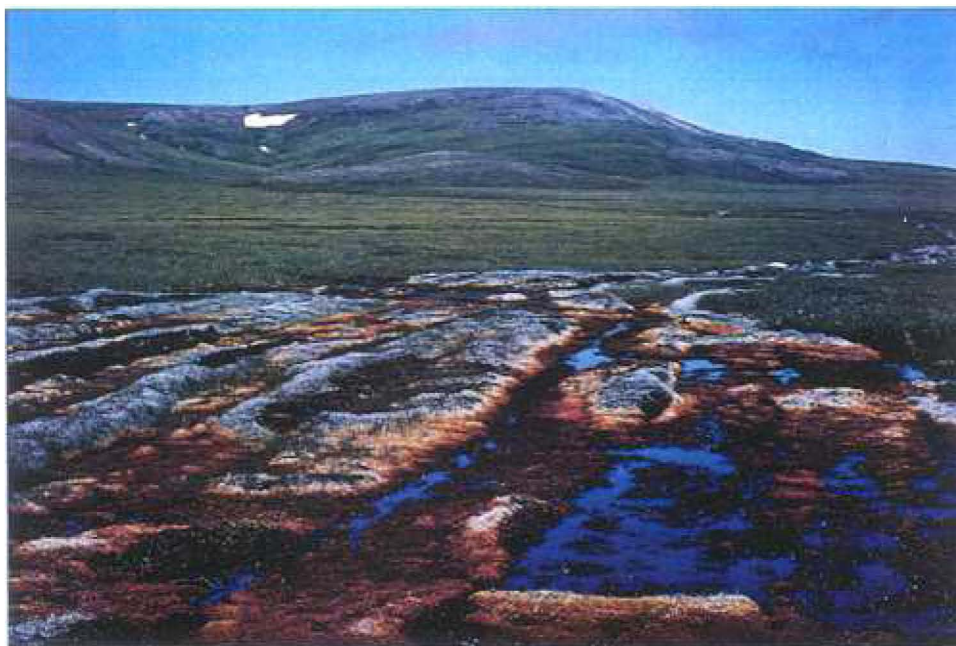
Figure 24. Same cross-flow area shown in Figure 23, July 1995, view east.

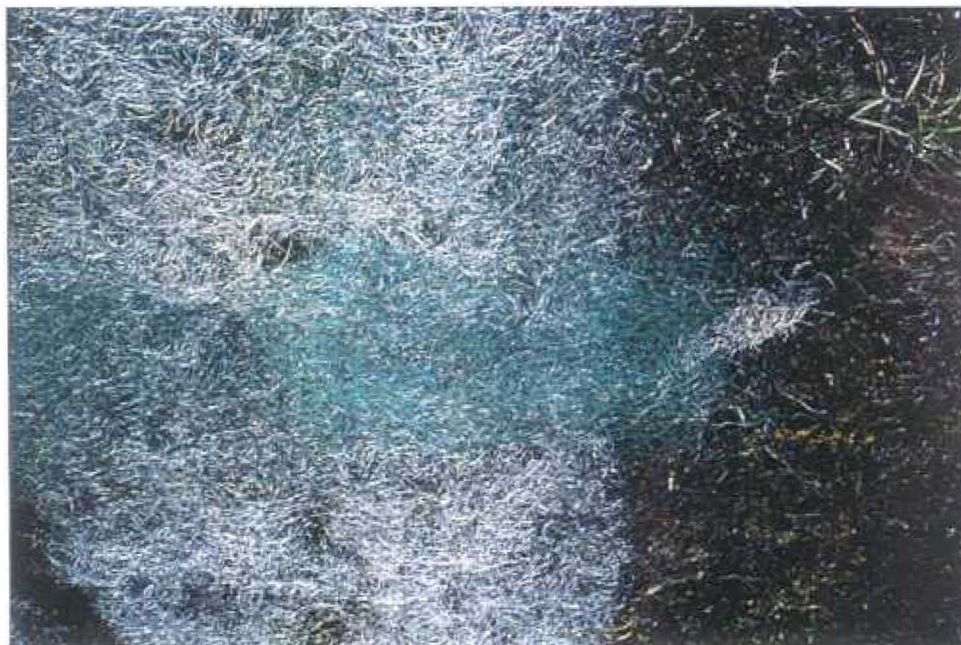
Decomposition of the Excelsior blankets is not occurring at a rapid rate. The visual impact of the blankets is still high. The plastic netting used in the manufacture of the blankets is tearing loose from the excelsior and forming "piles" (Figure 25). This plastic material resembles a gill net laying on the tundra. No wildlife was observed entangled in the plastic netting, however, a potential for small animal entanglement does exist.

Figure 25. Loose Excelsior backing (netting) forming potential entrapment "nets".

1. It is recommended that one additional site visit be conducted in August-September 1996. During this visit, the loose plastic netting from the Excelsior on the site will be picked up and destroyed. This material is biodegradable, however, the Arctic environment seems to delay the decomposition. To date, the netting has not entangled wildlife, but the potential for small animal entanglement does exist. During the 1996 site visit, a final evaluation can be conducted at a more appropriate period of the growing season. Observations noted at that time will be incorporated into this report and issued as an addendum.

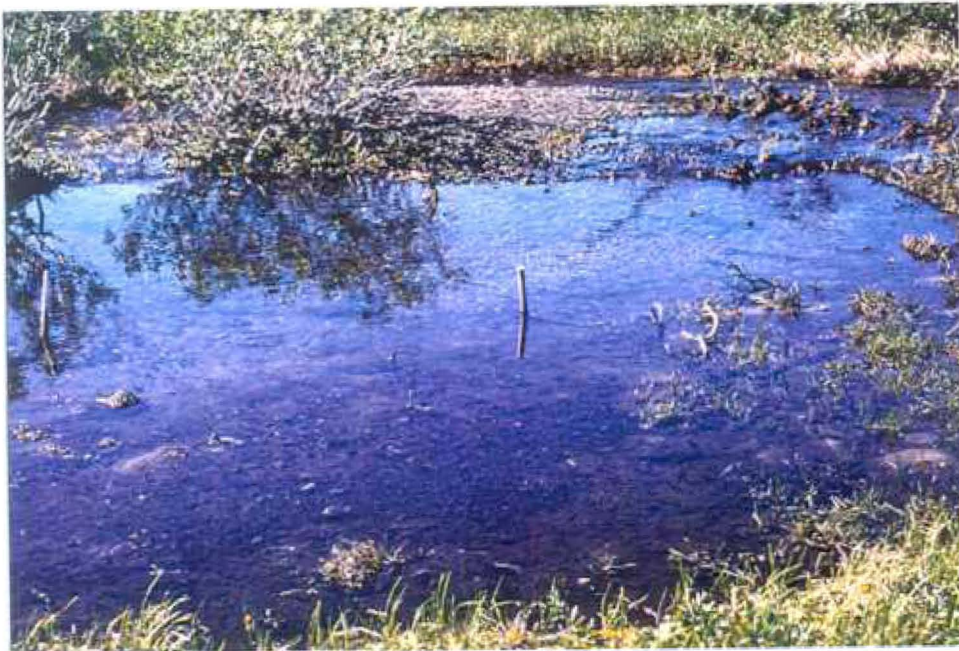
The conditions in the single species study plots did not change in 1995. The area remained flooded. At the time of evaluation, neither Norcoast Bering hairgrass nor Egan American sloughgrass had initiated new growth. The 1994 remnant foliage still remained in place (Figure 26).

Figure 26. Flooded study plots, July 1995.
