Beach Wildrye, Elymus arenarius, Sprigging
on Shemya Air Force Base, Lateral Clear Zone
- A Qualitative Study in Response to Questions
Arising From Contract DACA 85-86-C-0042
(Miscellaneous Earthwork and Utilities Repair)
April, 1986

Prepared by:
Alaska Department of Natural Resources
Division of Agriculture
Plant Materials Center
SRB Box 7440
Palmer, Alaska 99645

Submitted to:
U. S. Army Engineering District, Alaska
Corps of Engineers
P. O. Box 898
Anchorage, Alaska 99506-0898

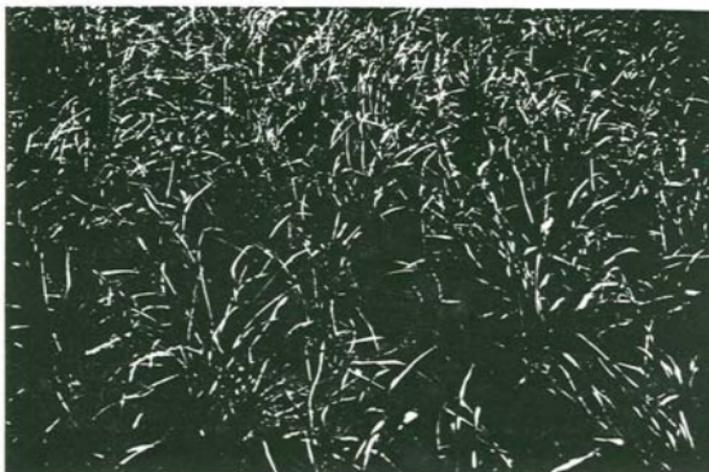
Figure 9. This photo shows an average sprig density in Plot 1 on 19 September 1986. Note the seedling grasses. The most obvious grasses are Annual Ryegrass, followed by Red Fescue and Hairgrass.

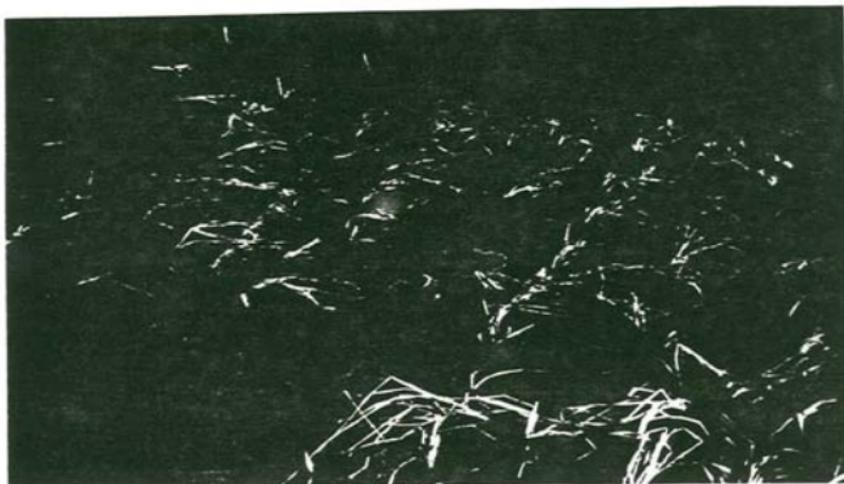
Figure 10. Plot 2 immediately after planting and Coherex treatment on 22 May 1986.

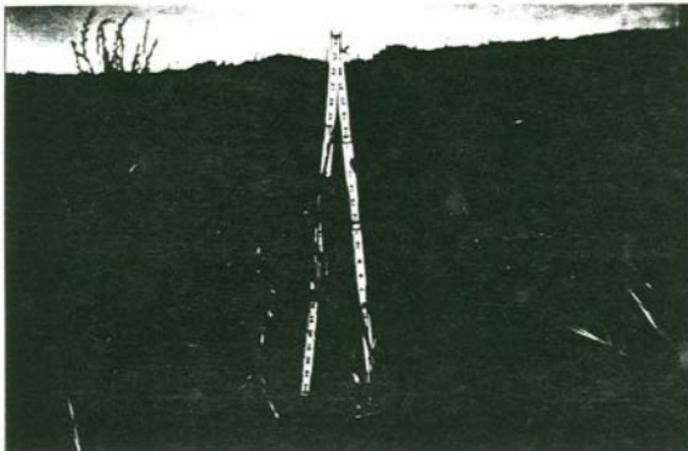
Figure 12. Close-up of established Beach Wildrye plants in Plot 1 which shows growth that had occurred between 22 May and 19 September 1986.

Vigor within Plot 1 varied slightly and was rated good to excellent. The Beach Wildrye plants exhibited between 12 and 33 inches of growth (Figure 12). The vigor of plants in Plot 2 was uniformly excellent and plants ranged from 18 to 40 inches tall (Figure 13). This vigor rating was based on comparisons to adjacent three-year old natural stands of Beach Wildrye, which ranged from 30 to 52 inches tall. Established Beach Wildrye sprigs were selected at random within both plots and all exhibited excellent root and rhizome growth.

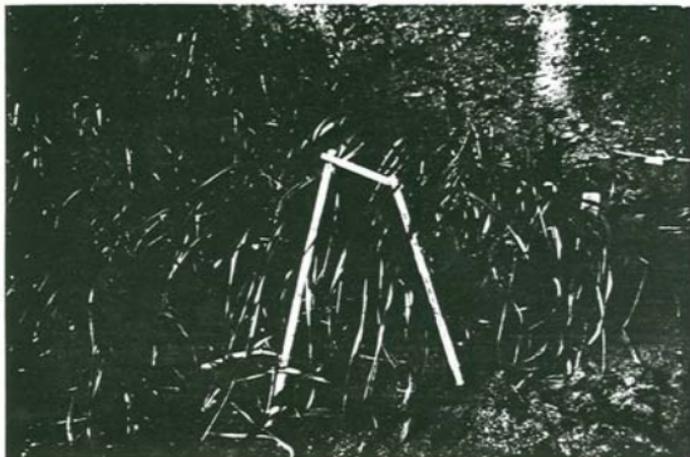
Figure 13. This photo shows Beach Wildrye plants in Plot 2. There were no signs of damage caused by Coherex.
