# Case Studies

### Interior Alaska Revegetation Projects

## *Interior Alaska Revegetation & Erosion Control Guide*

# **True North Mine Reclamation**

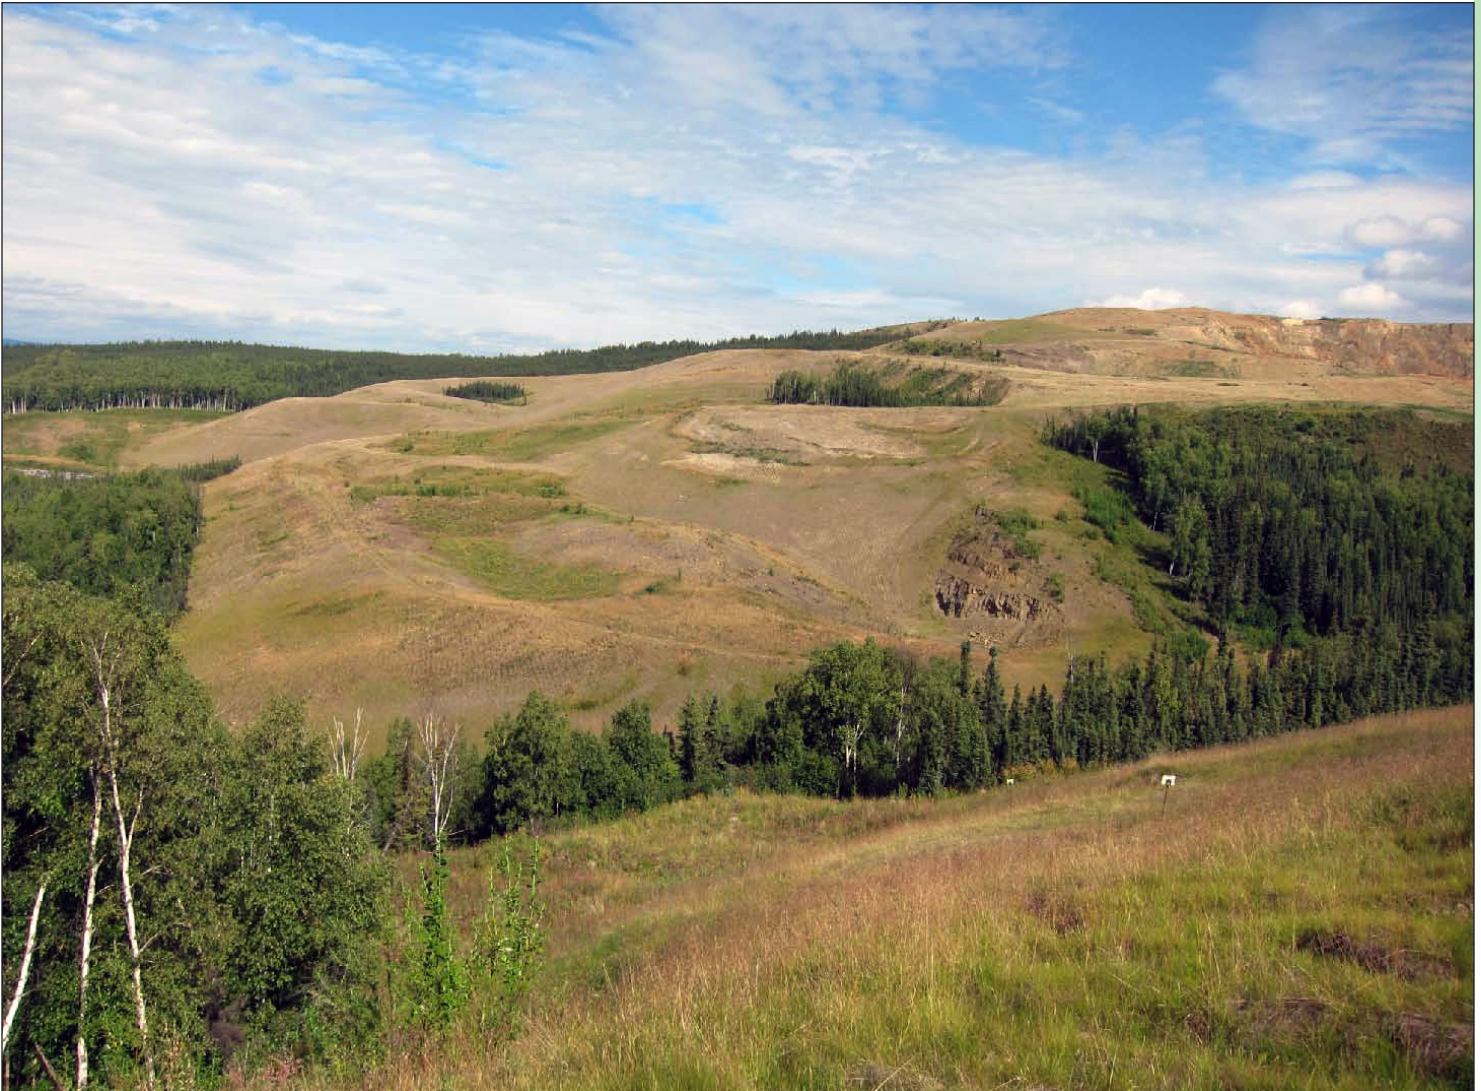
A recontoured and revegetated mine site at the Fort Knox mine, north of Fairbanks

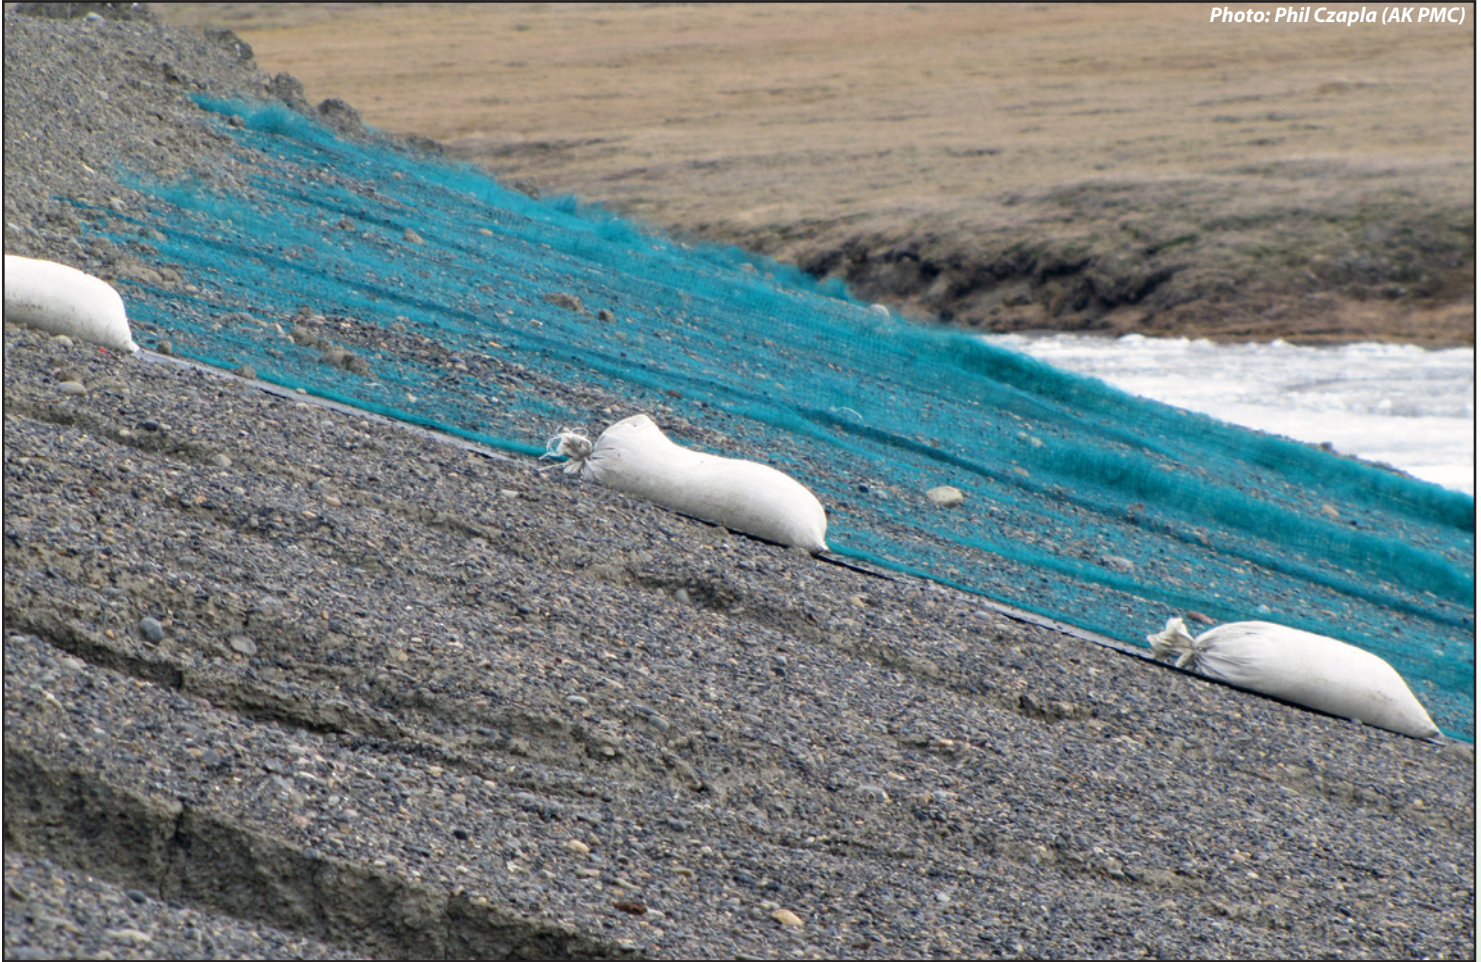
Geo-textile fabric armoring protects a constructed slope from wind and water erosion.

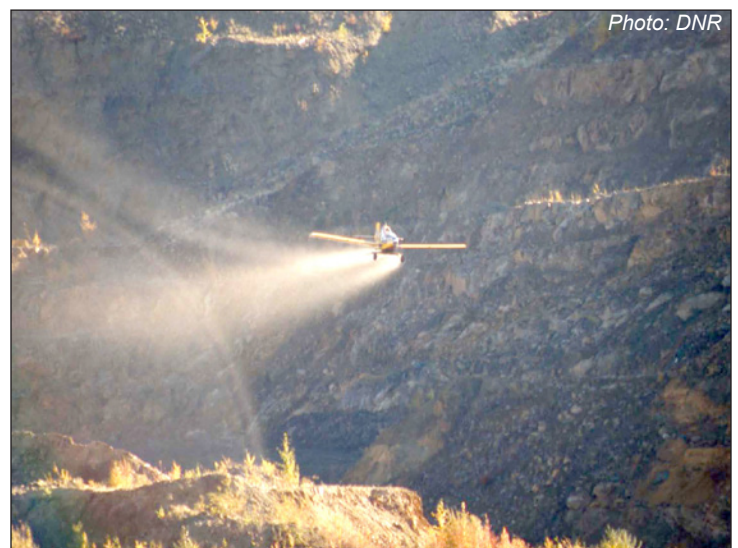
Aerial seeding - mid September, 2010

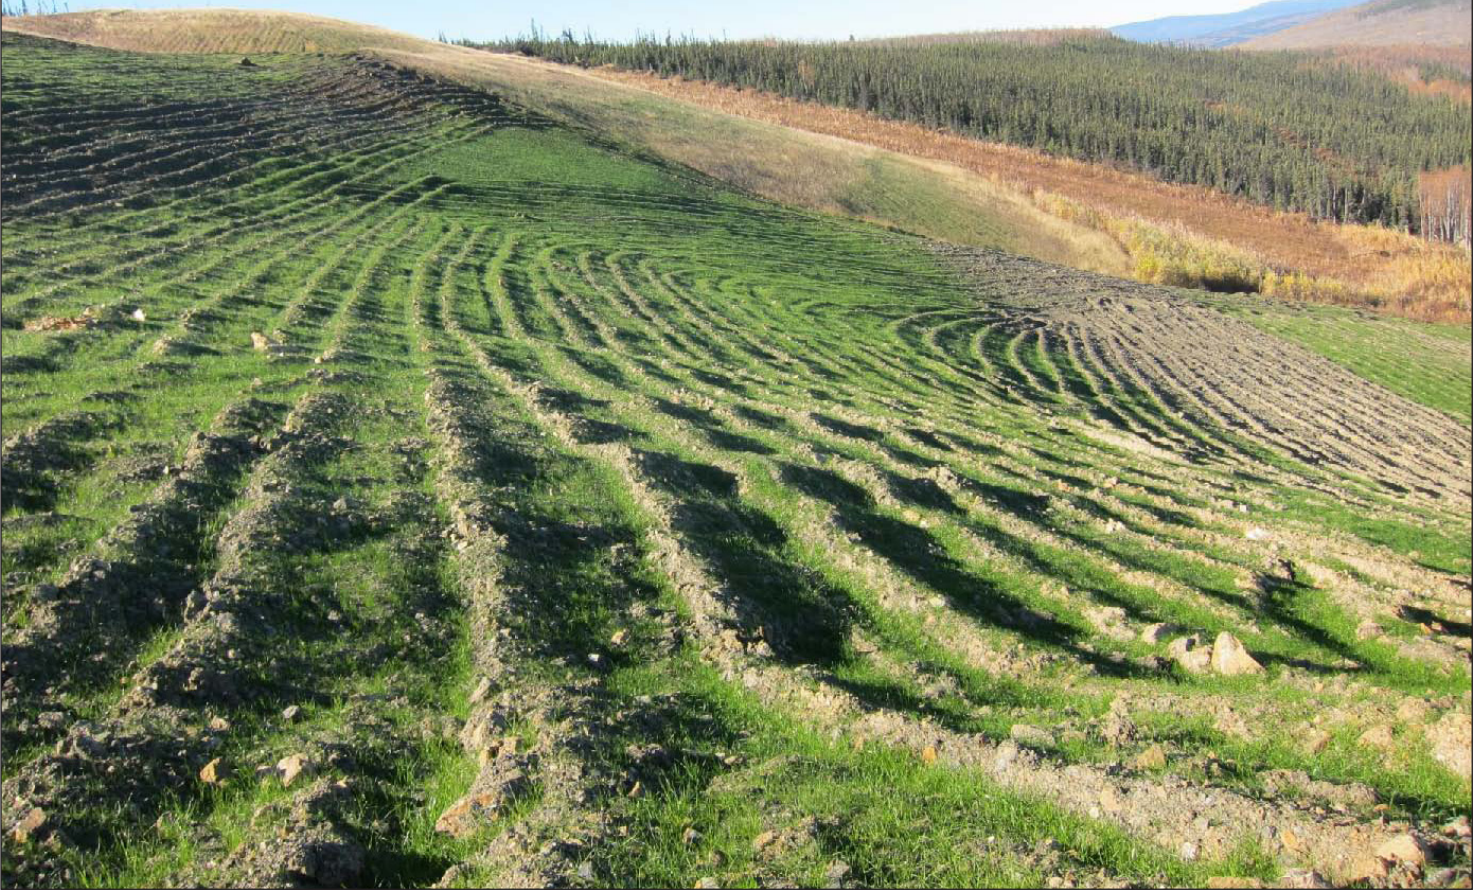
North Shepard dump - mid September, 2010 (seeded mid-August, 2010). Note furrows along horizontal contour of slope.

Following the application of growth media (if necessary) specific sites were prepared for seeding by scarifying on the contour to roughen the surface. A broken, roughened surface serves to trap moisture, reduce wind shear, minimize surface erosion by increasing infiltration, and create micro-habitats conducive to seed germination and development.

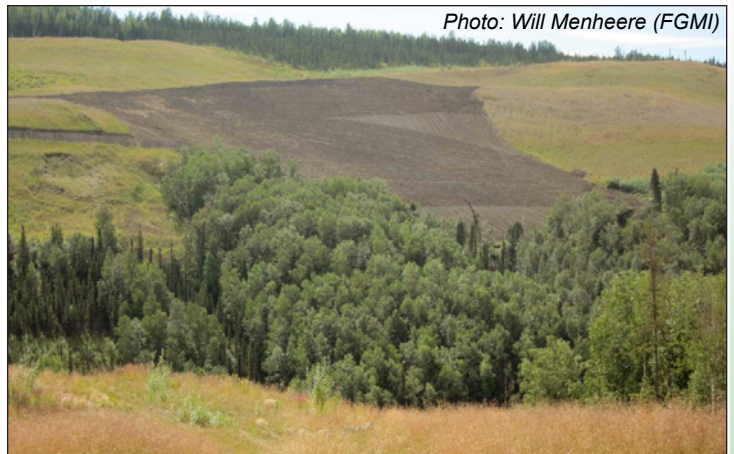
North Shepard dump - mid August 2010.  
Area reworked in July, 2010; surrounding area seeded in 2007.

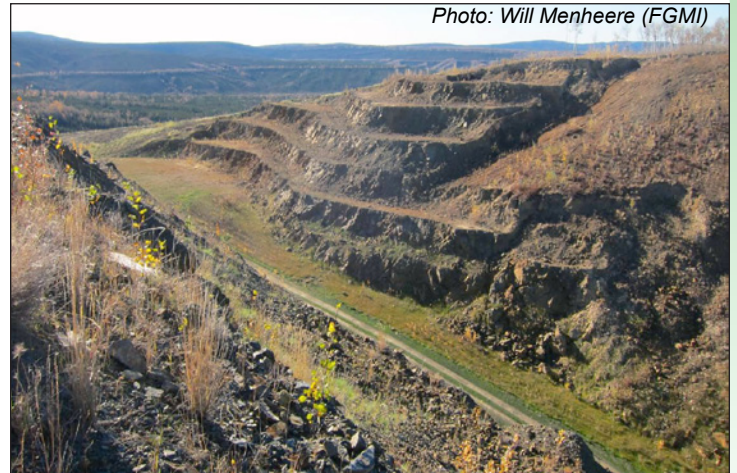
**Shepard pit vegetation - August 2010. Note: Pit walls were never seeded; growth is due to natural reinvasion.**

In addition to the applied seeding, natural re-invasion of native species has occurred throughout the mine. Areas such as the pit walls where no revegetation effort was made now contain eight-foot high birch saplings (volunteer species) on several benches. Areas reclaimed in 2007 now contain large patches of willow/alder/birch in addition to seeded grasses.

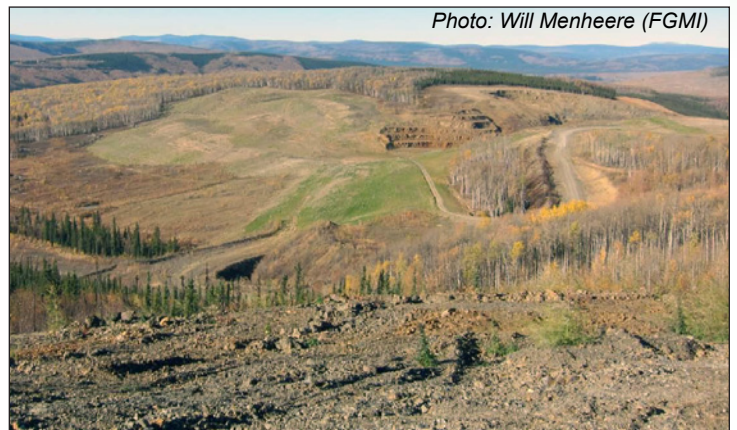
**South Shepard dump revegetation progress - early September, 2010 (area seeded late July, 2010)**

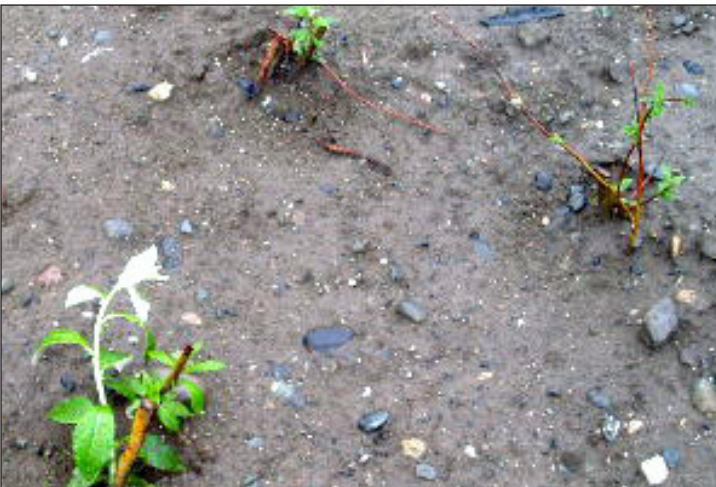
Well established leaves on willow live stakes

Revegetation material planted on the project site has become established. Vegetation growth and vigor was greatest near the water's edge in all three wetland locations. This is probably due to increased moisture availability in these lower areas. A large portion of the project site had soil consisting of sandy gravel, with little moisture holding capacity. About 80% of the dormant willow cuttings that were planted survived.

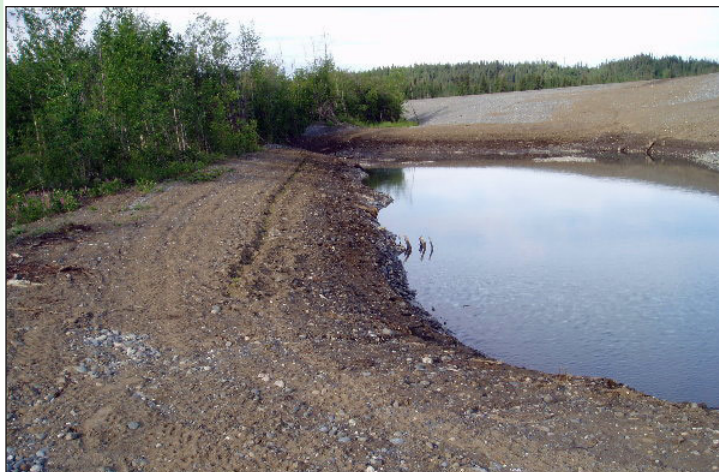
Southwest wetland - mid June, 2006

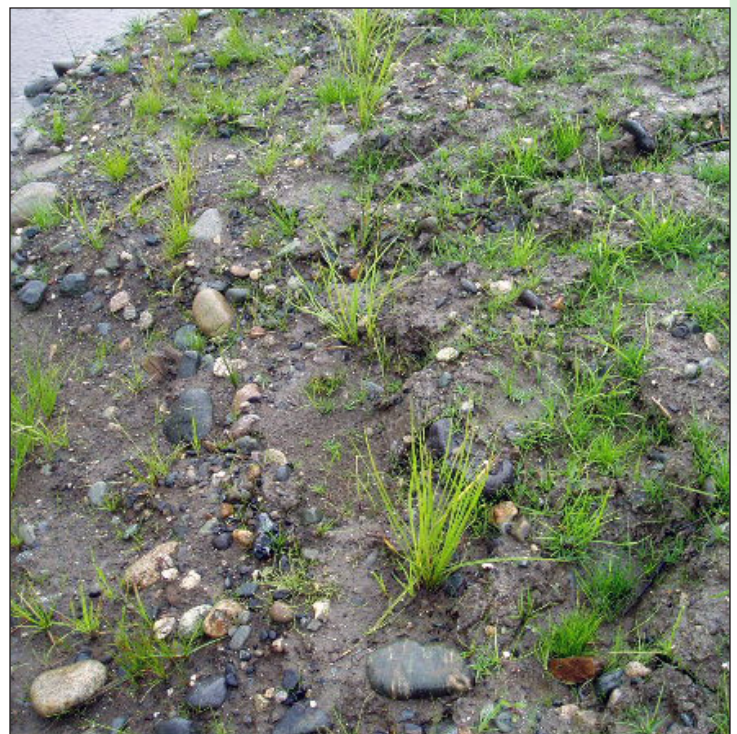
Established seedlings and transplants

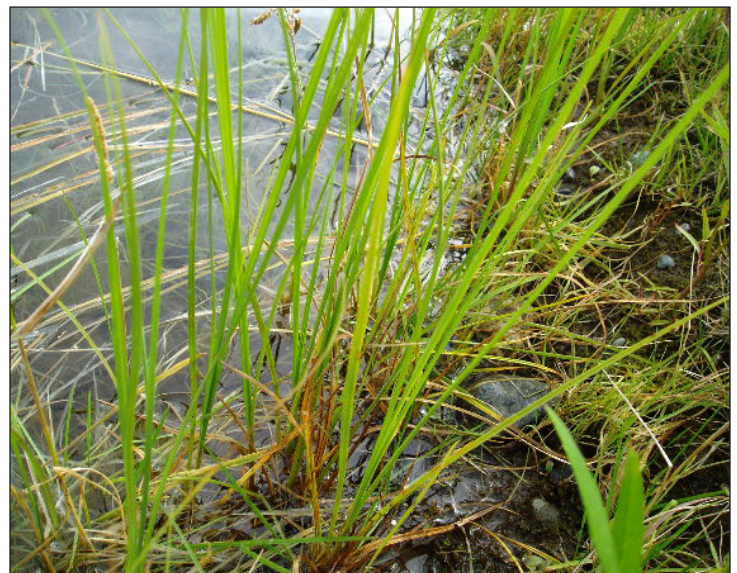
Thriving sedge transplant

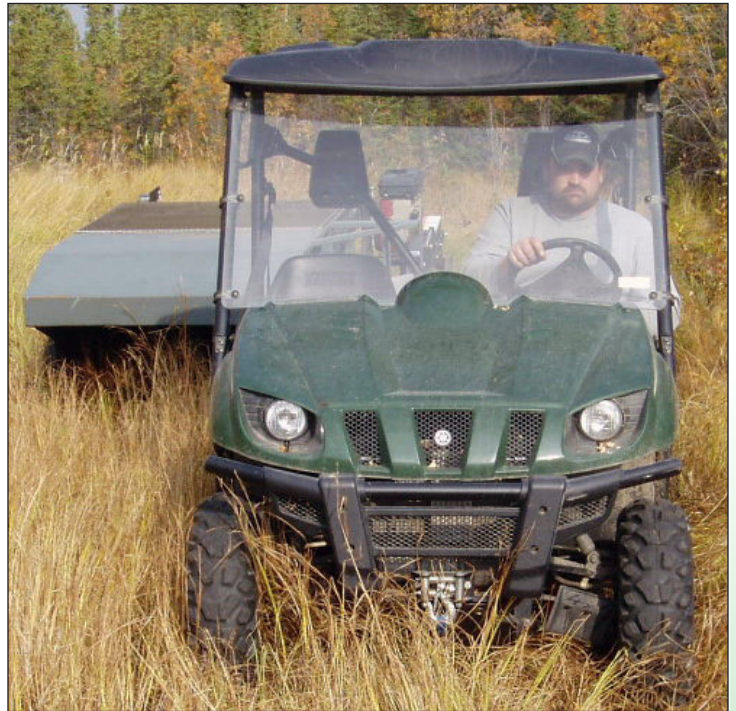
Mechanical seed stripper towed by an ATV

Seed for the project was acquired from commercial sources, or collected from the project area. Field collection of seed occurred in the fall of 2004 and 2005 with the use of a mechanical seed stripper towed behind an ATV. The area selected for harvest was easily accessible and had the desired wetland plant material present, consisting of Water Sedge (*Carex aquatilis*), Northwest Territory Sedge (*Carex utriculata*), and Bluejoint Reedgrass (*Calamagrostis canadensis*). A total of three pounds of seed was collected in 2004.

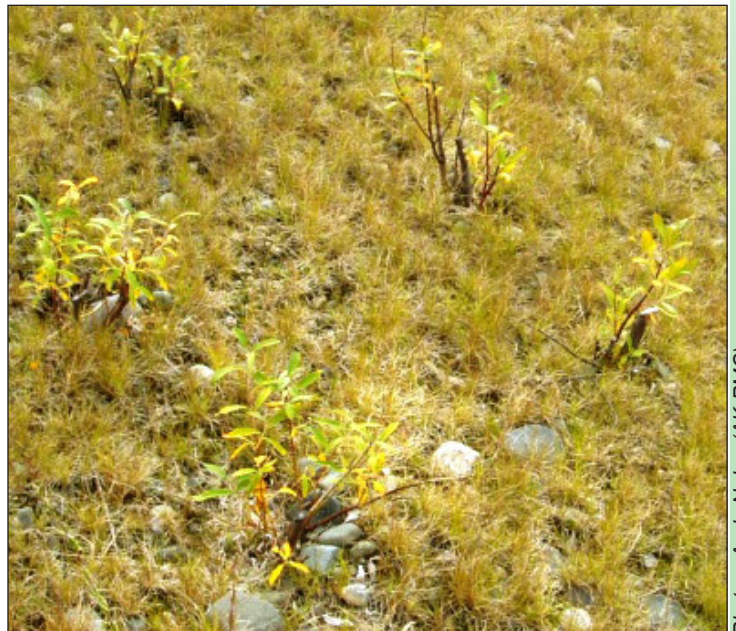
High survival rate for planted dormant willow cuttings

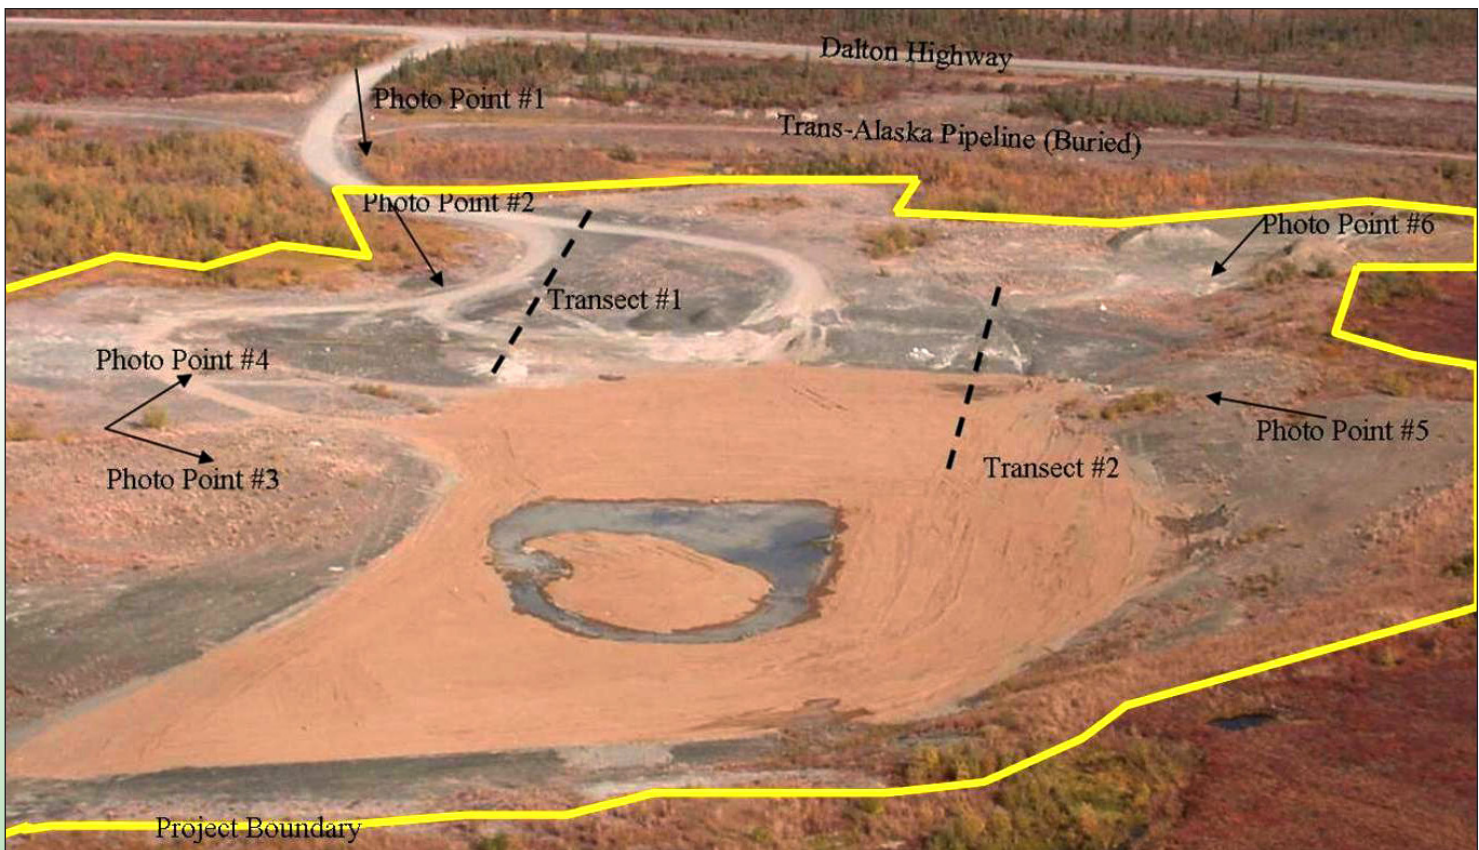
Aerial overview of Kanuti pit materials site, after grading and site preparation - Summer, 2002

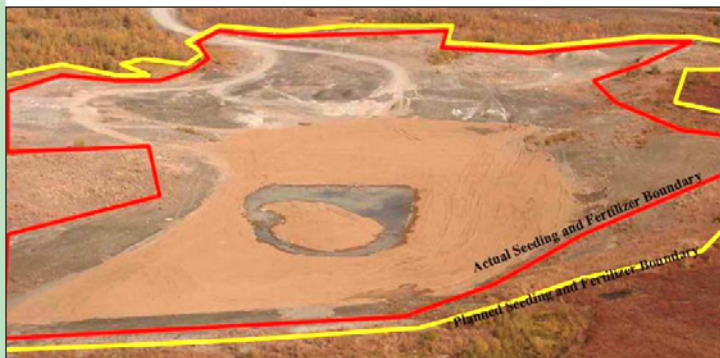
This photo depicts the planned seeding and fertilizer application boundary (in yellow) with the actual application boundary (in red), based on monitoring observations.

One area of the project exhibited less plant cover than other areas during the 2006 monitoring. Soil in this area consisted of sandy gravel. This area was also inaccessible during the site preparation phase, due to snow drifts. The low plant coverage may be due to no organic soil being spread in this area. Organic soil in this area would increase the moisture holding capacity of the sandy gravel soil and provide a better substrate for vegetation growth.

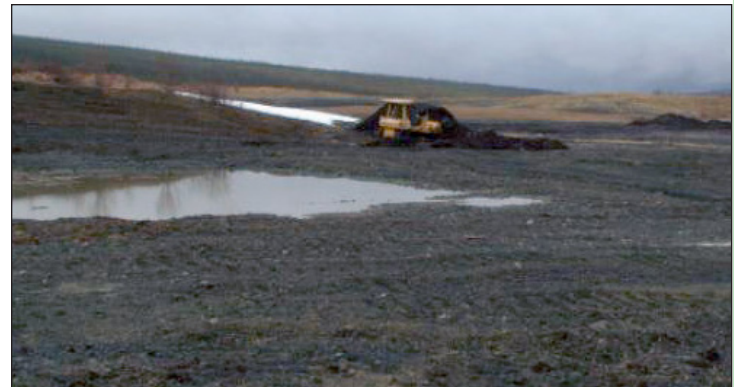
Dozer spreading organic soil during site preparation phase - June, 2003

Site preparation continued in 2003, with the spreading of organic soils by a dozer. To encourage invasion of alder and willow species, 'ripping' of the site was specified in the revegetation plan. The dozer did not include a ripper, however. Instead, the site was track-walked to create micro-catchments for seed and fertilizer and moisture.

The shortcomings of the Kanuti Pit Rehabilitation resulted from poor planning and not having the right equipment. The dozer was not equipped with a ripper as called for in the work plan. The track-walking technique used was the next best option. A ripping implement would have reduced soil compaction and created larger catchments for seed, fertilizer, and moisture. It may have also better supported woody species establishment.

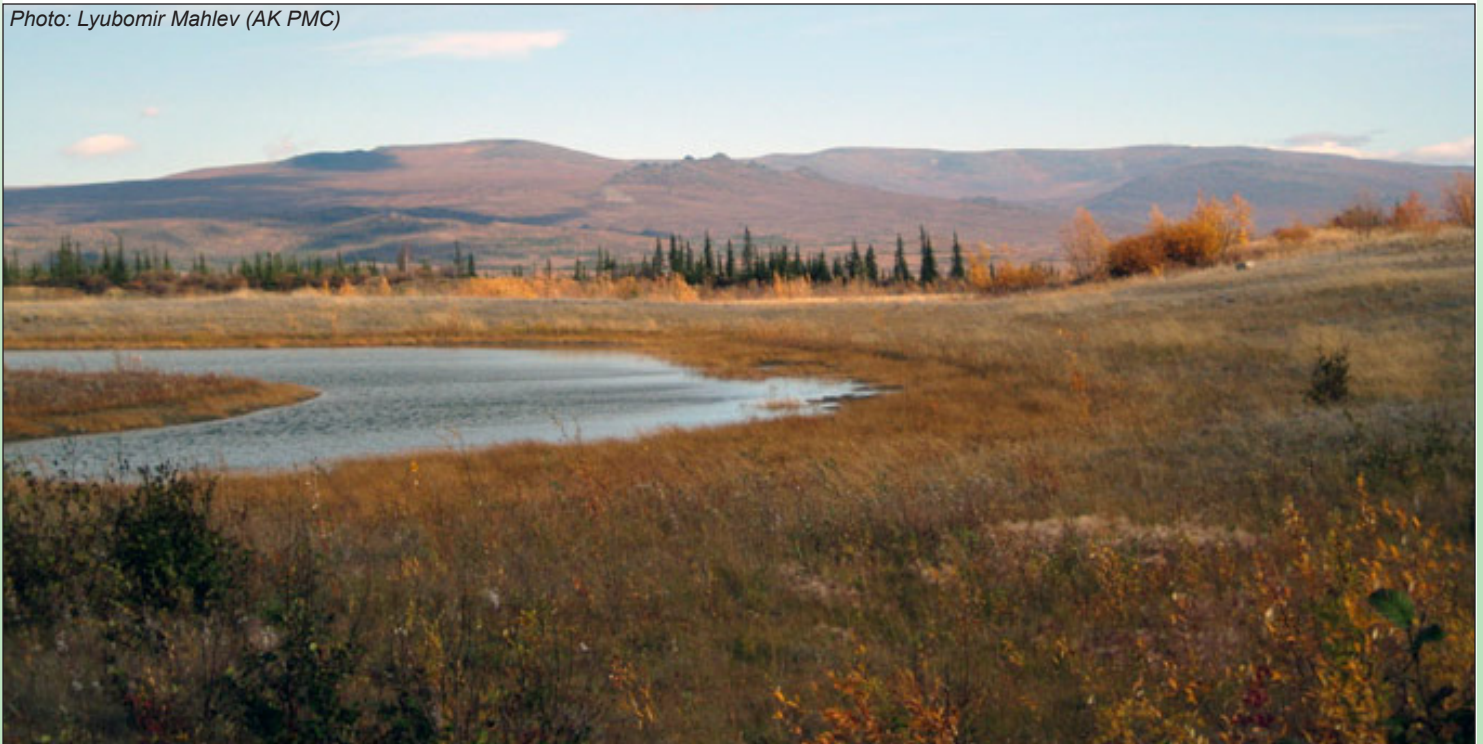
Rehabilitated Kanuti pit materials site - Summer, 2009

In 2010, satisfactory performance of seeded grasses was observed. High density plant cover was also noted in the 2010 monitoring. Planted species were evident and natural re-invasion of other native species was observed. Wetland areas were holding water, promoting the development of niche wetland habitats. Monitoring will continue through 2013.

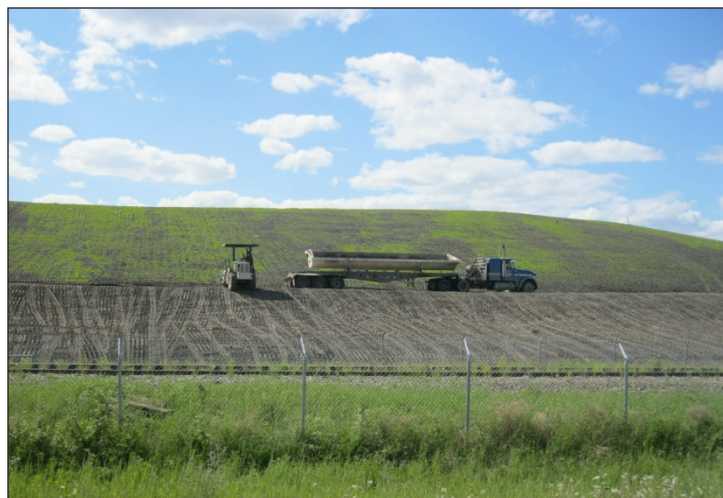
Site recontoured before topsoil placement - mid June, 2010

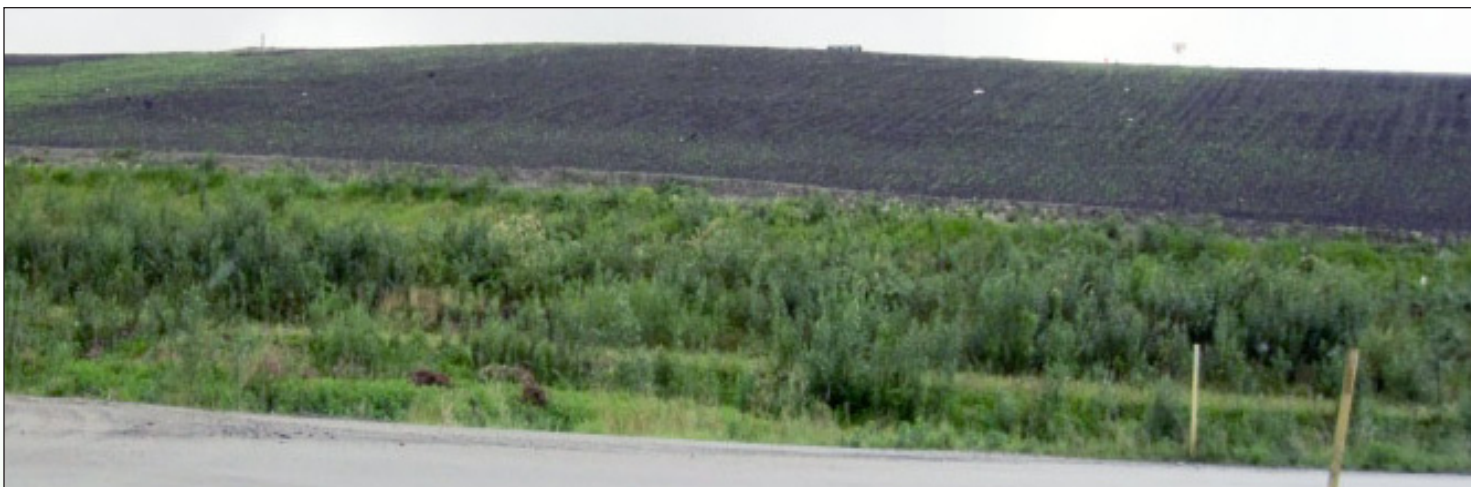
Two feet of N-Viro treated sludge was deposited on cell C/D - early June, 2010

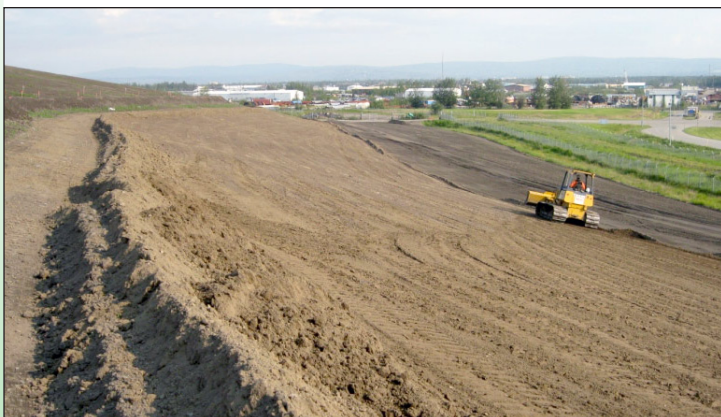
Salvaged topsoil was applied in a 6" layer all over the site.

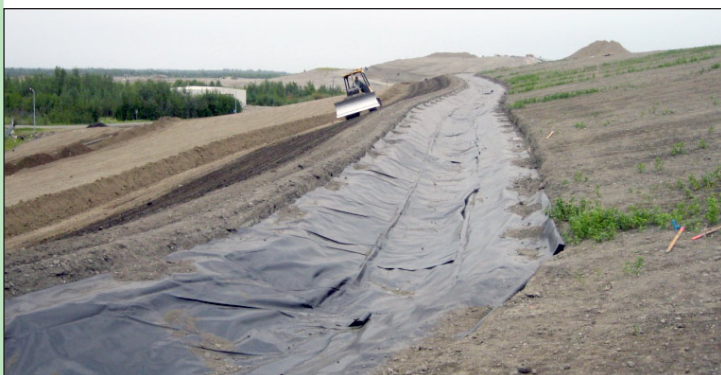
A rubber liner was placed along the length of the ditch in late June, 2010.

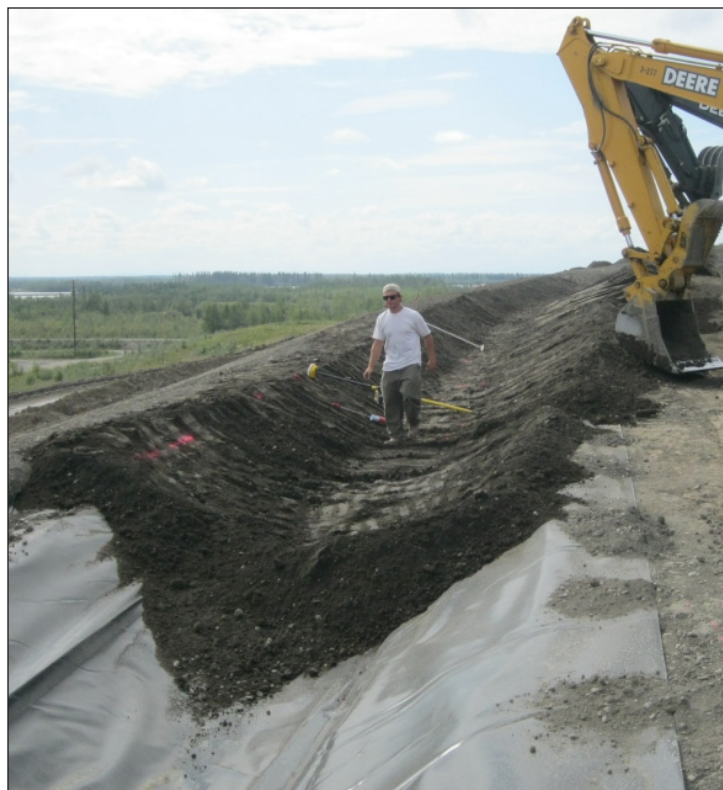
The ditch was filled in a three step process: 6" of gravel was placed over the rubber liner, followed by 18" of silt, and then capped with 6" of topsoil in early July, 2010.

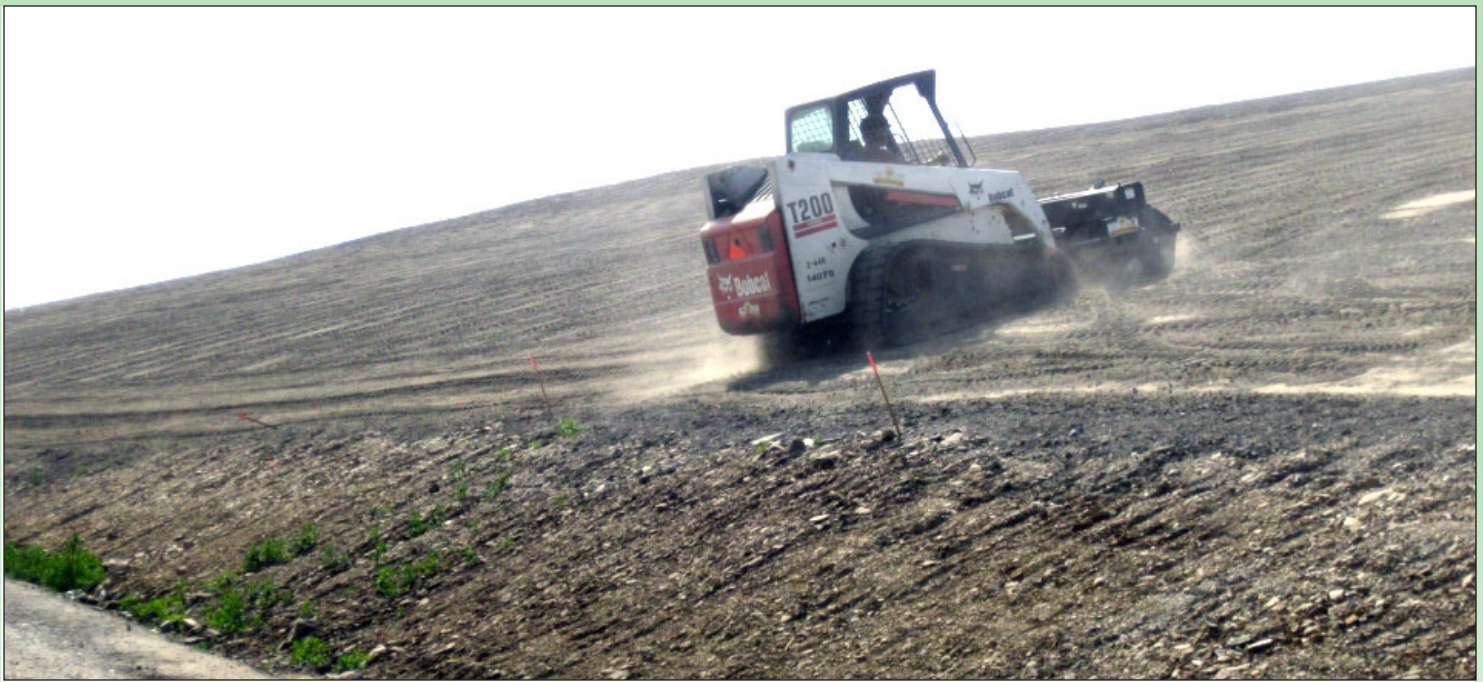
A Bobcat T-200 dozer with a drill seeder attachment applies a seeding mixture to the site.

Ninety percent of the project area was drilled in one direction using a Bobcat T-200 with a drill seeder attachment. After drill seeding, the areas were sprayed with a light application of Eco-Fibre/Plus, containing tackifier in the mulch. The purpose of the mulch application was to moderate soil surface temperatures, conserve soil moisture, and increase seed germination.

Drill seeding is the preferred method of seeding when site conditions allow. Hydroseeding required more human maintenance (watering), so this method may not be appropriate for remote sites or areas without an available water supply.

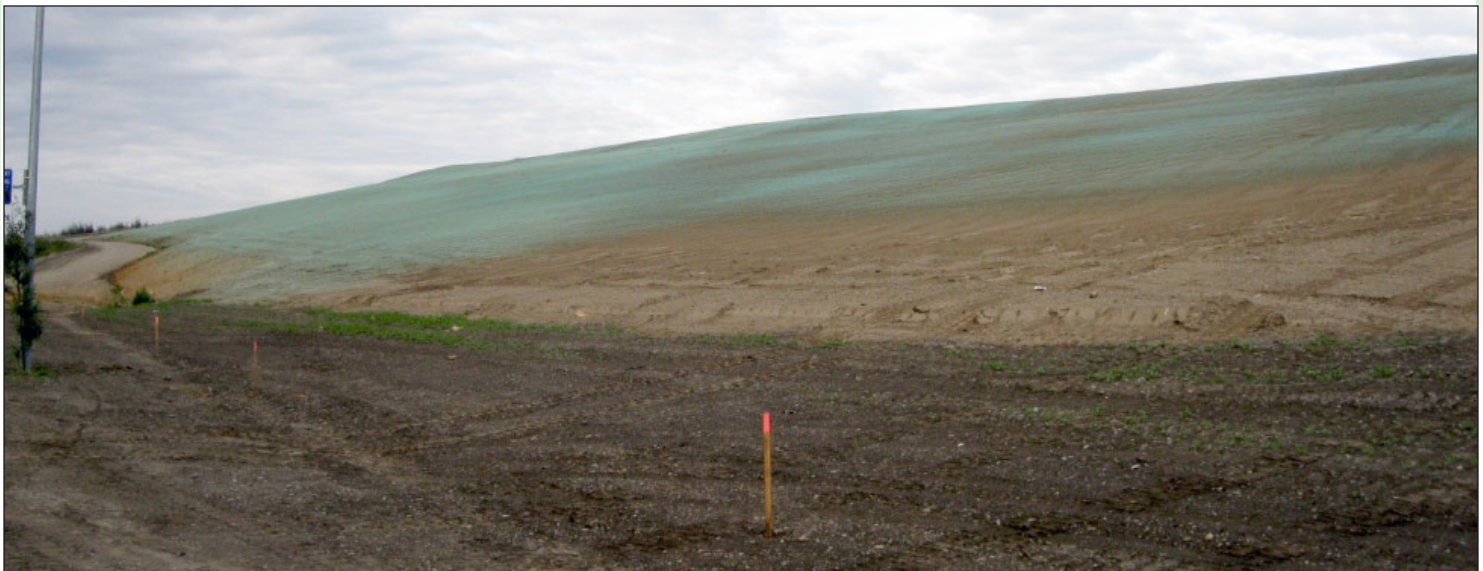
A hydro-mulch application of Eco-Fibre / Plus with tackifier was lightly sprayed over the area after drill seeding in mid July, 2010.

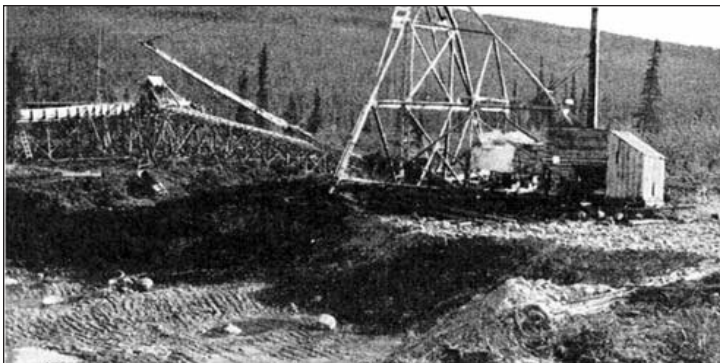
Drag-line used by a placer mining operation on Nome Creek in the early part of the 20th century.

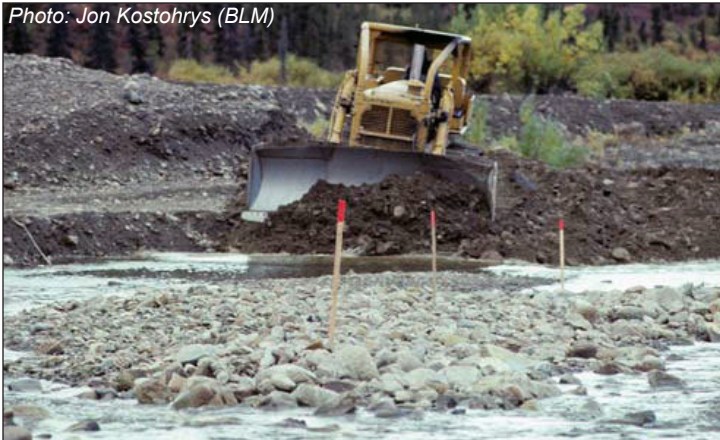
The initial step in reclamation was to fill the settling ponds using the material from the surrounding tailings piles.

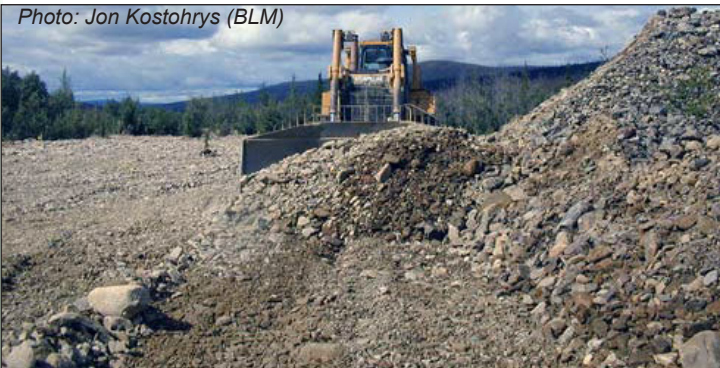
After filling the ponds, the bulldozer then graded the floodplain as flat as possible.

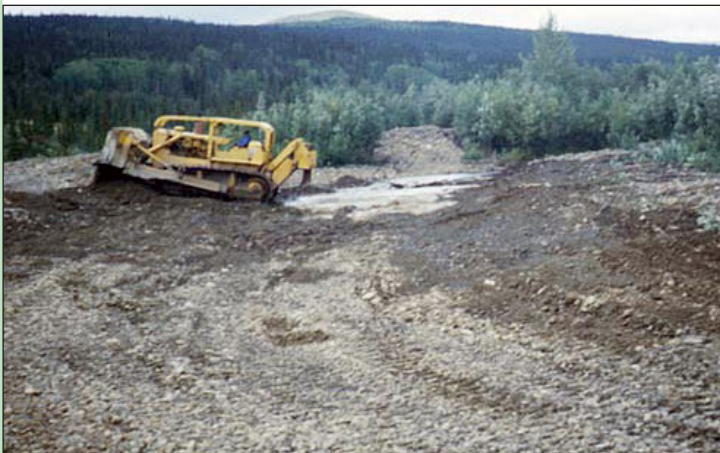
The bulldozer constructed the channel using short, almost level grading to deepen the pilot channel.

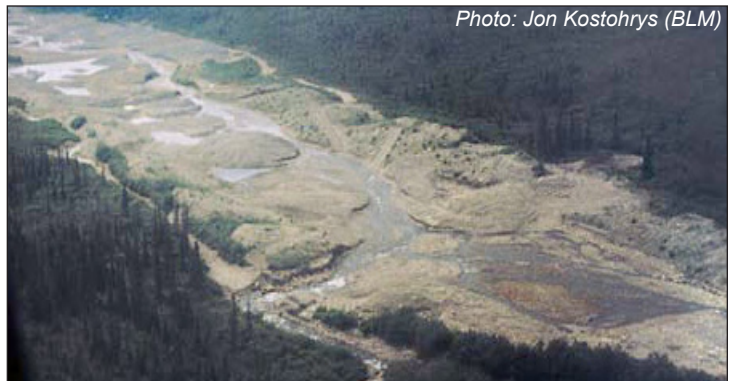
Aerial photo of Nome Creek before reclamation

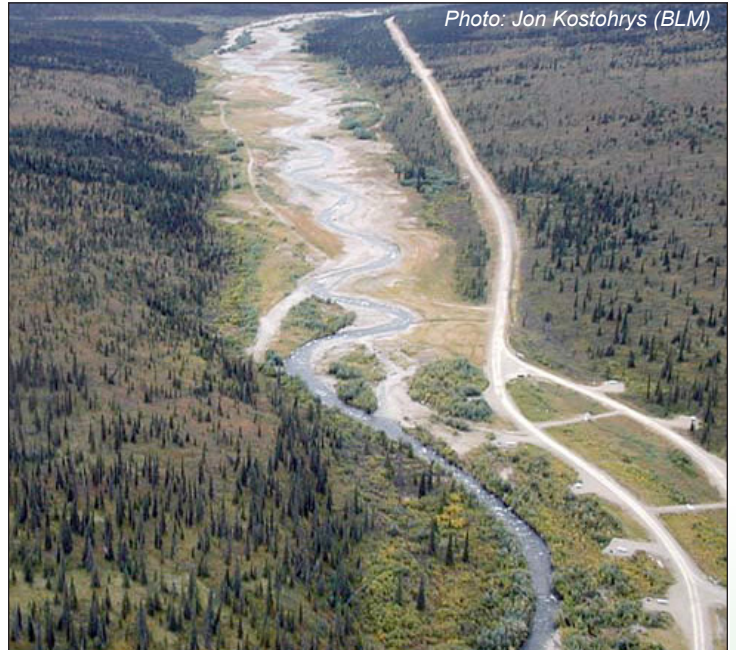
Upper Nome Creek, road, and campground after reclamation

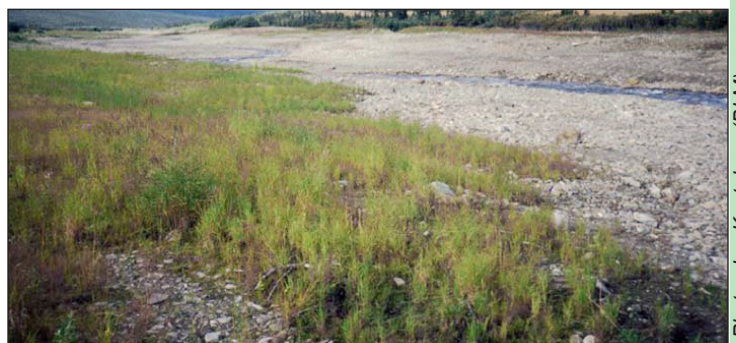
Upstream portion of the reclaimed area, showing grass establishment in 1993. Most of this grass was dead or dying by 1996.

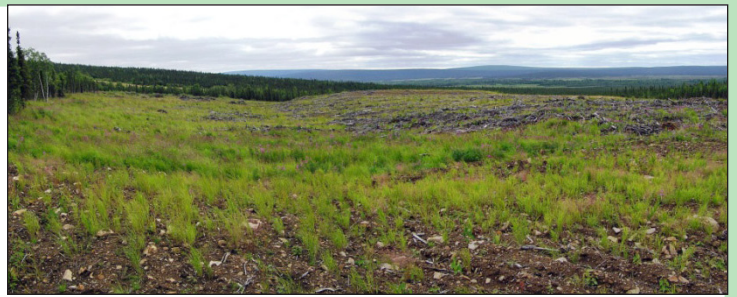
West pit waste rock dump - July, 2005

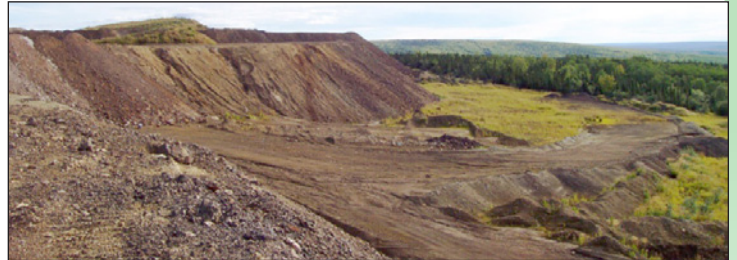
Central pit waste rock dump, before regrade - August, 2001

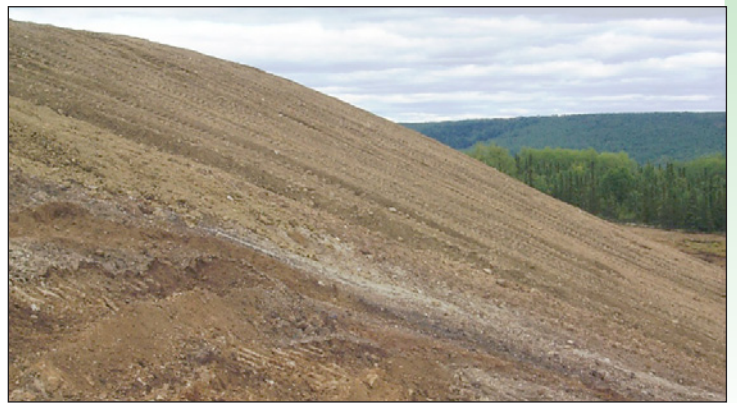
Recontoured slope at central pit waste rock dump - August,

Vegetation and topsoil was set aside and stockpiled in windrows prior to development. Waste rock was backfilled into the pit and recontoured using a dozer. The vegetative debris was spread back over the site and left in a roughened condition. Application of a seed and fertilizer mixture followed.

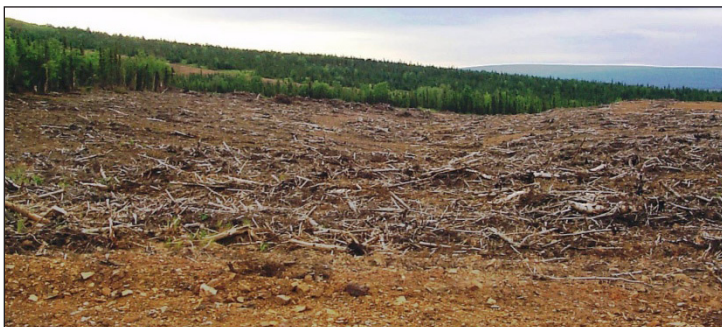
West pit waste rock dump - July, 2003

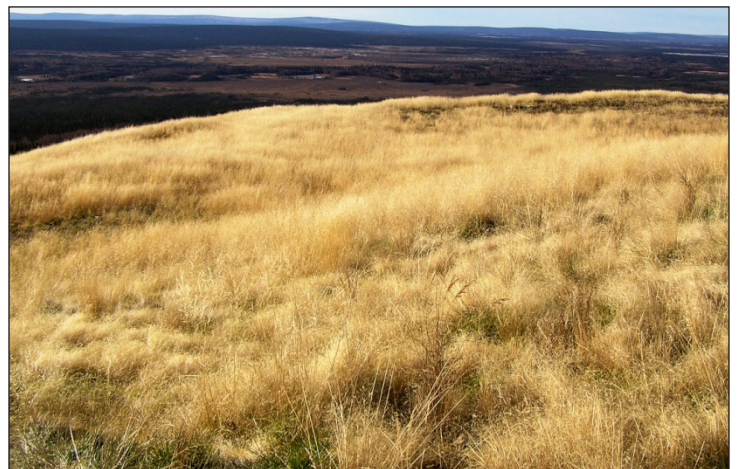
Revegetated central pit waste rock dump - October, 2004

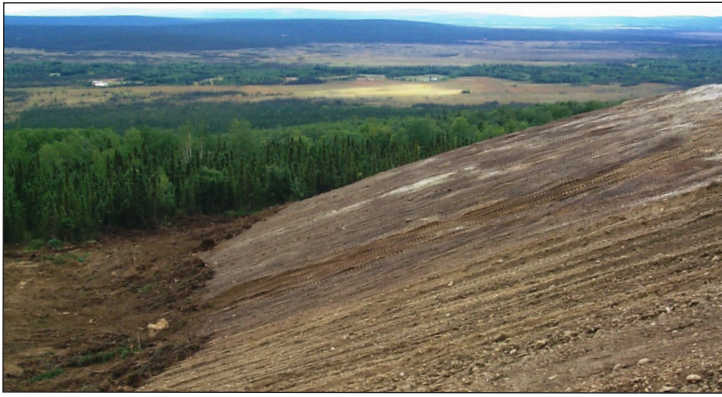
SW corner of central pit waste rock dump - August, 2002

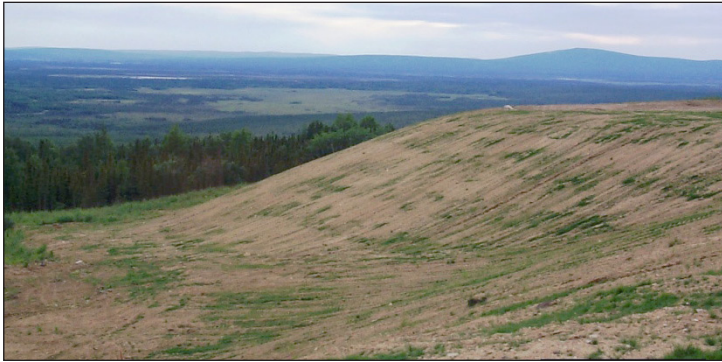
SW corner of central pit waste rock dump - July, 2003

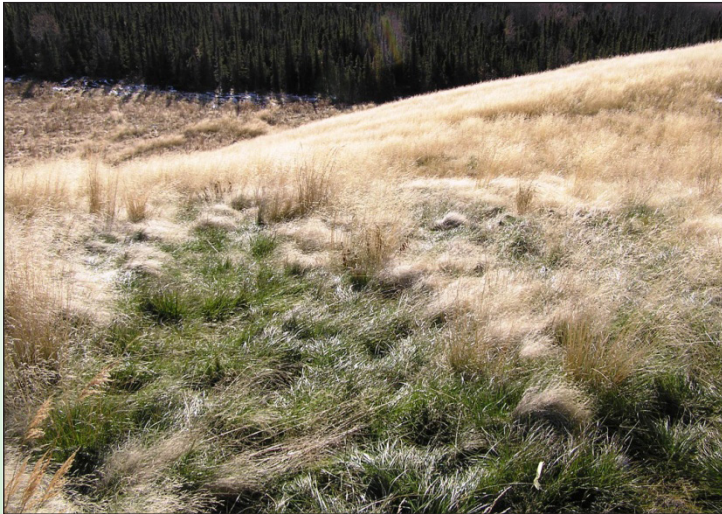
SW corner of central pit waste rock dump, - October, 2004

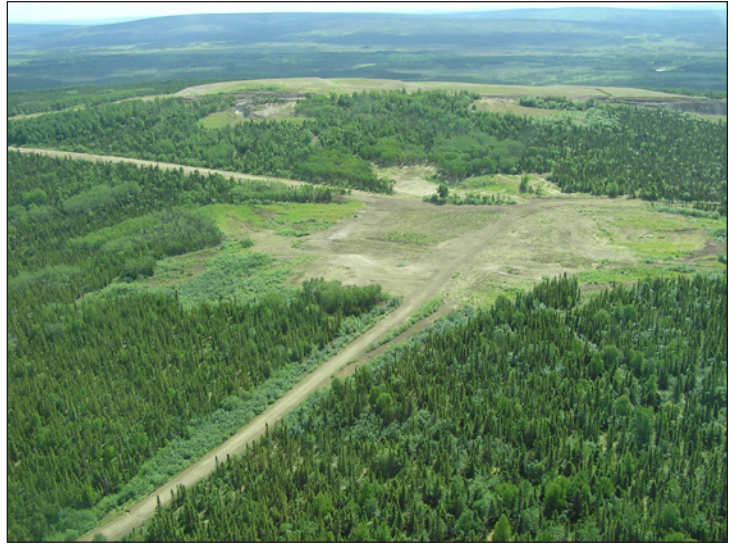
Reclaimed office / shop area - June, 2009
