**ASSESSMENT OF EROSION AND PLANT COVER  
ON THE TRANS ALASKA PIPELINE  
RIGHT OF WAY  
MILEPOSTS 0 TO 800  
VOLUME 2**

**PREPARED FOR  
THE STATE PIPELINE COORDINATOR'S OFFICE  
ALASKA DEPARTMENT OF NATURAL RESOURCES  
SEPTEMBER, 1992**

**PREPARED BY  
NANCY J. MOORE  
ALASKA PLANT MATERIALS CENTER  
DIVISION OF AGRICULTURE  
ALASKA DEPARTMENT OF NATURAL RESOURCES**

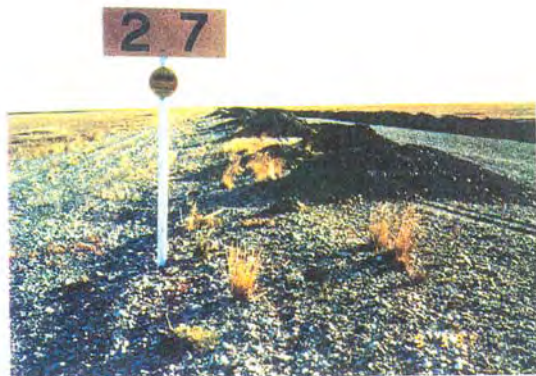
Milepost 28 in the floodplain.

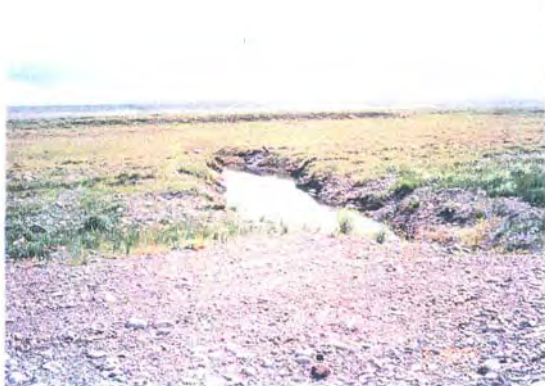
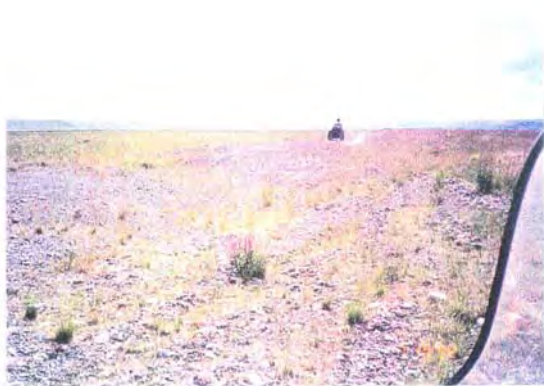
Mileposts 63 and 64. Thermokarst activity (refers to all four photographs).

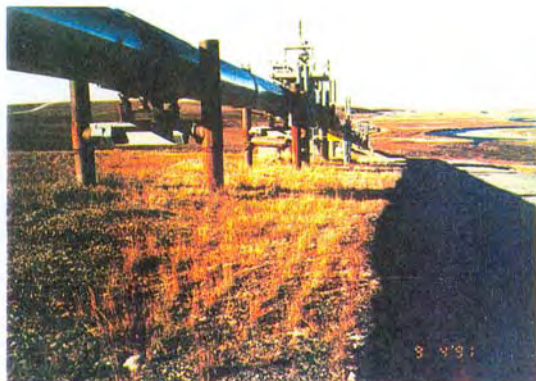
Milepost 84 in the floodplain.

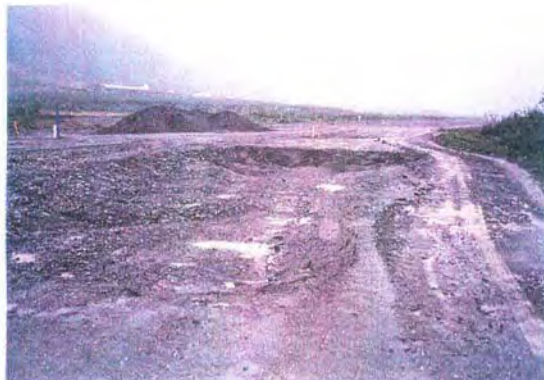
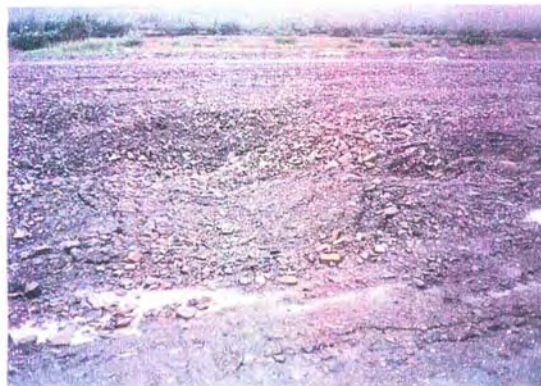
Mileposts 172 - 172.2. After corrosion dig in 1992 - workpad is subsiding.

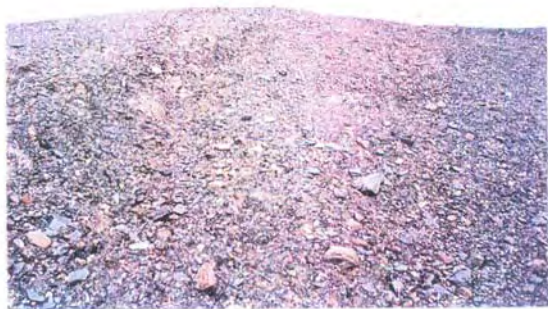
Thermokarst adjacent to workpad at approximately 174.8.

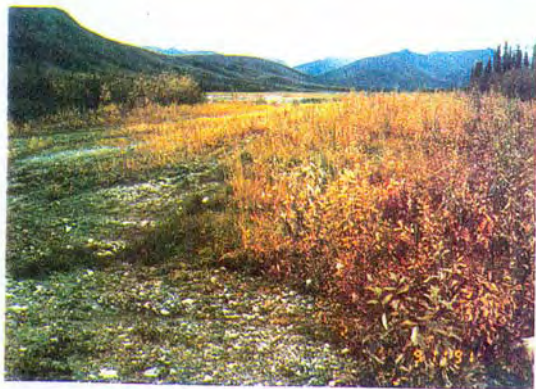
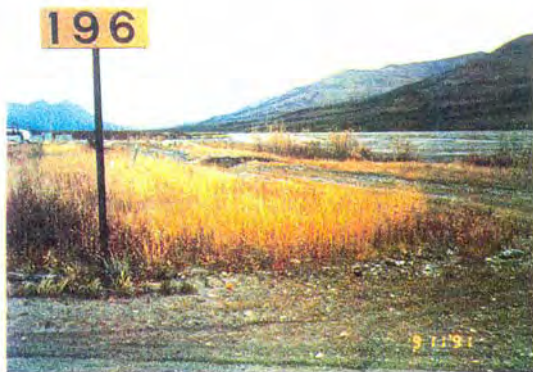
Milepost 195 in the floodplain.

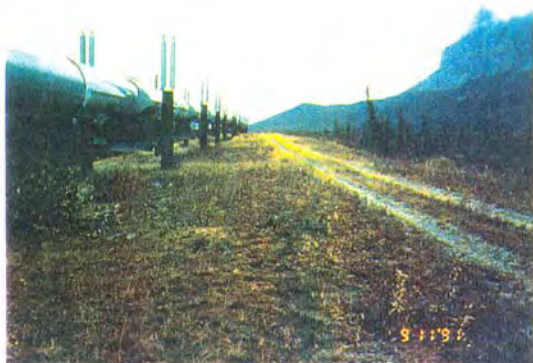
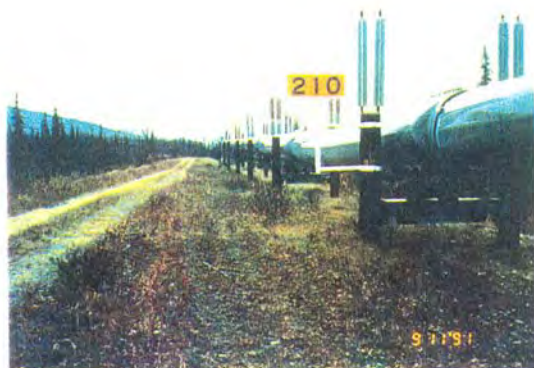
Milepost 211 in the floodplain.
